DIAGNOSTIC/TYPICAL SIGNATURES

February 1st, 2013

Contents per Brand and Model

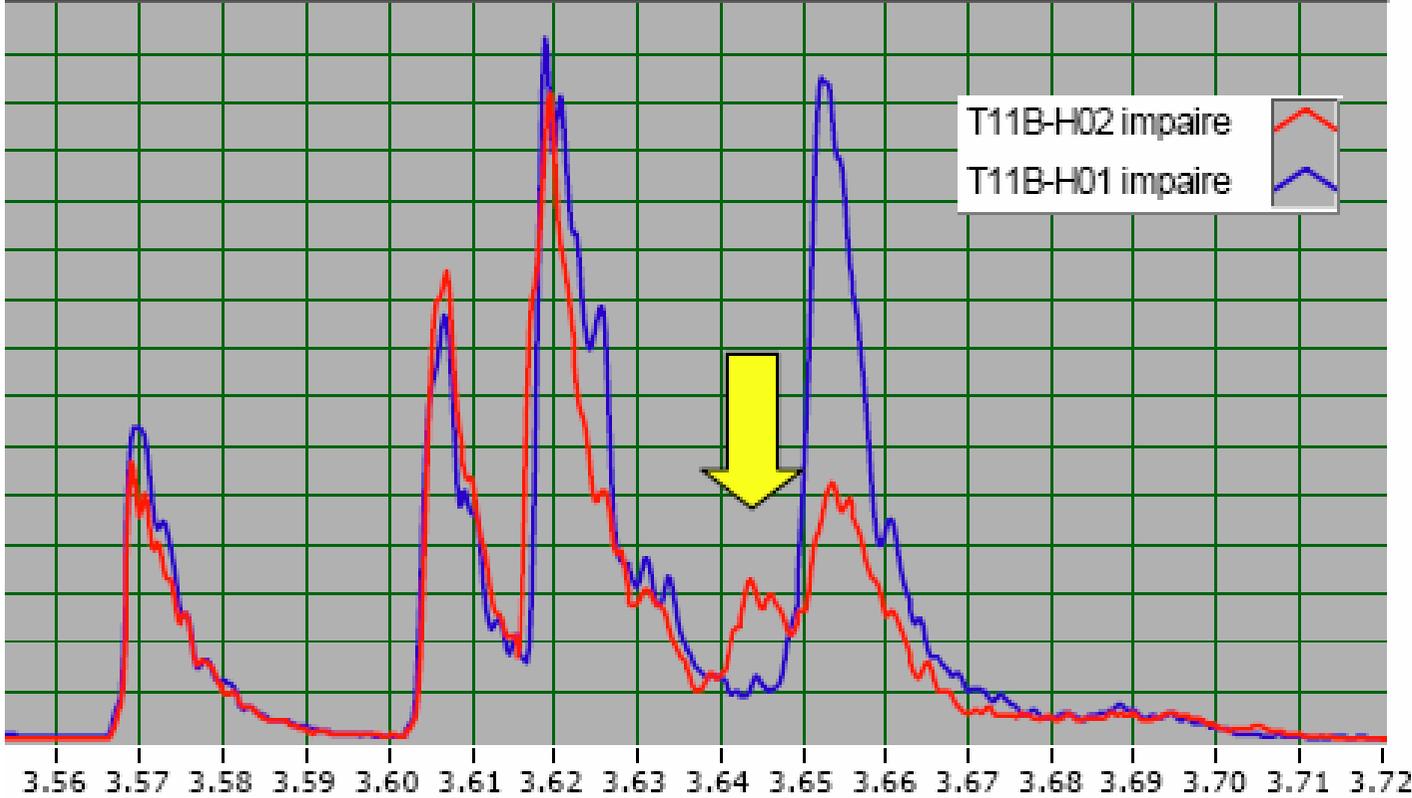
#1 ABB – UC (B, C, D, G and L) and UZ (B, C, D, E and F) - Braid improperly installed

<p data-bbox="1093 432 1469 544">T11B-H02 impaire T11B-H01 impaire</p>	<p data-bbox="1653 619 2123 834">The signature of a switch with a braid improperly installed (red trace) is easily distinguished from a normal switch (blue trace).</p>
<p data-bbox="91 1166 2022 1241">Notes: An improper installation of the braid may interfere with the operation of the mechanism and eventually cause its failure.</p>

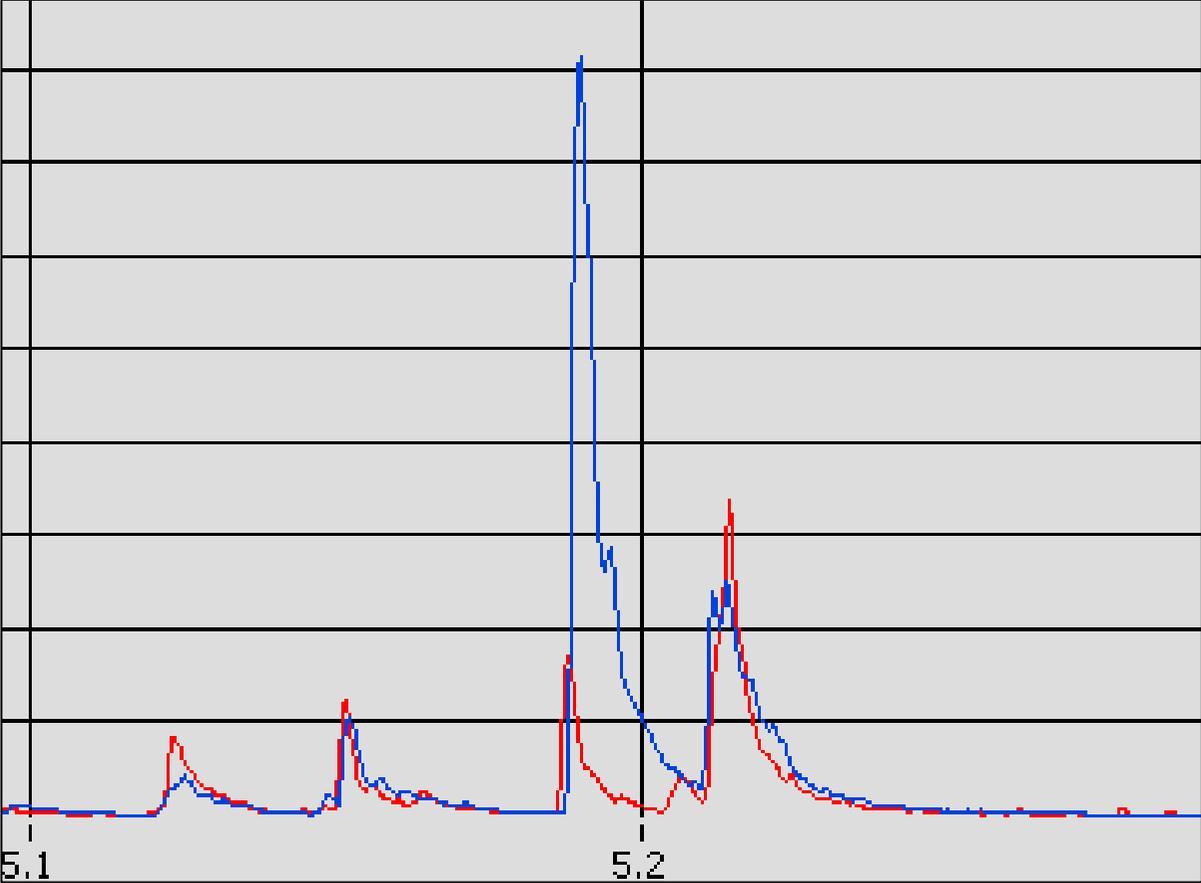
#2 ABB – UC (B, C, D, G and L) and UZ (B, C, D, E and F) - Bending of the moving main contact arm

<p>As a result of repeated impacts during normal operations, the copper arm of the mobile contacts is bent and the minimum distance between mobile and fixed points of tungsten (0.5 mm) is no longer respected. This anomaly may cause local overheating due to the lower conductivity of tungsten. This anomaly is visible on the noise impact of arcing contacts. To discern the phenomenon of wear, you can note that the bending of the moving contact's arm does not alter the sequence. (red trace) is contact arm bent. (blue trace) is after recovery of the arm.</p>
<p>Notes: Recovery or replacement of the main contact moving arm.</p>

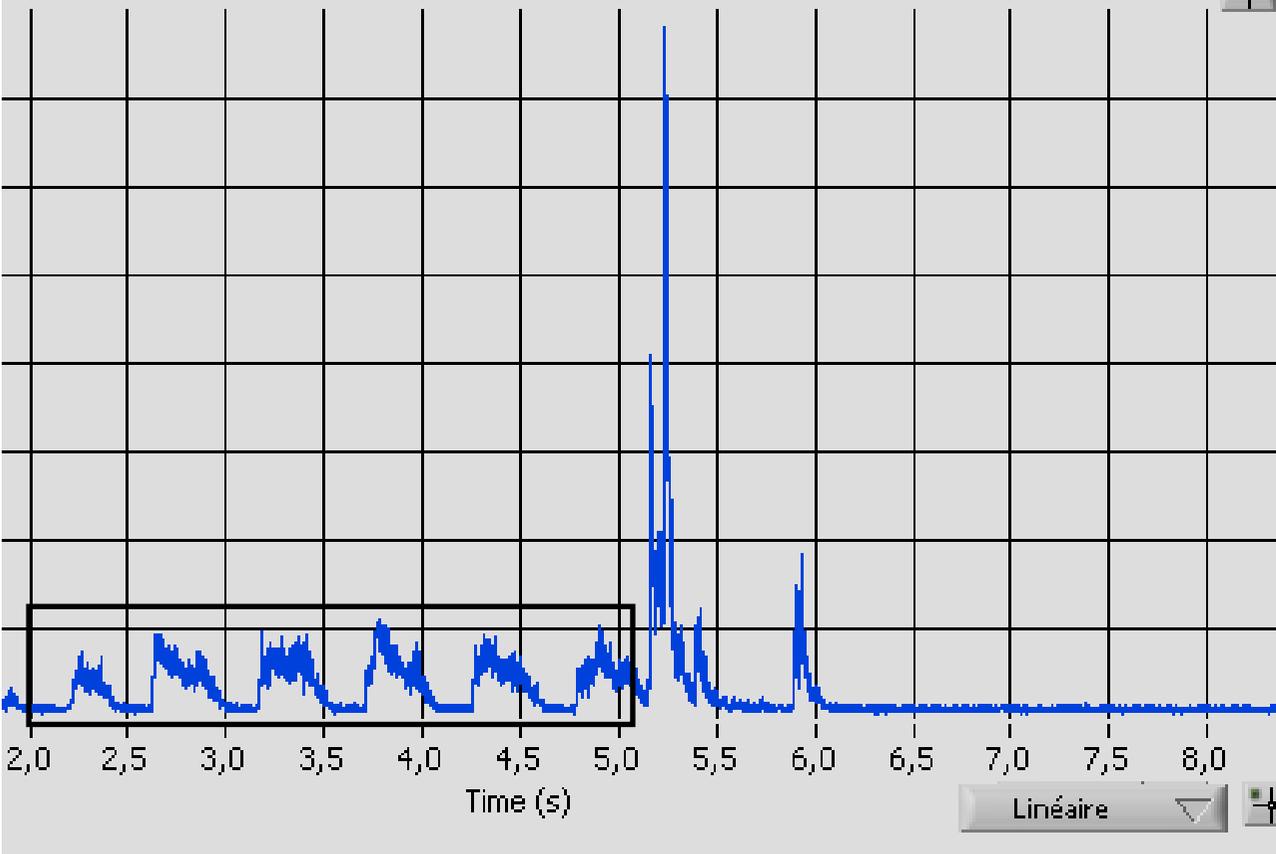
#3 ABB – UC (B, C, D, G and L) and UZ (B, C, D, E and F) - Lack of lubrication of the control gear

<p data-bbox="224 1061 1500 1181">Time (s)</p> <p data-bbox="1182 1114 1500 1157">Linéaire</p>	<p data-bbox="1641 598 2136 917">A lack of lubrication of the gear drive mechanism may affect the acoustic signature as shown in this example. This phenomenon is highlighted in particular in the signature of the lower frequencies.</p>
<p data-bbox="91 1198 203 1230">Notes:</p> <p data-bbox="869 1241 1346 1278">Lubrication of the control gear.</p>

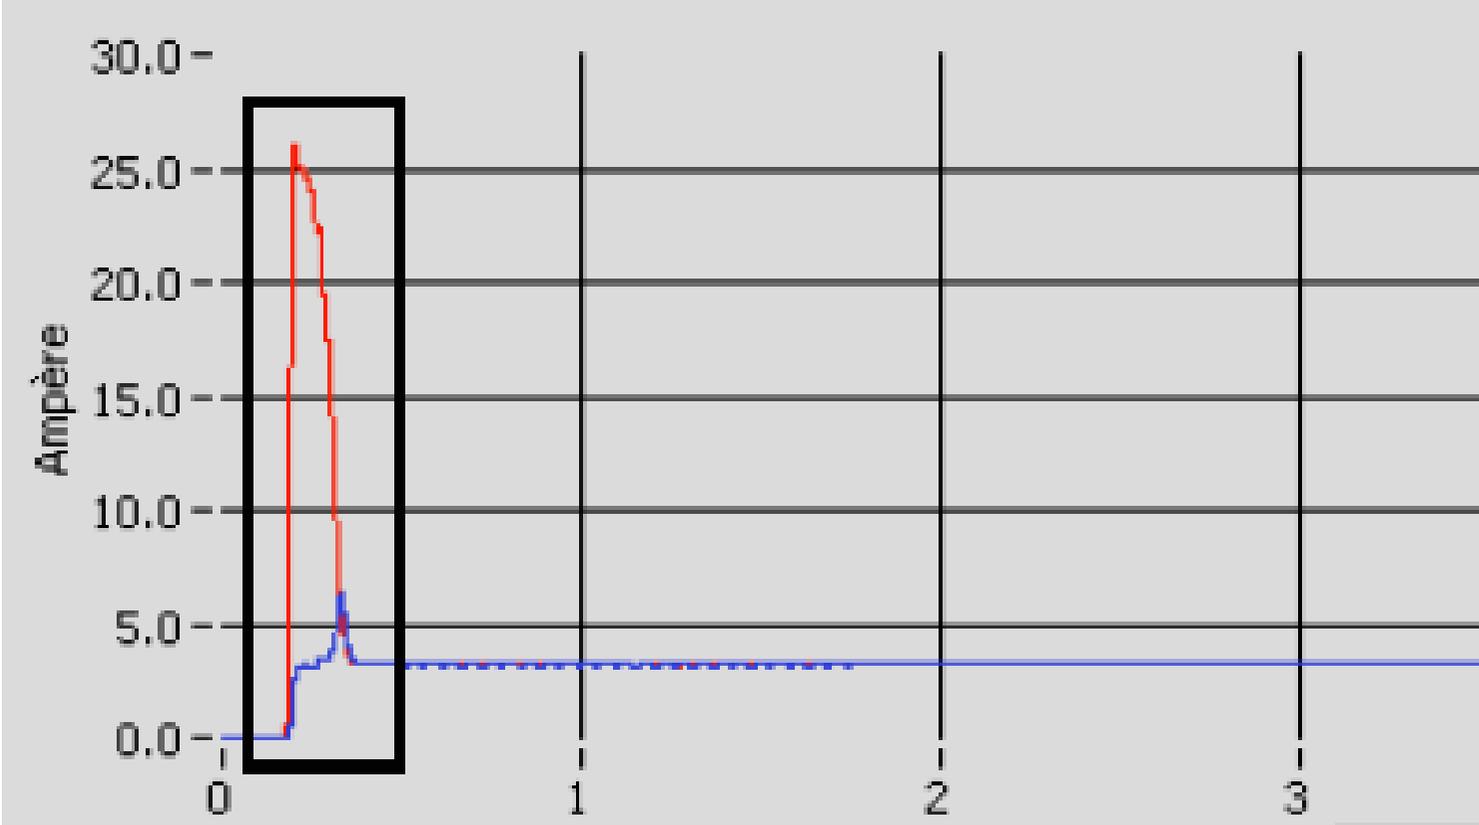
#4 ABB – UC (B, C, D, G and L) and UZ (B, C, D, E and F) - Slack in the control rod

<p>An important slack in the control rod can be shown in the signature of the motor current as shown above. When the motor starts with loose parts, the amplitude of the inrush current can be significantly reduced.</p>
<p>Notes:</p> <p style="text-align: center;">Tighten any loose components.</p>

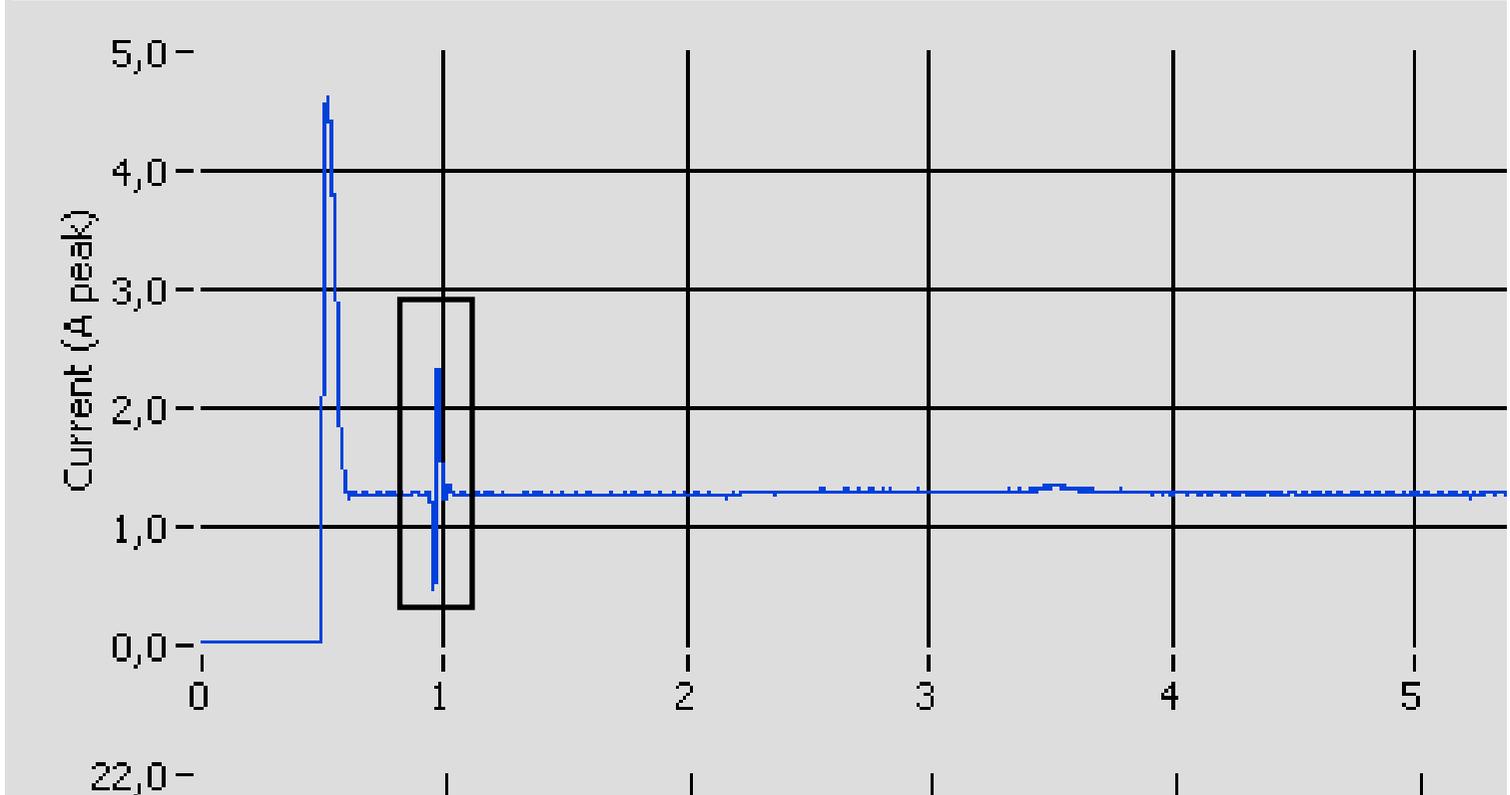
#6 ABB – UC (B, C, D, G and L) and UZ (B, C, D, E and F) - Faulty control relay

<p>Anomalies of operation or of adjustment of control relays (upward, downward, maintenance, etc.) can often be observed by rapid fluctuations of the current. These anomalies are usually benign but still indicate a deterioration of the device which can ultimately lead to a refusal to operate; the operations are jerky or jumping to a position other than the set point. From the exploitation perspective, this behavior explains the reports of skipped taps.</p>
<p>Notes:</p> <p>Monitor this activity because it can lead to faulty tap switching.</p>

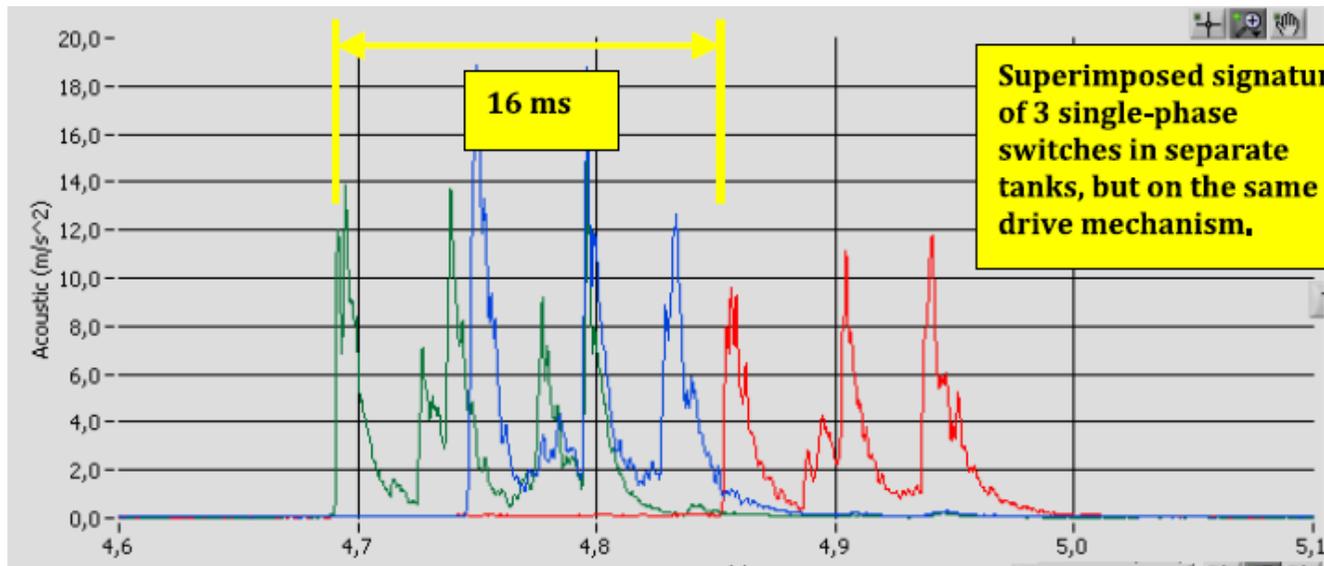
#7 ABB – UC (B, C, D, G and L) - Desynchronization between switches

Synchronization between single-phase switches can be accurately verified especially when they are in separate tanks but on a single mechanism as shown on the left. By performing the measurement with 3 accelerometers, the signatures of the 3 switches occur simultaneously and the timing is measured directly. If the manufacturer does not specify a maximum offset, the adjustment (coupling shafts) can usually be made so that the offset does not exceed 25 ms.

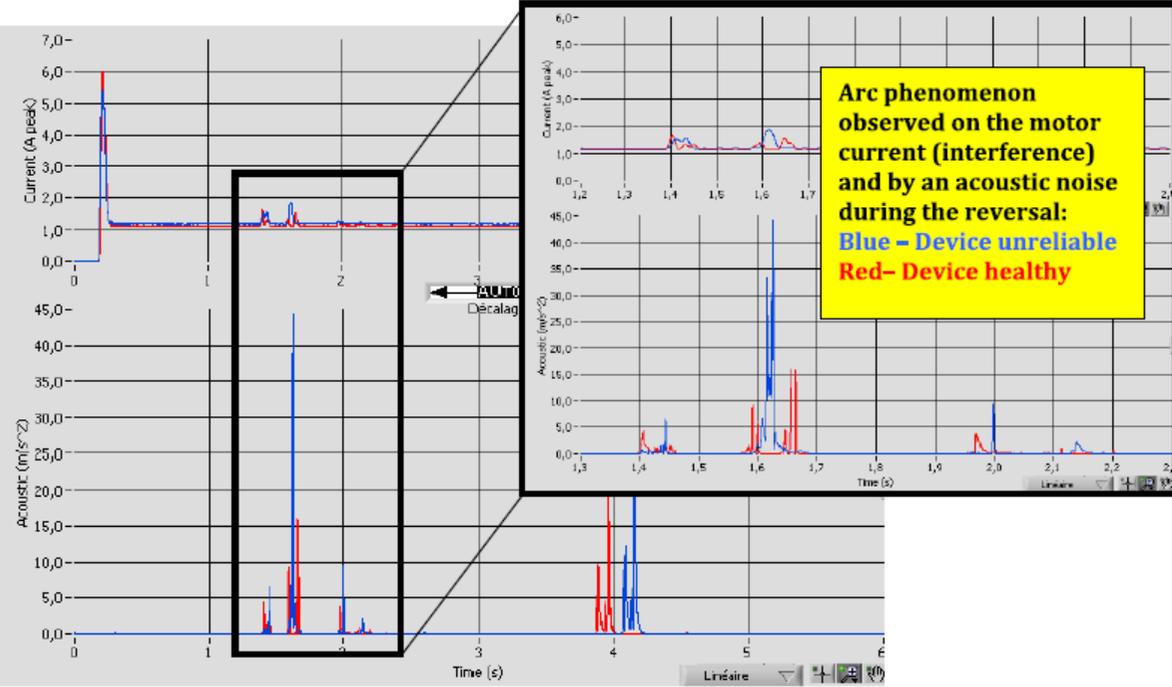
#8 ABB – UC (B, C, D, G and L) - Anomaly in the voltage limiter device

<p>The figure consists of two vertically stacked line graphs. The top graph plots 'Current (A peak)' on the y-axis (0.0 to 7.0) against 'Time (s)' on the x-axis (0 to 6). It shows two traces: a red line representing a 'healthy' device and a blue line representing an 'unreliable' device. Both show a sharp initial peak followed by a steady state. The blue trace exhibits small, irregular oscillations during the steady state. The bottom graph plots 'Acoustic (m/s²)' on the y-axis (0.0 to 45.0) against 'Time (s)' on the x-axis (0 to 6). It also shows red and blue traces. The blue trace shows significantly higher and more irregular acoustic noise peaks compared to the red trace. A yellow text box is overlaid on the right side of the graphs, stating: 'Arc phenomenon observed on the motor current (interference) and by an acoustic noise during the reversal: Blue - Device unreliable Red - Device healthy'. A black box highlights a region of the graphs between 1.5s and 2.5s, which is magnified in a smaller inset graph to the right.</p>	<p>Description</p> <p>The operation of the inverter under voltage causes a low-intensity arc, which is picked up by the current clamp (for electromagnetic interference) by means of the acoustic noise of the spark. It can often be observed at the time of the contact separation, a few alternations to 120 Hz corresponding to voltages peaks.</p>

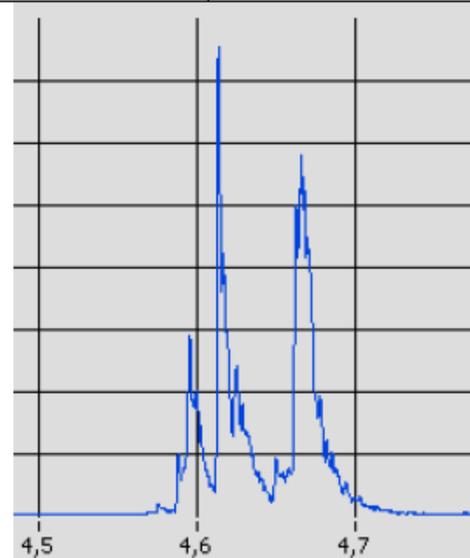
<p>Time of transition barely perceptible</p>	<p>When the transition time is barely perceptible by a visual examination of the acoustic signature, the most likely causes are:</p> <ul style="list-style-type: none"> -Misalignment of the mechanism (pass-through bolts) -Wear of the mechanism -Wear of the driving ring <p>These anomalies are followed by an assymetry between even and odd operations. Contacts badly worn may also complicate the identification of the 3rd pic, but without causing an assymetry.</p>

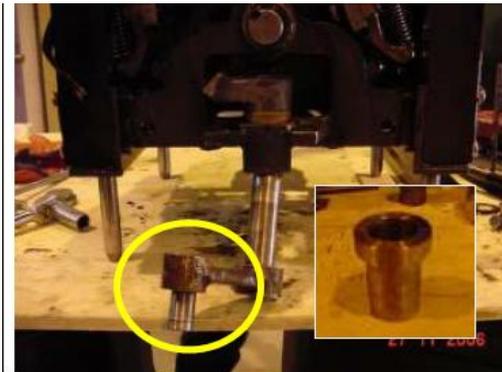
Wear of driving finger and ring

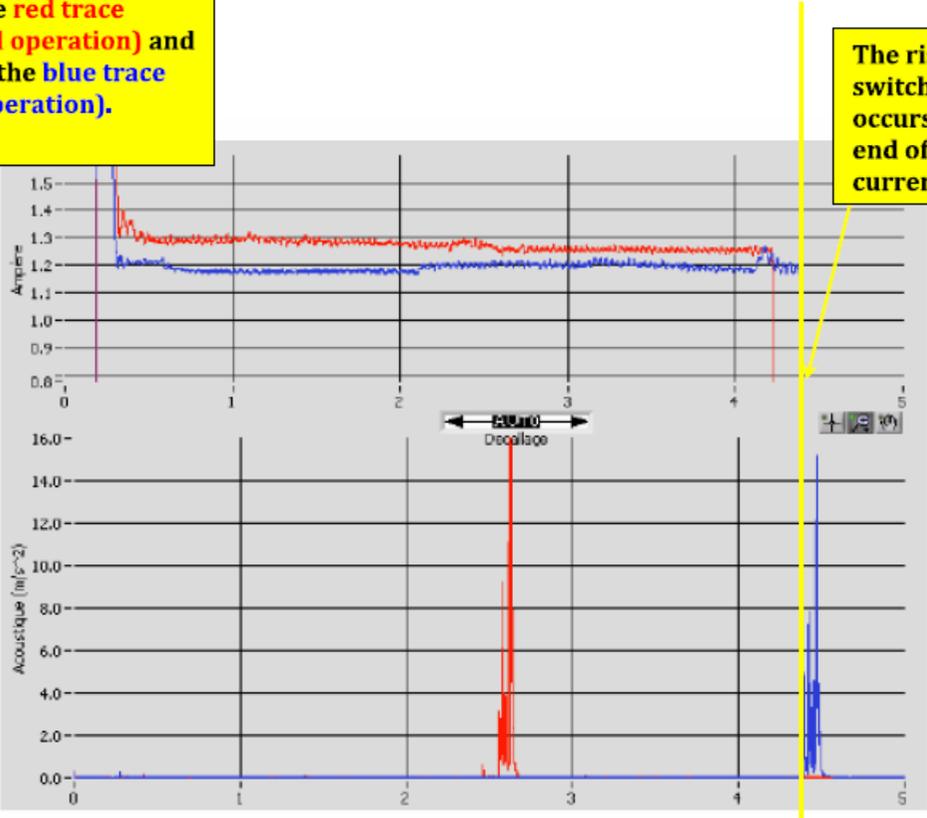
Pictures	Description
<p data-bbox="152 331 519 539">The switching occurs too early on the red trace (downward operation) and too late on the blue trace (upward operation).</p>

<p data-bbox="1137 403 1384 579">The rise of the switching occurs after the end of the motor current!</p> <p data-bbox="750 783 891 826">Emission Decalage</p> <p>The figure consists of two vertically stacked plots sharing a common x-axis representing time from 0 to 5 seconds. The top plot shows 'Amplitude' on the y-axis, ranging from 0.8 to 1.5. It features two traces: a red trace and a blue trace. Both traces start at approximately 1.3, drop to about 1.2, and then remain relatively stable. A vertical yellow line is drawn at approximately 4.5 seconds. A yellow callout box points to the blue trace at this time, stating 'The rise of the switching occurs after the end of the motor current!'. The bottom plot shows 'Acoustique (m/s^2)' on the y-axis, ranging from 0.0 to 16.0. It features two traces: a red trace and a blue trace. Both traces show a sharp peak at approximately 2.5 seconds, labeled 'Emission' and 'Decalage'. A vertical yellow line is also drawn at approximately 4.5 seconds, corresponding to the one in the top plot.</p>	<p data-bbox="1464 628 2123 890">Following repairs, or adjustments in the driving mechanism, it is possible that the switching is out of synchronization. In these models, this anomaly can be demonstrated by comparing the upward and downward operations.</p>

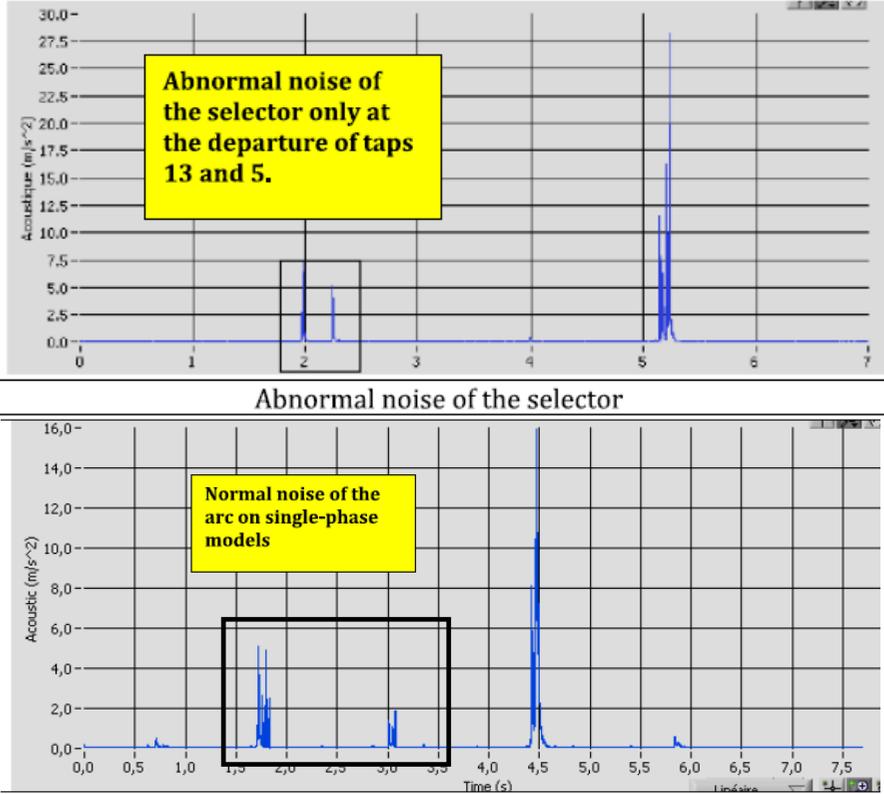
<p>The top graph, titled 'Abnormal noise of the selector', shows acoustic intensity (m/s²) on the y-axis (0.0 to 30.0) versus time (s) on the x-axis (0 to 7). A yellow box highlights a sharp peak at approximately 5.2 seconds. A smaller peak is visible at approximately 2.2 seconds. The bottom graph, titled 'Normal noise of the arc on a single-phase model (UCBRT)', shows acoustic intensity (m/s²) on the y-axis (0.0 to 16.0) versus time (s) on the x-axis (0.0 to 7.5). A yellow box highlights a sharp peak at approximately 4.5 seconds. A smaller peak is visible at approximately 1.8 seconds.</p>	<p>A misalignment of the selector contacts can cause abnormal noise during its operation. For a model with inverter (or pre-selector) that noise will be observed in the two operations corresponding to the same tap as shown on the left. In this example, there is a noise at the departure of the taps 5 and 13 only, which corresponds to the same fixed contact.</p>

<p>Notes:</p> <p>For single-phase models, this noise can be confused with a normal arc noise when the test is performed under voltage. These arc noises can be observed both at departure and arrival of the selector. The amplitude is usually a little higher at the departure of the selector when the movement removes the turns of regulation and vice versa for the arrival. For these models, the misalignment of contacts can be observed only if the test is performed disconnected from voltage.</p>

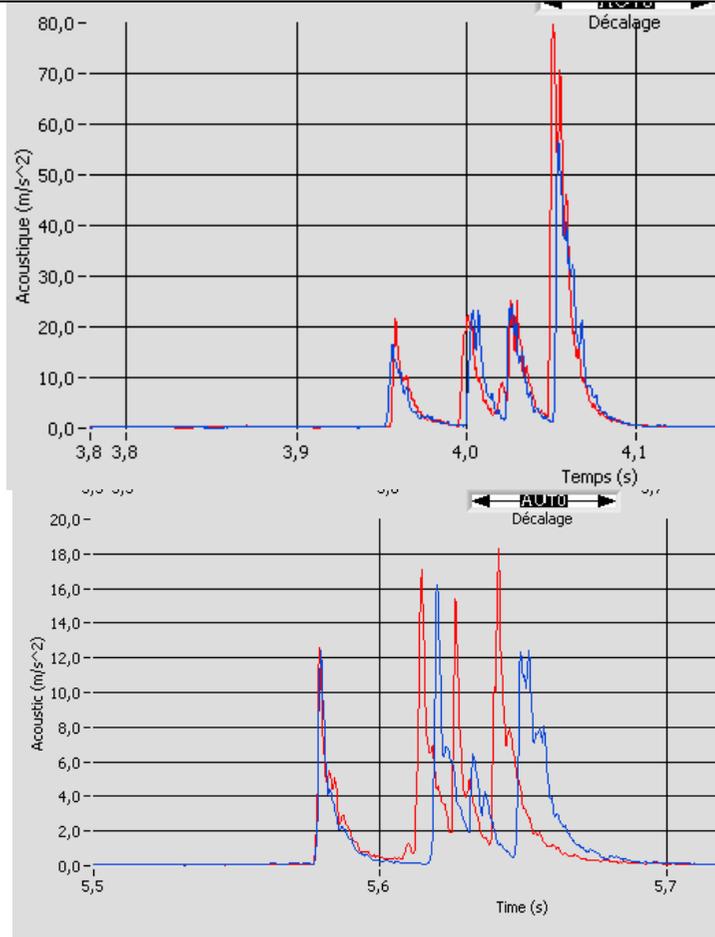
The probable causes of this asymmetry are:

- The excessive wear of the driving wheel of the switch
- A bad adjustment of the switch (adjustment screw – pass through bolts)
- An uneven wear of contacts between the even and odd sides.

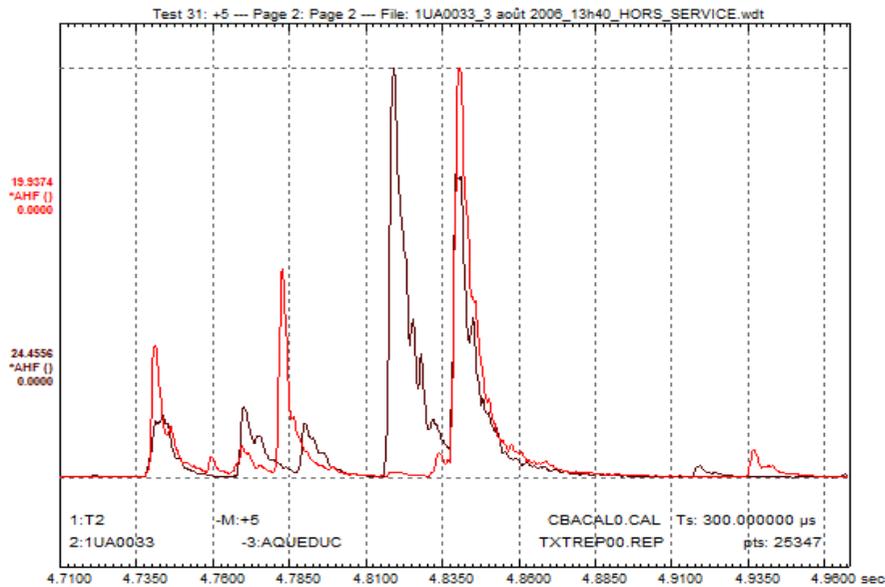
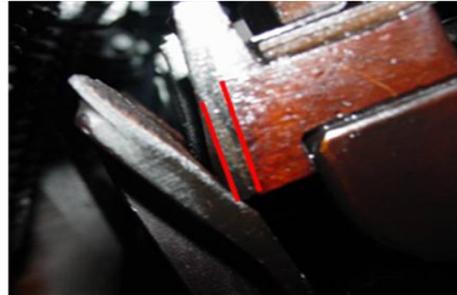
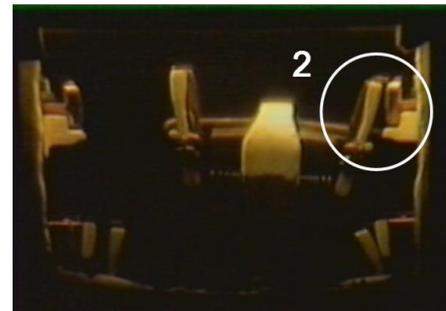
#13 ABB – UCCRN - Contact wear by missing impacts

The closing of the main contacts becomes very weak with the wear of contacts.

Contact wear is confirmed by opening up the ABB UCCRN tap changer and replacing the arcing contacts, as highlighted by the traces.

The loss of material caused by the wear of the driving contacts, for inertial effect, a variation in the sequence and a reduction of the impact noise of the main arc contacts. Trending of the suspected contacts is necessary to know the speed of the degradation.

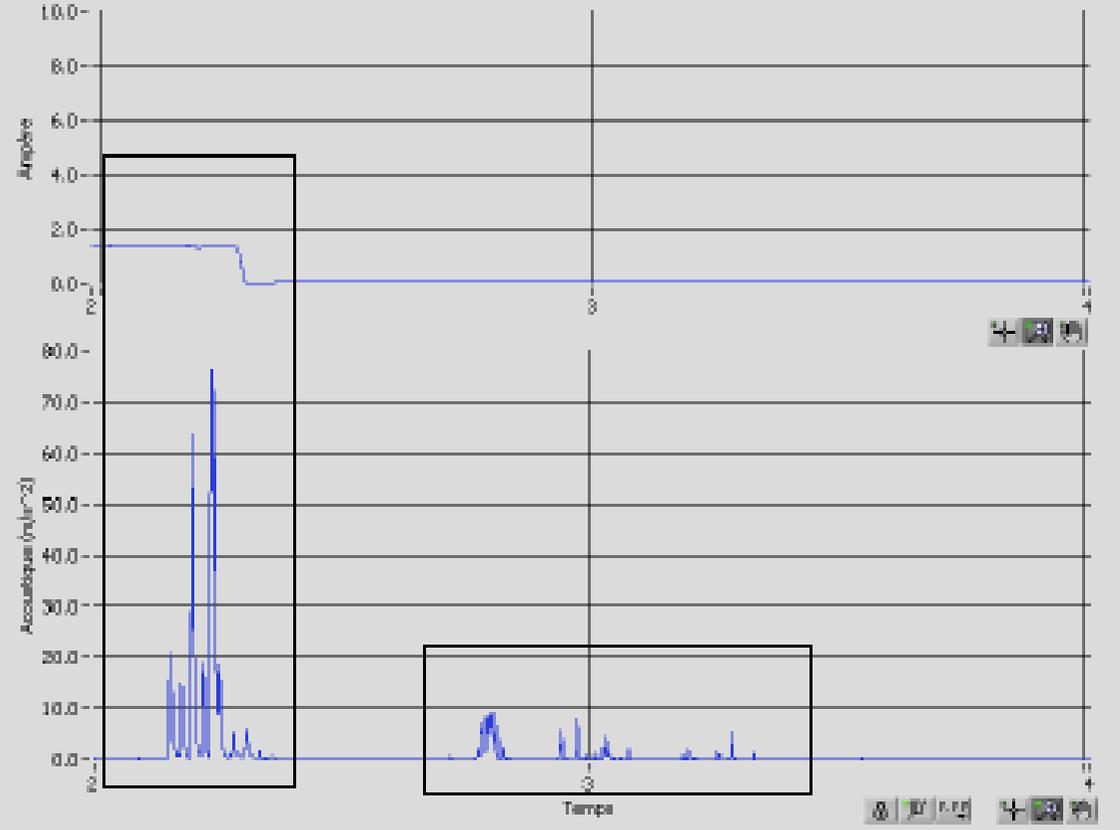
#20 ABB – UZ (B, C, D, E and F) - Brake failure

<p>The braking system of the ABB UZ is mechanical, by pressure pads on the inertial flywheel. These systems have experienced failures in the past, including the presence of grease on the surface, which caused malfunctions. In this case, the rotating mechanism continues its momentum and triggers the cascading of operations beyond the position required to stop at one of the extreme positions (1 or 17). The noise after the end of operation is not normal.</p>
<p>Notes:</p> <p style="text-align: center;">Verify the brake circuits and components.</p>

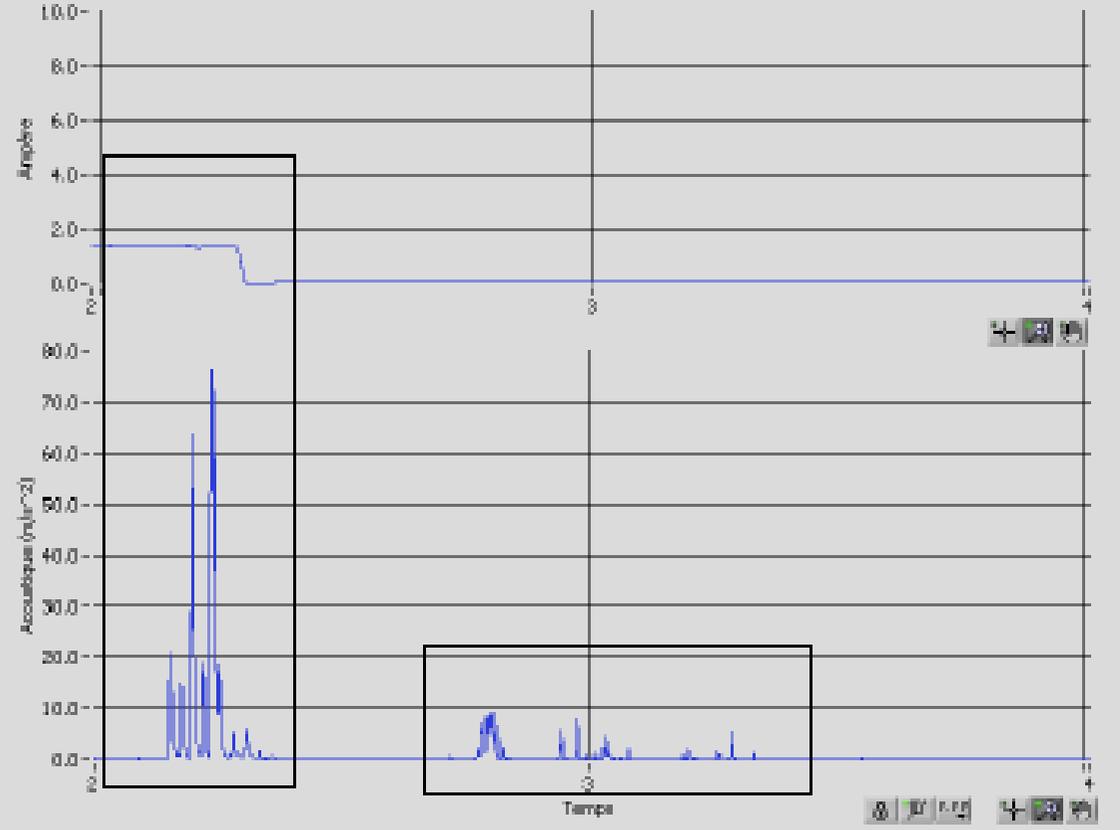
#21 ABB – UZ (B, C, D, E and F) - Brake failure

<p>The braking system of the ABB UZ is mechanical, by pressure pads on the inertial flywheel. These systems have experienced failures in the past, including the presence of grease on the surface, which caused malfunctions. In this case, the rotating mechanism continues its momentum and triggers the cascading of operations beyond the position required to stop at one of the extreme positions (1 or 17). The noise after the end of operation is not normal.</p>
<p>Notes:</p> <p style="text-align: center;">Verify the brake circuits and components.</p>

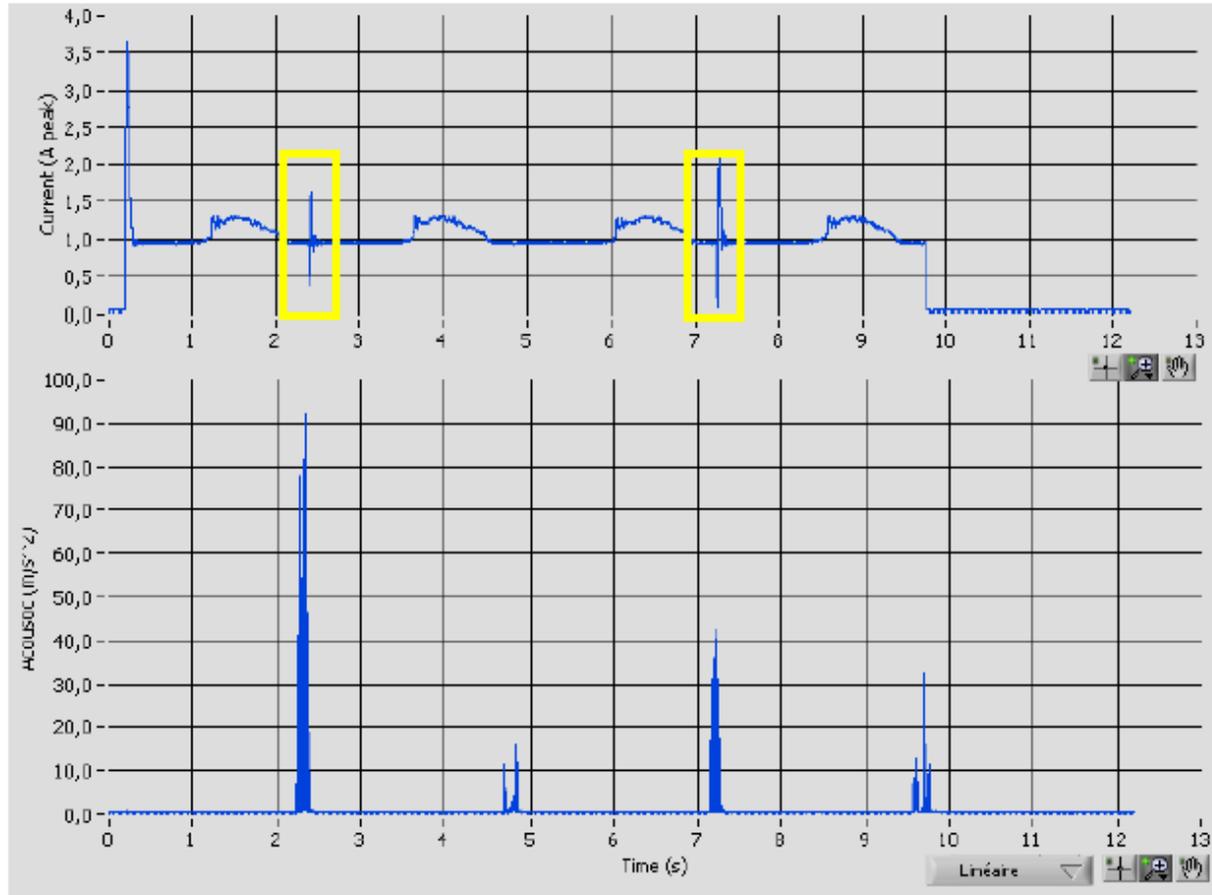
Usually a minor problem that can be tuned either by adjusting or replacing the defective relay.

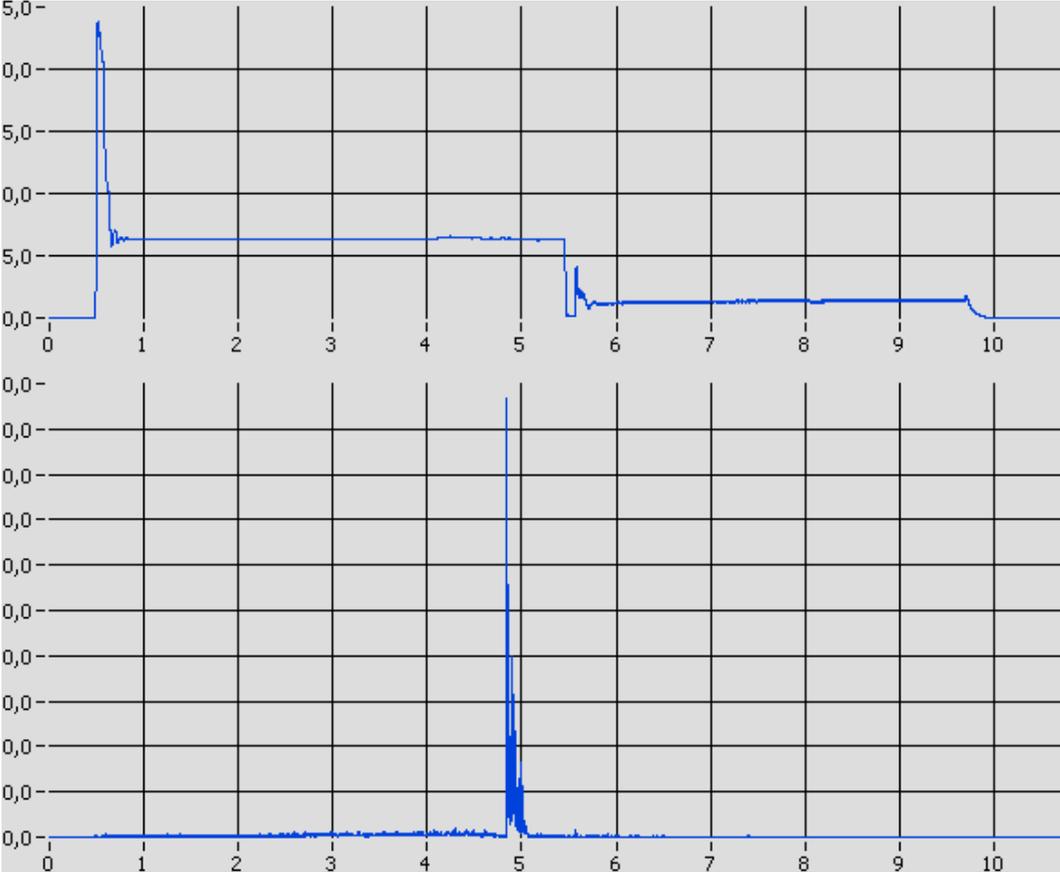
#32 FEDERAL PIONEER – REACTIVE MODELS - Extended length of the braking

<p>The trace of the current contains an extended braking. Dynamic brake is applied for an abnormally long time.</p>
<p>Notes:</p> <p style="text-align: center;">Adjust and repair the braking system.</p>

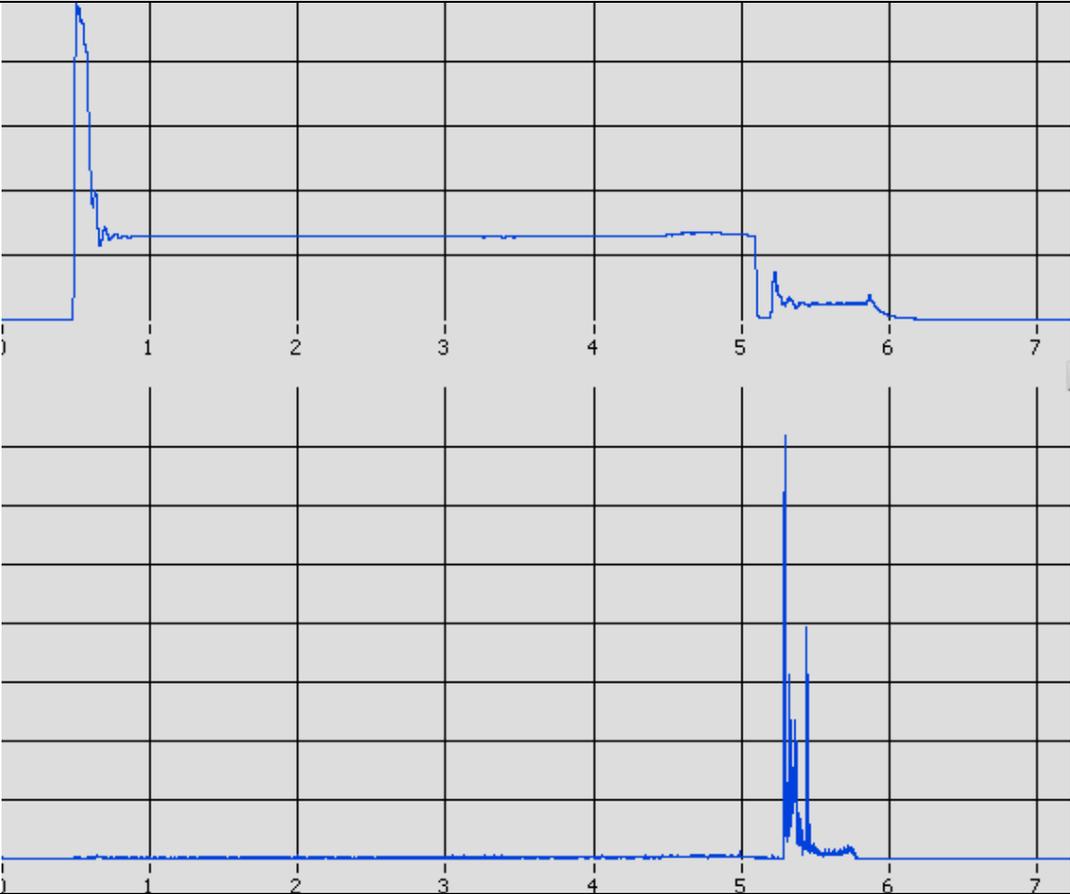
<p>The figure displays two waveforms on a grid. The top waveform shows a signal that rises sharply at approximately 0.5 units, remains constant until 5 units, then drops sharply. The bottom waveform shows a signal that is zero until approximately 5.5 units, where it exhibits a sharp, high-amplitude spike before returning to zero. The x-axis is labeled from 0 to 7.</p>	<p>The switching occurs too early/late. It happens after the end of the motor current during the braking or much too early in the operation.</p>
<p>Notes:</p> <p>Synchronize the switching.</p>

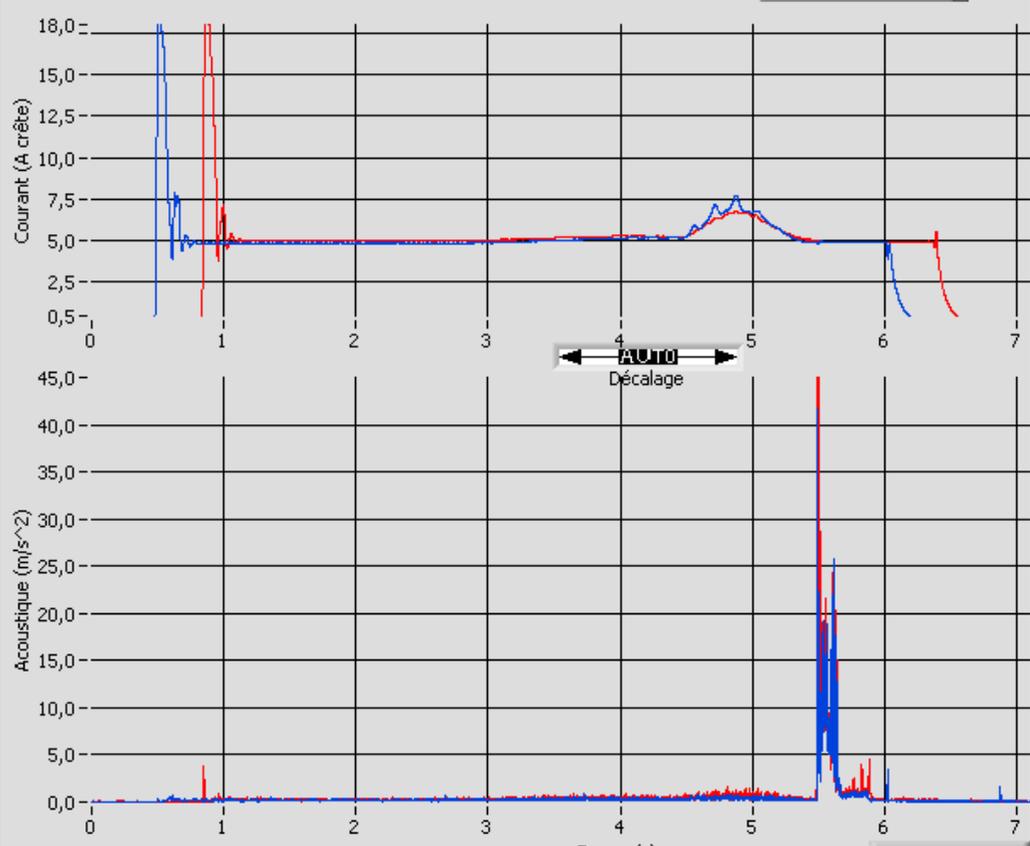
<p>The figure consists of two vertically stacked line graphs sharing a common x-axis representing time in seconds, ranging from 0 to 7. The top graph plots 'Courant (A crête)' (Peak Current in Amperes) on the y-axis, ranging from 0 to 18.0. It shows two traces: a red trace representing normal operation and a blue trace representing operation with oscillations. Both traces show a sharp peak at approximately 0.8 seconds, reaching about 18.0 A. The blue trace exhibits significant high-frequency oscillations before and after this peak. A horizontal double-headed arrow labeled 'Décalage' (offset) is positioned between the two traces, indicating a time shift. The bottom graph plots 'Acoustique (m/s<sup>2</sup>)' (Acoustic noise in m/s²) on the y-axis, ranging from 0 to 45.0. It also shows two traces: red (normal) and blue (oscillatory). Both traces show a sharp peak at approximately 5.5 seconds, reaching about 45.0 m/s². The blue trace shows much higher amplitude and more complex oscillations compared to the red trace.</p>	<p>Fluctuations such as oscillations appear on the trace of the motor current during the operation of the switch, selector or inverter. (red trace) is normal. (blue trace) shows oscillations.</p>

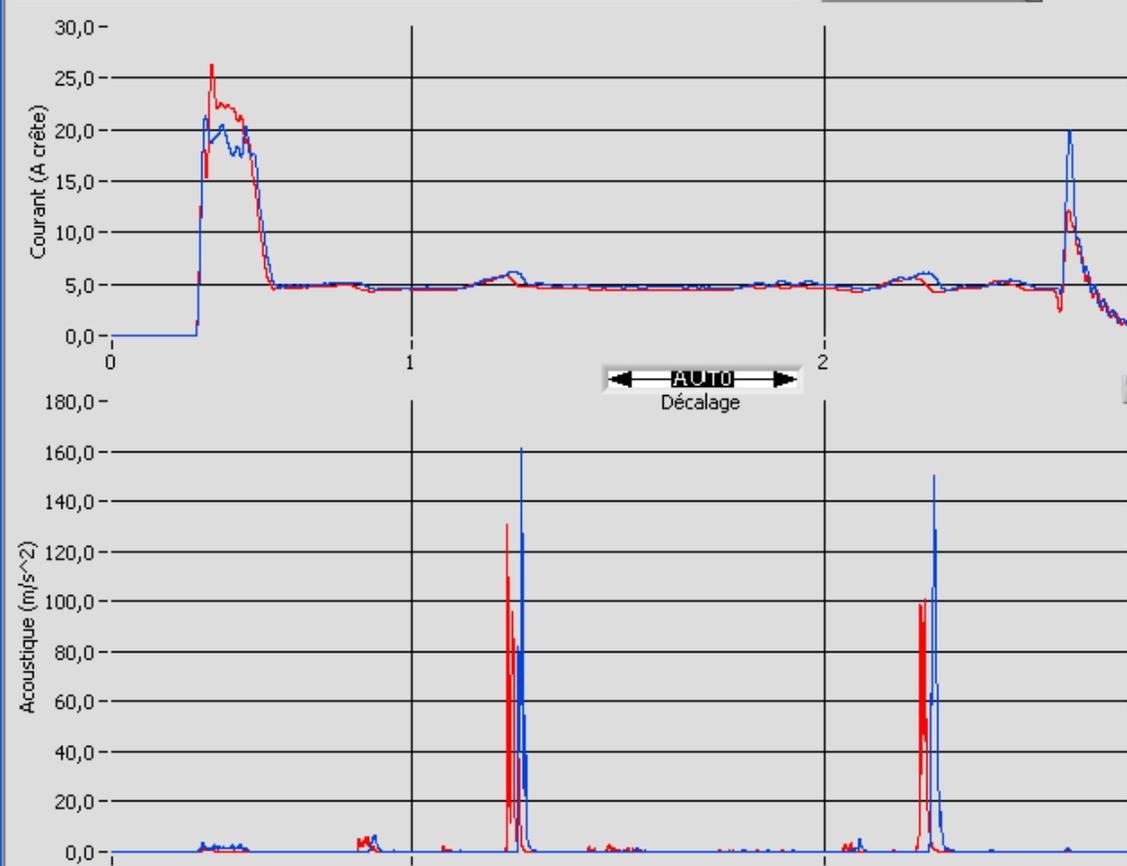
<p>The image displays two vertically stacked line graphs. The top graph plots 'Courant (A crête)' (Current in Amperes peak) on the y-axis, ranging from 0,0 to 30,0. It shows two traces: a red trace with a sharp, oscillating peak reaching approximately 25,0 A, and a blue trace with a smoother peak reaching approximately 20,0 A. The bottom graph plots 'Acoustique (m/s²)' (Acoustic signal in m/s²) on the y-axis, ranging from 0,0 to 180,0. It shows two traces: a red trace with a sharp, oscillating spike reaching approximately 160,0 m/s², and a blue trace with a smoother spike reaching approximately 140,0 m/s². A horizontal scale bar labeled 'AUTO Décalage' is positioned between the two graphs, indicating a time shift.</p>	<p>The inrush trace presents abnormal oscillations, while the normal inrush trace (blue trace) is generally smooth and stable (red trace). These oscillations can be caused by a problem with the contactor that starts the motor or with the motor itself.</p>

<p>Notes:</p> <p>Readjust the contactor or replace the motor if it is defective.</p>

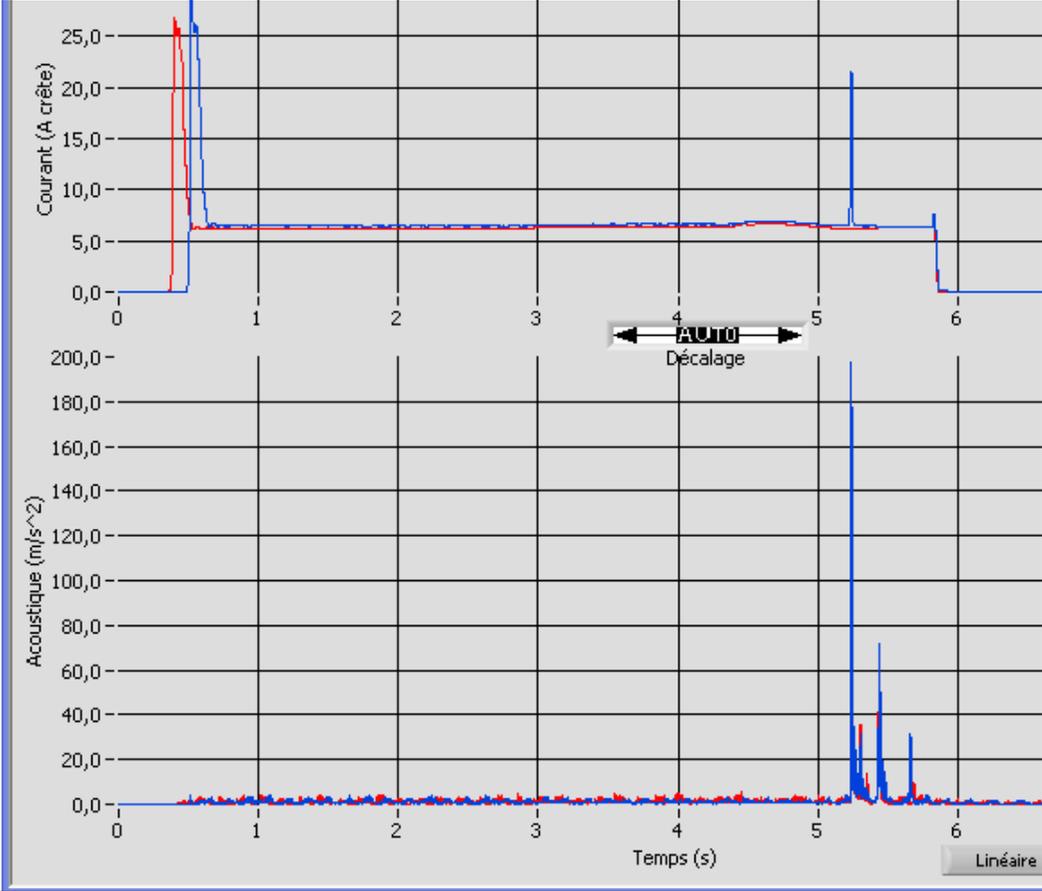
<p>The figure consists of two vertically stacked plots sharing a common x-axis representing time in seconds (0 to 6). The top plot shows 'Courant (A crête)' (Current peak) on the y-axis, ranging from 0.0 to 25.0. It features a sharp red spike at approximately 0.5s reaching about 25.0 A, and a smaller blue spike at approximately 5.5s reaching about 22.0 A. The bottom plot shows 'Acoustique (m/s²)' (Acoustic noise) on the y-axis, ranging from 0.0 to 200.0. It shows a very large blue spike at approximately 5.5s reaching about 200.0 m/s². A horizontal double-headed arrow labeled 'Délai' (delay) is positioned between the two plots, indicating a time shift. A 'Linéaire' (Linear) button is visible in the bottom right corner of the plots.</p>	<p>The switching shows a noise with very high amplitude compared to normal switching, and compared with other noises on the same switching.</p> <p>This may be due to a problem of the transition of the spring, a problem with the switch mechanism or another cause.</p>

<p>Notes: Identify the cause of the problem and repair, by readjustment of the mechanism, changing the much worn parts or the springs.</p>
