DIAGNOSTIC/TYPICAL SIGNATURES

February 1st, 2013

Contents per Brand and Model

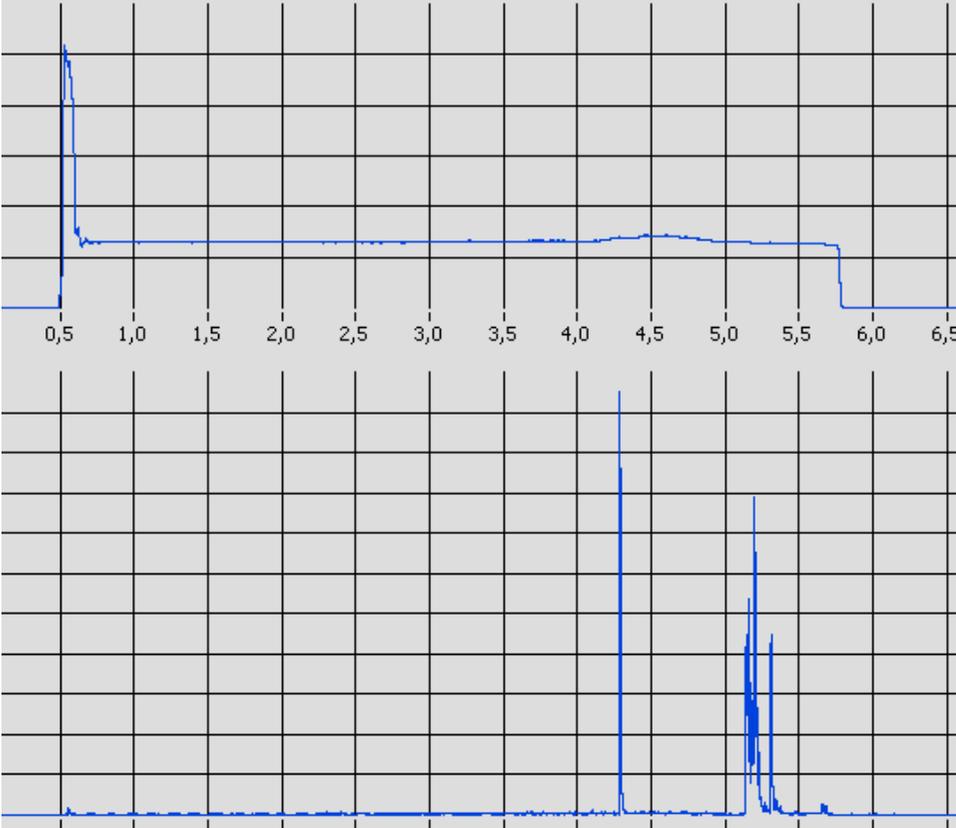
<p>This defines an arc of very high amplitude present during the operation of the inverter. This may be due to too much carbon in the oil, or to a problem with the limiting voltage device, or other sources.</p>
<p>Notes: Identify the cause of the problem and repair, change or filter the oil, etc.</p>

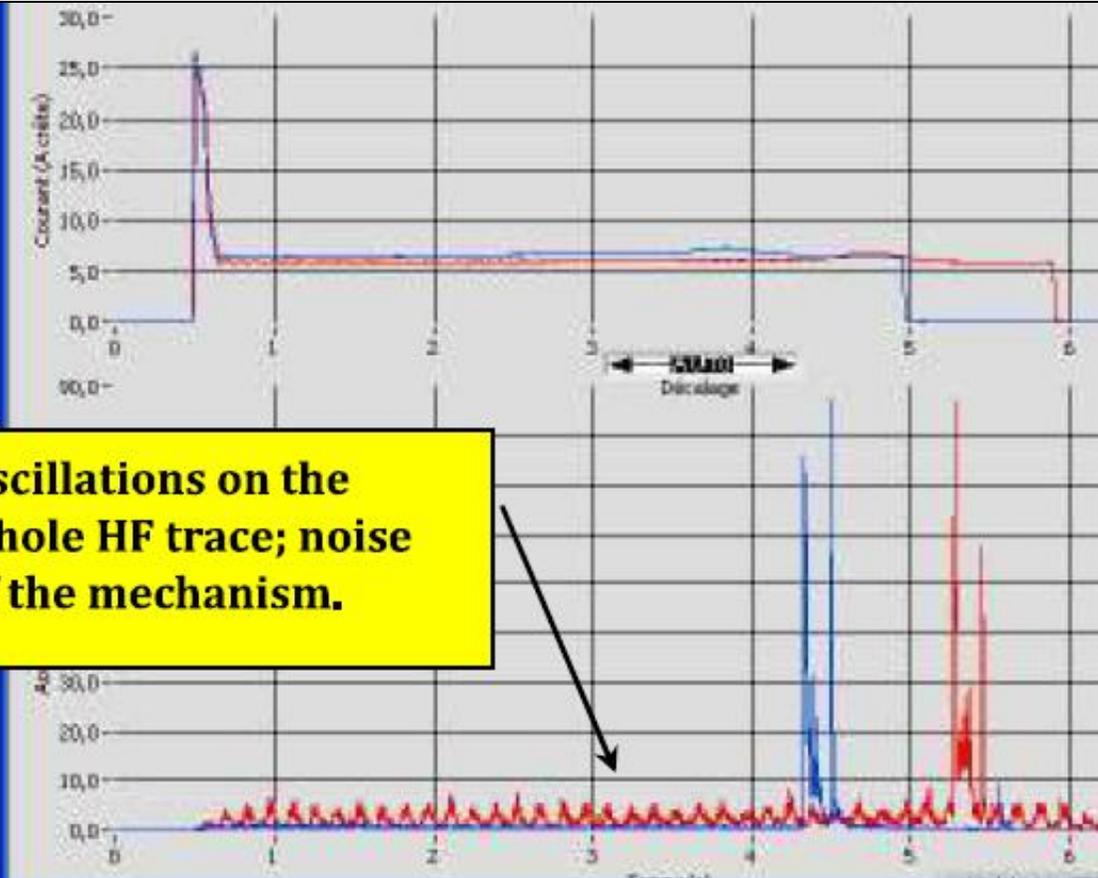
<p>Oscillations on the whole HF trace; noise of the mechanism.</p>	<p>We notice a noise of the mechanism during its operation. The oscillations are present throughout all the trace of the High Frequency. A lack of lubrication of the drive mechanism or an advanced wear of the drive mechanism is present.</p>
<p>Notes: Correct the situation by lubricating or replacing worn parts or observe the OLTC periodically to monitor the problem at hand.</p>

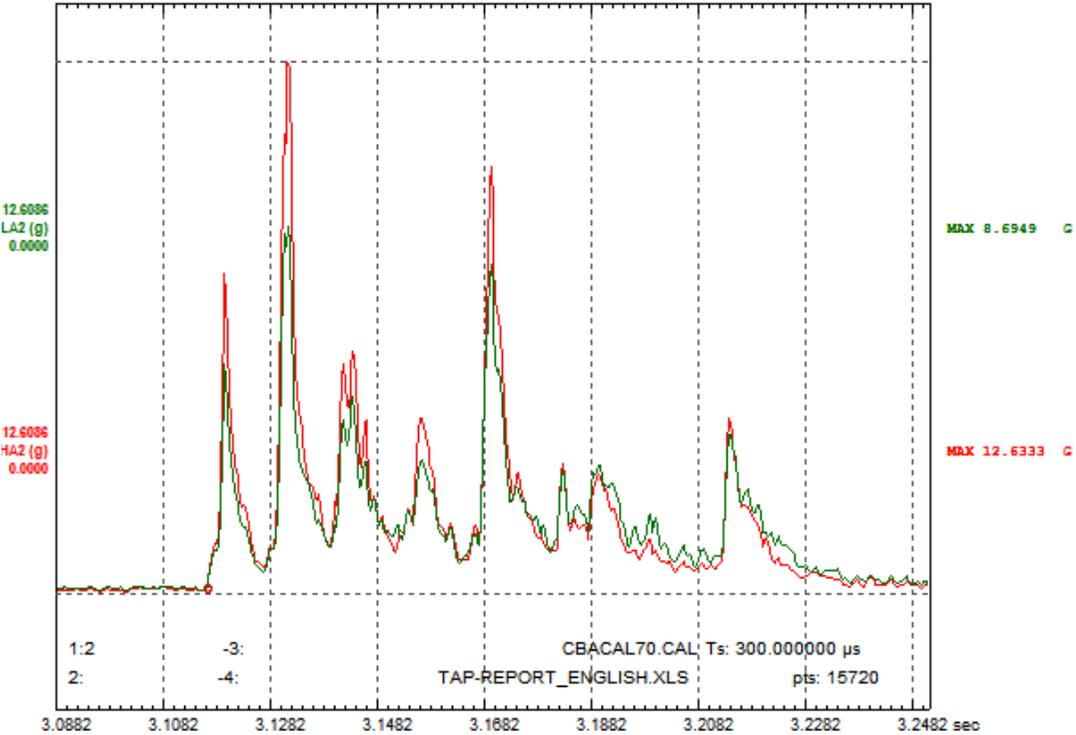
#39 MR REINHAUSEN – M and V - Wear of contact

<p>12.6086 LAZ (g) 0.0000</p> <p>MAX 8.6949 G</p> <p>12.6086 HA2 (g) 0.0000</p> <p>MAX 12.6333 G</p> <p>1:2 -3: 2: -4:</p> <p>CBACAL70.CAL; Ts: 300.000000 µs TAP-REPORT_ENGLISH.XLS pts: 15720</p> <p>3.0882 3.1082 3.1282 3.1482 3.1682 3.1882 3.2082 3.2282 3.2482 sec</p>	<p>The wear of contacts is seen as gaps between low and high frequency envelopes. A new mechanism will show similar envelopes while one of the envelopes becomes dominant as the wear increases.</p>
<p>Notes:</p> <p>Trending of the suspected contacts is necessary to know the speed of the degradation.</p>

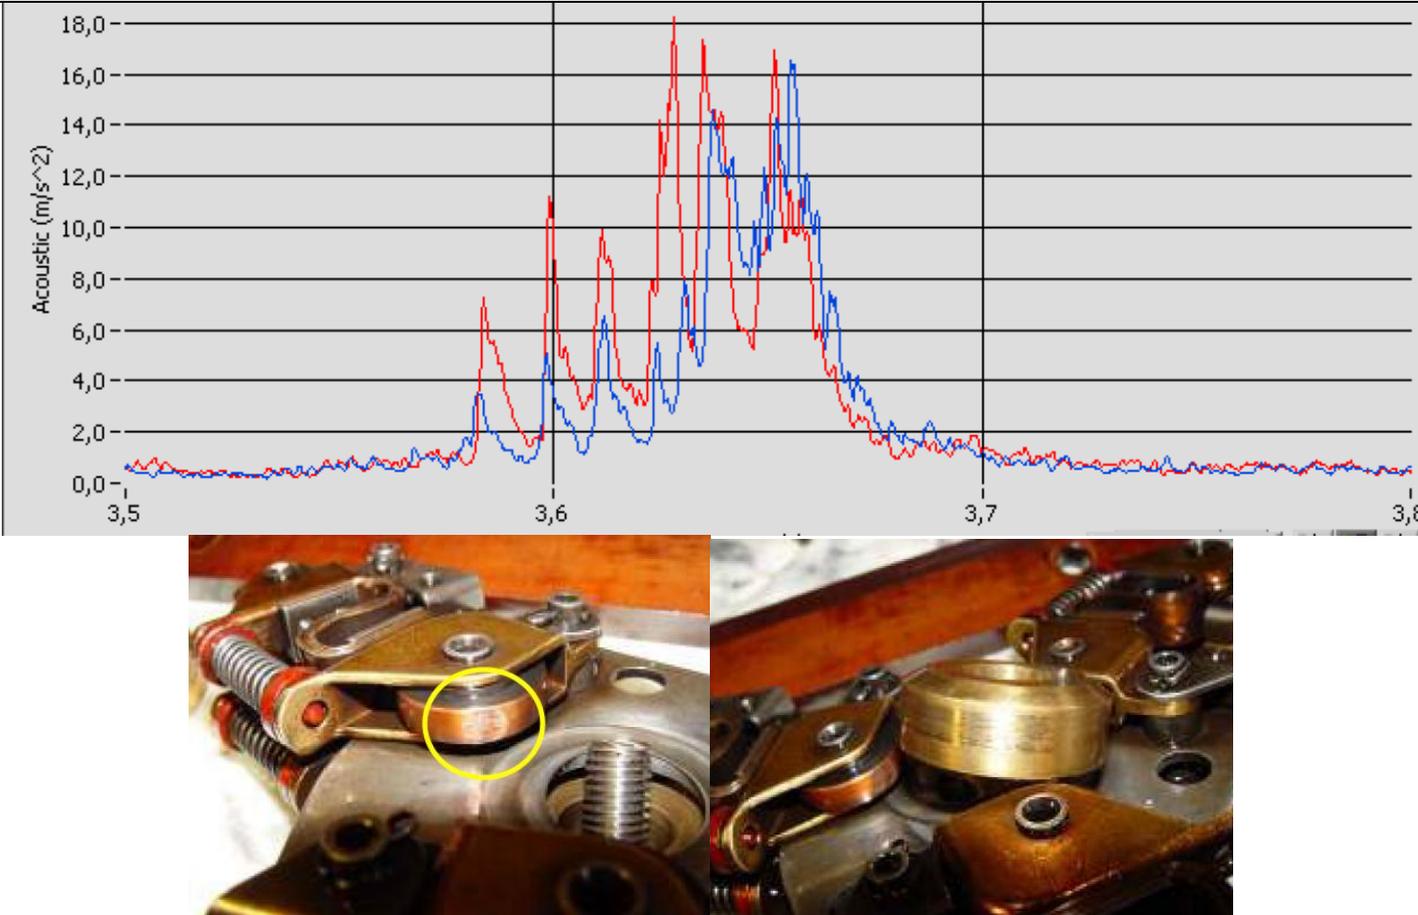
#40 MR REINHAUSEN – M and V - Wear of the rolls of main contacts

<p>The figure consists of an acoustic signature graph and two photographs of mechanical hardware. The graph plots Acoustic intensity in m/s^2 on the y-axis (ranging from 0.0 to 18.0) against time on the x-axis (ranging from 3.5 to 3.8). Two curves are shown: a red curve representing the state before repairs and a blue curve representing the state after repairs. The red curve shows several sharp, high-amplitude peaks between 3.6 and 3.7 seconds, reaching up to 18.0 m/s^2. The blue curve shows a much smoother and lower-amplitude signal in the same time range, with peaks around 10.0 m/s^2. Below the graph are two photographs of a mechanical contact assembly. The left photo shows a worn, flattened brass contact roll highlighted with a yellow circle. The right photo shows the same assembly after repair, with a new, smooth brass contact roll installed.</p>	<p>The rolls of the main contacts on a type D-0466 mechanism can wear off and show flats and streaks as above. Such type of wear can cause variations in the resistance measurements. The change of the cross is easily perceptible on the signatures of low-frequencies, Red curve is before repairs and blue is after repairs.</p>

<p>Notes:</p> <p>Replacement of the faulty hardware.</p>

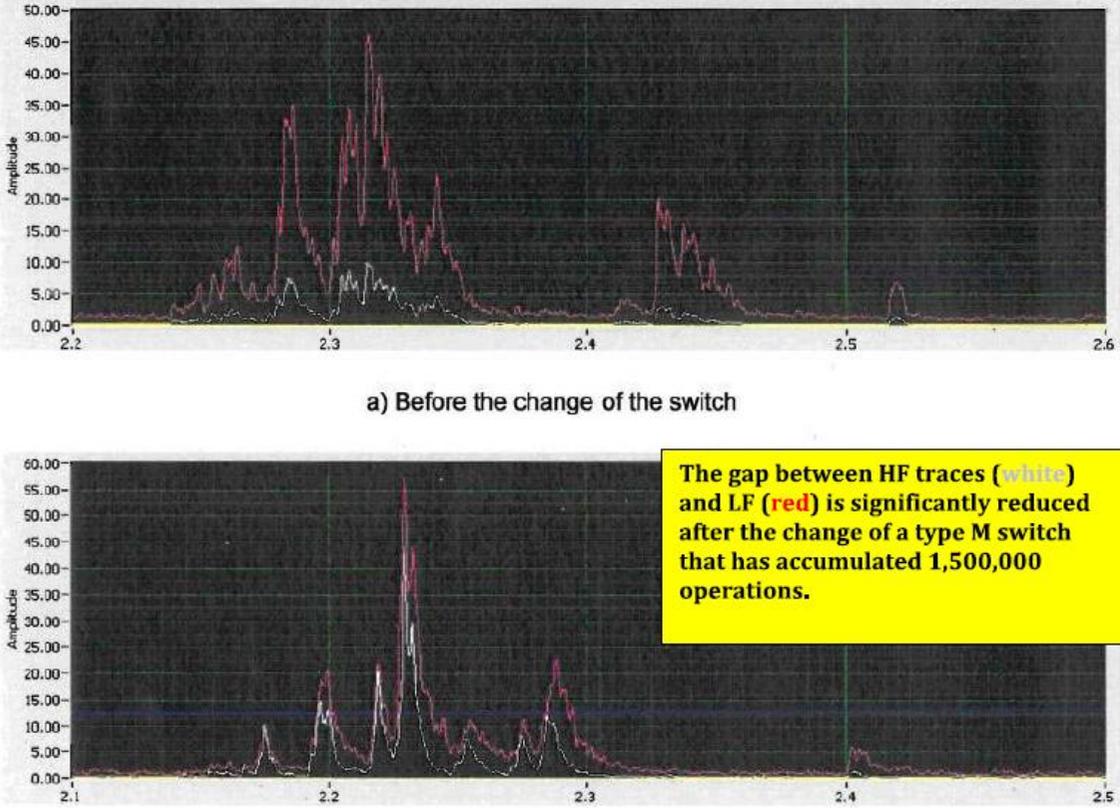
#41 MR REINHAUSEN – M and T - General wear of the switch

<p data-bbox="618 719 992 746">a) Before the change of the switch</p> <p data-bbox="618 1166 976 1193">b) After the change of the switch</p> <p data-bbox="920 783 1384 975">The gap between HF traces (white) and LF (red) is significantly reduced after the change of a type M switch that has accumulated 1,500,000 operations.</p>	<p data-bbox="1563 639 2123 906">In addition to the wear of contacts, gaps between frequency bands are also indicative of the general wear of the switch. This example illustrates a case of extreme wear of a type M mechanism.</p>
<p data-bbox="96 1230 197 1257">Notes:</p>

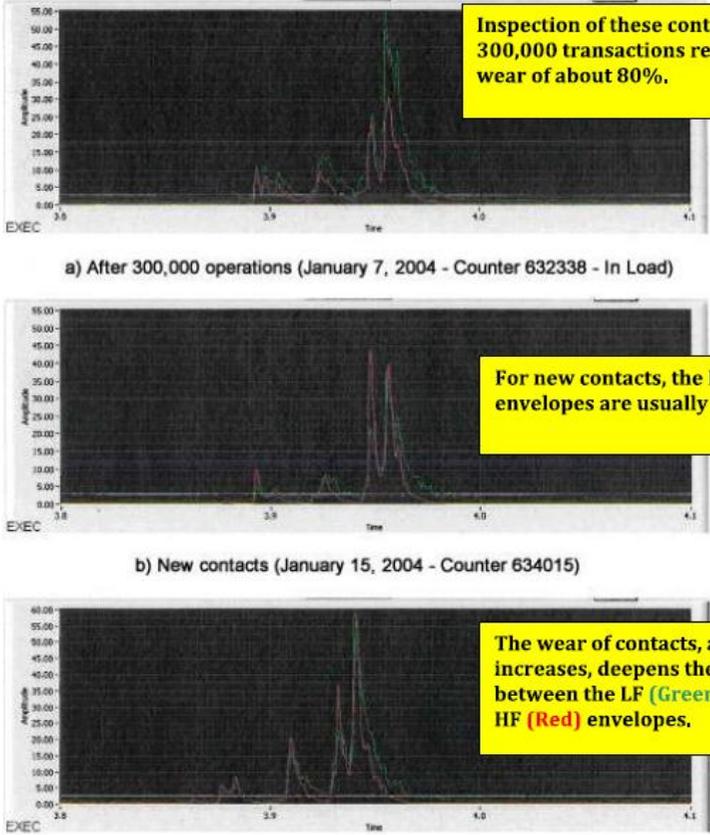
#42 MR REINHAUSEN – M and T - Wear of contacts

<p data-bbox="907 352 1272 464">Inspection of these contacts after 300,000 transactions revealed a wear of about 80%.</p> <p data-bbox="504 603 1120 627">a) After 300,000 operations (January 7, 2004 - Counter 632338 - In Load)</p> <p data-bbox="922 703 1288 799">For new contacts, the HF and LF envelopes are usually similar.</p> <p data-bbox="571 900 1025 924">b) New contacts (January 15, 2004 - Counter 634015)</p> <p data-bbox="922 975 1254 1102">The wear of contacts, as it increases, deepens the gap between the LF (Green) and HF (Red) envelopes.</p> <p data-bbox="533 1198 1081 1222">c) After 125,000 operations (November 5, 2004 - Counter 761087)</p>	<p data-bbox="1653 692 2123 863">The wear of contacts on types M and T, are seen as gaps between low and high frequency envelopes.</p>
<p data-bbox="91 1241 203 1273">Notes:</p> <p data-bbox="170 1286 2042 1321">A new mechanism will show similar envelopes while the low frequency envelope becomes dominant as the wear increases.</p>

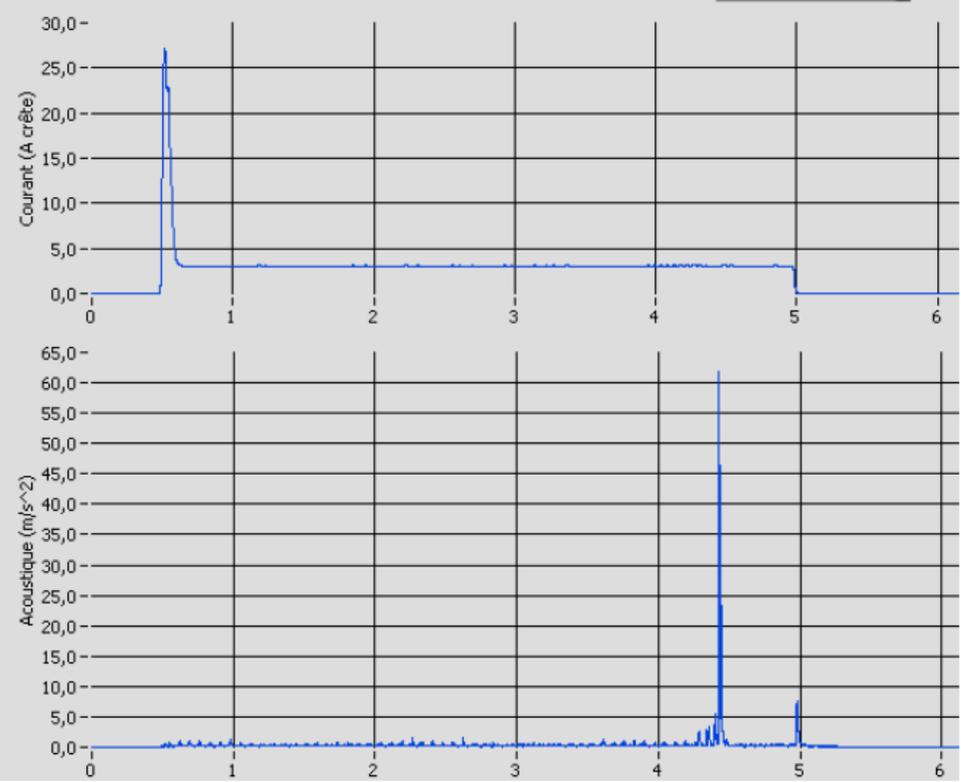
<p>The figure consists of two vertically stacked line graphs sharing a common x-axis representing time from 0 to 6 seconds. The top graph plots 'Courant (A crête)' (Peak Current in Amperes) on the y-axis, ranging from 0.0 to 30.0. The current starts at 0.0, rises sharply to a peak of approximately 27.0 A at around 0.5 seconds, then drops to a steady state of about 3.0 A. At approximately 5.0 seconds, the current drops back to 0.0. The bottom graph plots 'Acoustique (m/s^2)' (Acoustic noise in m/s^2) on the y-axis, ranging from 0.0 to 65.0. The noise level is low (around 2.0 m/s^2) until about 4.5 seconds, where it spikes to a peak of approximately 62.0 m/s^2, then drops to 0.0 by 5.0 seconds.</p> <p data-bbox="526 1137 1198 1165">Figure 1 : Single operation upwards of a Reinhausen C (tap +5)</p>	<p data-bbox="1653 550 2123 949">The single operation is a movement upwards or downwards of the selector, followed by a transfer of the load through the switch. The operation of the selector is silent on all Reinhausen models with exception of the M model.</p>

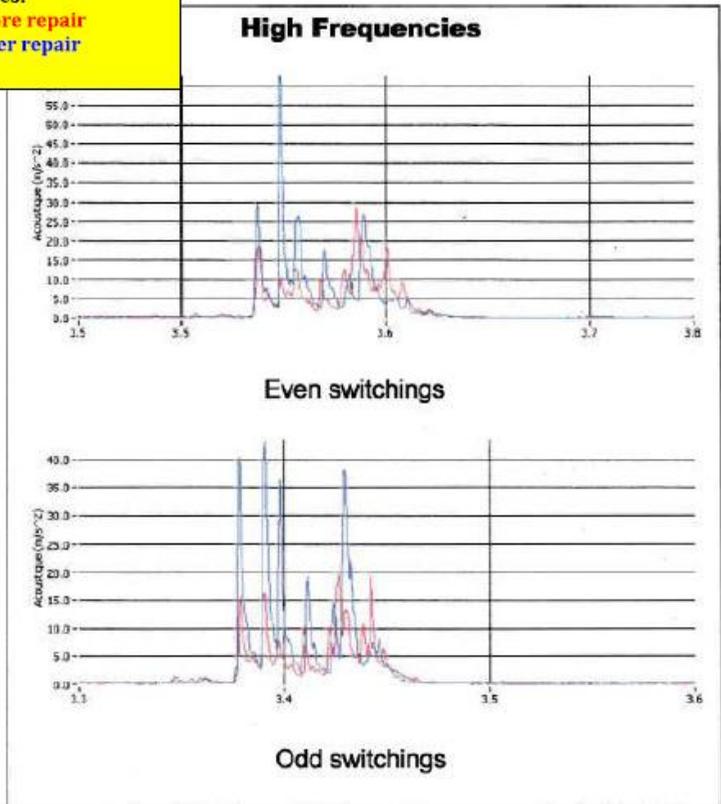
Effect of changing springs
on the envelope of high
frequencies:
Red- before repair
Blue - after repair

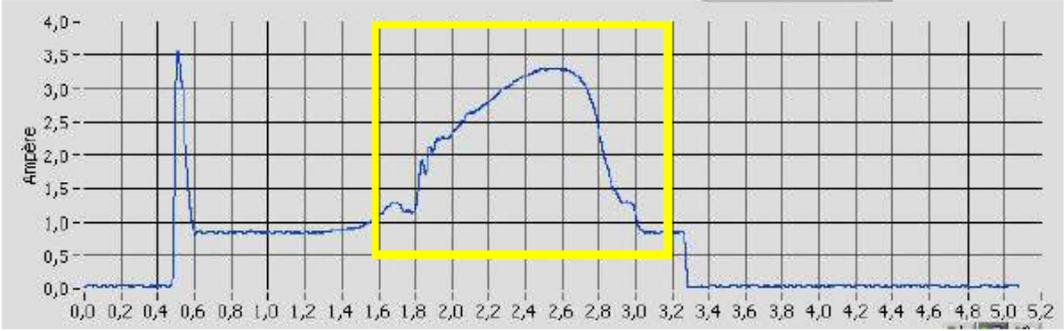
<p data-bbox="667 683 1064 715">Signature before lubrication</p>	<p data-bbox="1653 443 2123 703">The trace of the motor current shows obvious fluctuations towards the end of the operation. There is a lack of lubrication of the drive mechanism.</p>

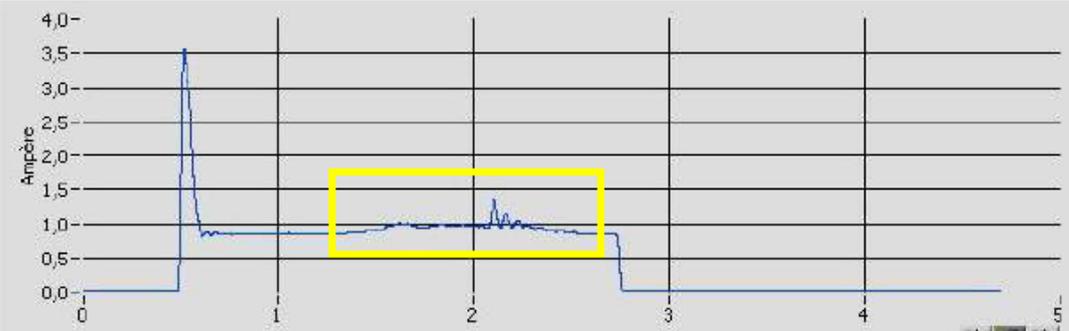
<p data-bbox="197 1121 1541 1189">Signature after lubrication - It may be noted that high currents are substantially reduced and the operating time are slightly decreased</p>	<p data-bbox="1653 762 2123 1070">The lack of lubrication of the drive mechanism has a significant effect on the stress of the motor and sometimes causes a refusal to operate followed by the start of the motor protection.</p>
<p data-bbox="91 1198 199 1230">Notes:</p> <p data-bbox="293 1241 1917 1278">To lubricate or replace worn parts or observe the tap changer periodically to monitor the problem at hand.</p>

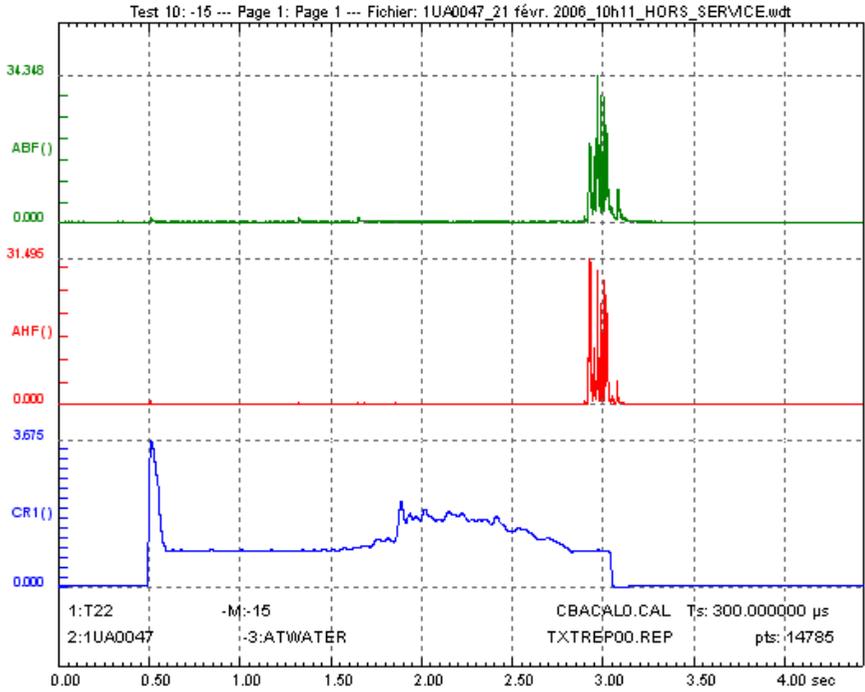
<p>Test 10: -15 --- Page 1: Page 1 --- Fichier: 1UA0047_21 févr. 2006_10h11_HORS_SERVICE.wdt</p> <p>34.348 ABF()</p> <p>0.000</p> <p>31.495 AHF()</p> <p>0.000</p> <p>3.675 CR1()</p> <p>0.000</p> <p>1:T22 -M:-15 CBACALD.CAL Ts: 300.000000 µs 2:1UA0047 -3:ATWATER TXTREPO0.REP pts: 14785</p> <p>0.00 0.50 1.00 1.50 2.00 2.50 3.00 3.50 4.00 sec</p>	<p>An easy interpretation example is shown by the unusual shape of the motor current which increases at the end of the movement. Lack of lubrication leads to larger torques felt by the motor. As a result, the motor current can see sharp increases.</p>
<p>Notes:</p> <p>To lubricate or replace worn parts or observe the tap changer periodically to monitor the problem at hand.</p>

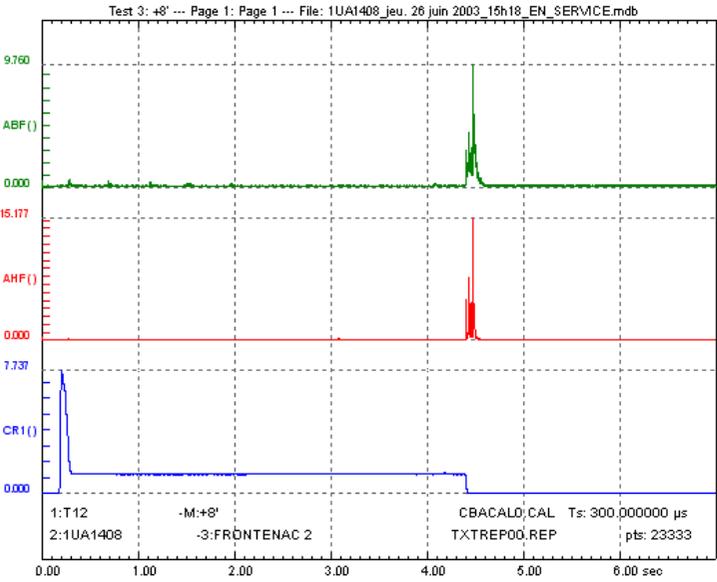
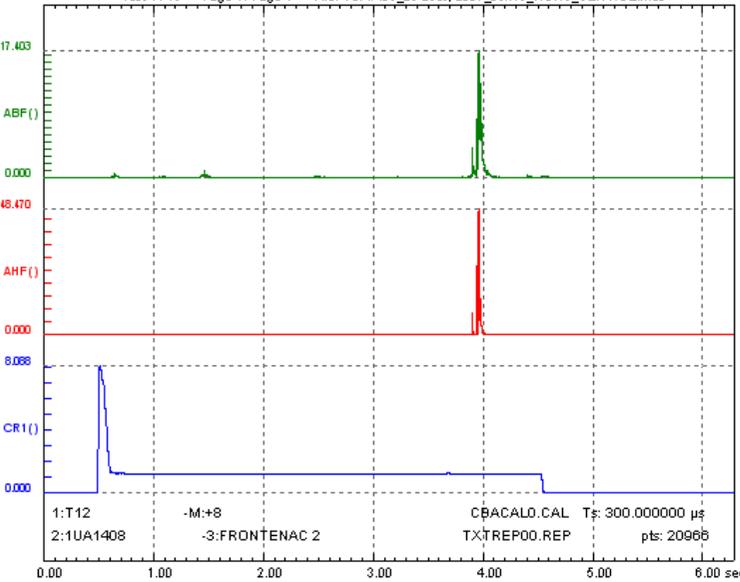
<p>Test 3: +8' --- Page 1: Page 1 --- File: 1UA1408_jeu.26.juin.2003.15h18_EN_SERVICE.mdb</p> <p>BEFORE REPAIR</p> </div> <div style="text-align: center;">

<p>Test 7: +8' --- Page 1: Page 1 --- File: 1UA1408_29.aout.2007.08h16_HORS_SERVICE.mdb</p> <p>AFTER REPAIR</p> </div> </div>	<p>Certain types of signal analysis may be easily performed without a reference signature. The example shown demonstrates a switching operation signal delayed by 120 milliseconds after the end of the current envelope.</p>	
<p>Notes:</p> <p>The repair was simply to uncouple the drive motor in order to adjust it so the switching occurs before the motor current drops.</p>

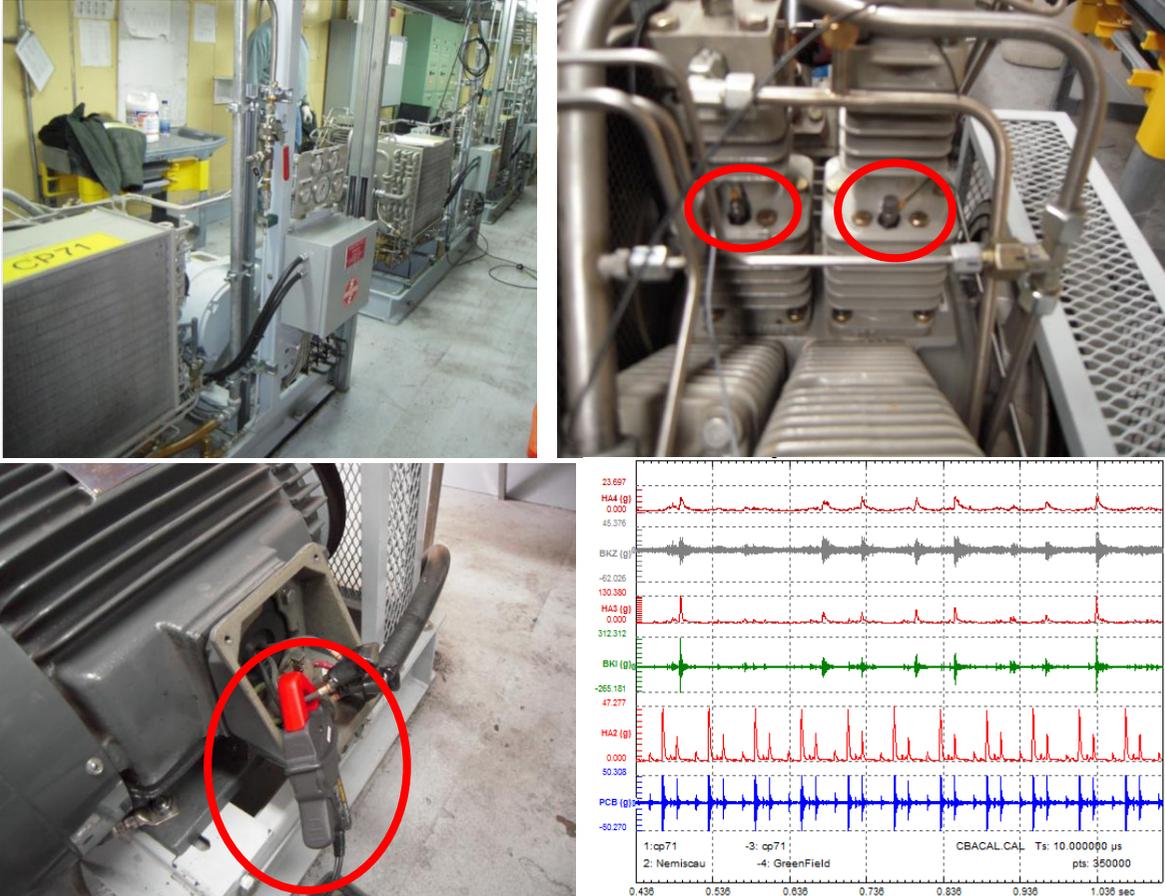
<p>The purposes of these tests were:</p> <ul style="list-style-type: none"> -To verify the mounting of the compressor and make sure that it respects the manufacturer's recommendations. -To find the origin of the random noise which is present before and after the #72 compressor mounting. <p>With the results, we notice that the 60 ms cycle is divided in 4 regular impacts which refer to the mechanical motion.</p> <p>We also notice unpredictable impacts between 250G and 300G that would come from the radiator on the pipes on the #72 compressor.</p>
<p>Notes:</p> <p>Tests have been performed with accelerometers with a range of + or – 500G and AC current clamp. The tests allows to see regular cycles in Amplitude, Time and Shape and also allow to check that there is no seating in the bearing; no wearing on the tree; no wearing on pistons.</p>

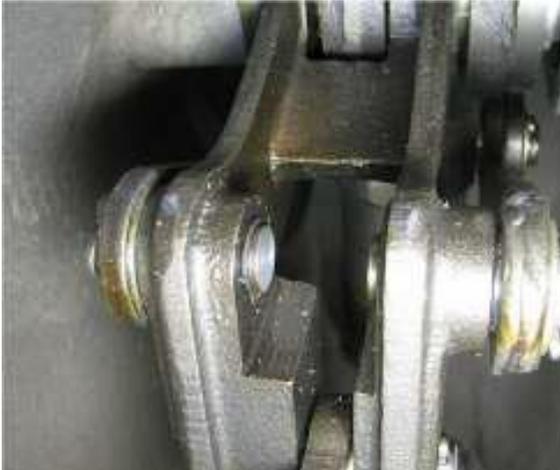
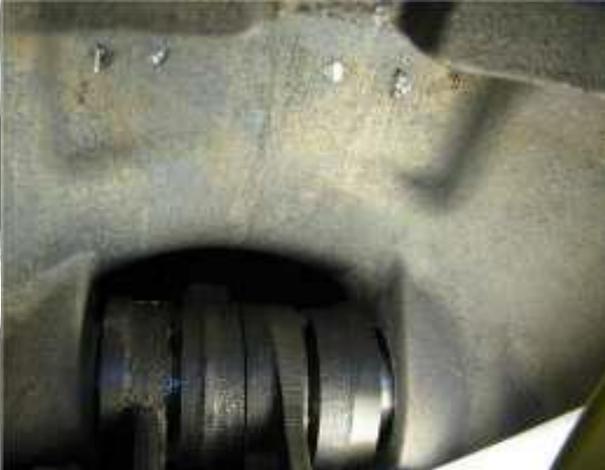
</div>	<p>This example shows two cases where a bad adjustment has broken the casing of a breaker that has produced an explosion and the other has produced a SF6 alarm. These two cases have been detected thanks to vibration testing.</p> <p>The figure shows the high impacts around 1300G for the middle trace which is phase B, whereas phases A and C show amplitude around 500G.</p>
<p>Notes: We see after repair, similar shapes and amplitudes for all three phases. The pictures show impact marks inside the casing of phase B.</p>
