Diagnostic Cards

ABB UZ - models B, C, D, E and F

Rev.0
December 17, 2009

The following diagnostic cards focus on the symptoms of the main problems of tap changers (OLTP) of the ABB UZ family, models B, C, D, E, and F, as seen by their acoustic signatures. It is important to note that several of the anomalies illustrated here do not show up in the tabular report of the DIAC software.

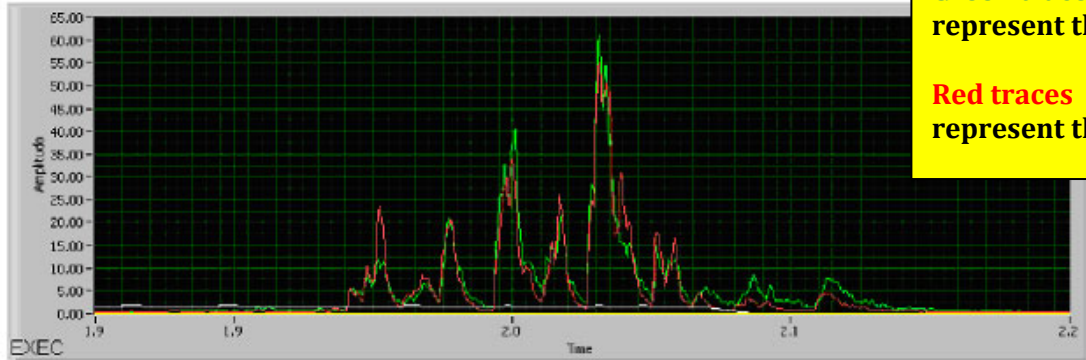
a) New contacts (October 21, 2002)

Wear of the switch contacts appears on the acoustic signatures by a gap between the amplitudes of the traces of HF and LF.

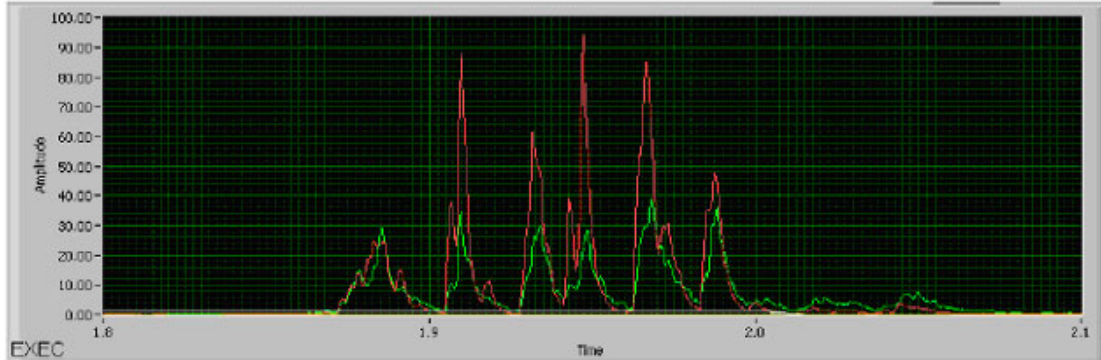
b) Worn contacts (October 1, 2002)

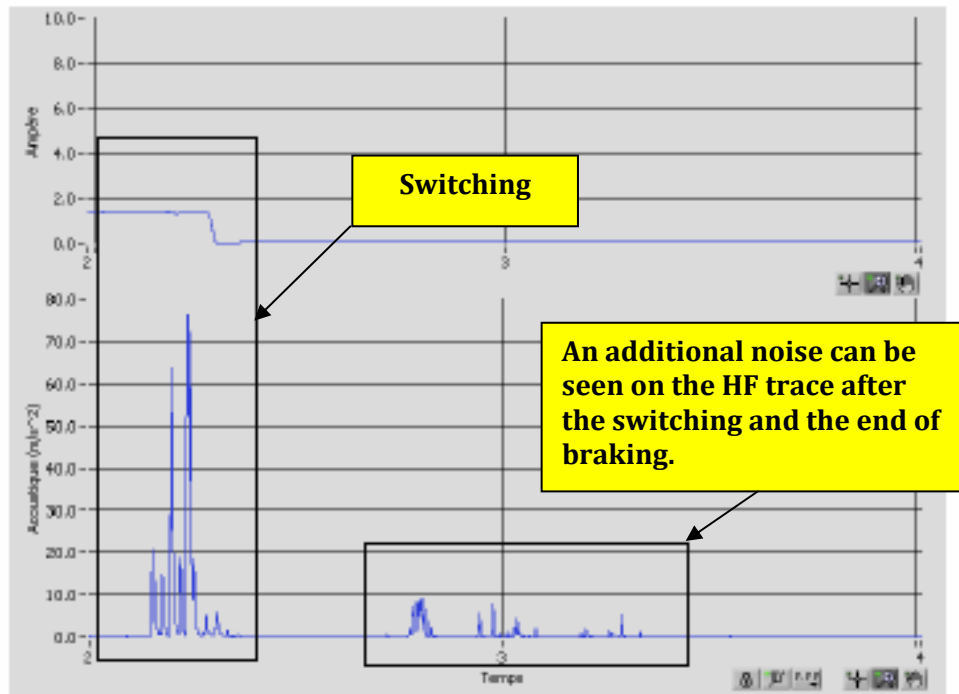
The braking system of the ABB UZ is mechanical, by pressure pads on the inertial flywheel. These systems have experienced failures in the past, including the presence of grease on the surface, which caused malfunctions. In this case, the rotating mechanism continues its momentum and triggers the cascading of operations beyond the position required to stop at one of the extreme positions (1 or 17).

The noise measured on the figure above is caused by the impact of moving contacts on adjacent fixed positions. At this stage, the tap changer takes the position sought by the force of the springs. If the brake problem worsens, the movement keeps engaging and beyond a point of no return, a command forces automatically the next operation.

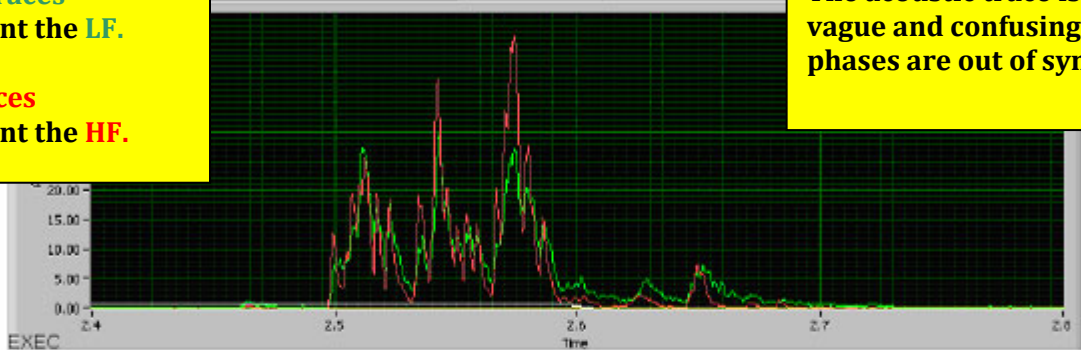
The acoustic trace is very
vague and confusing when the
phases are out of sync.

a) Desynchronization in the high frequencies

When the three mechanisms are out of sync, the acoustic trace becomes very confusing and it becomes difficult to distinguish between the switching elements and the transition time. The desynchronization may be due to a poor adjustment of the **assembly shaft** or due to a **slack** that is developed in the assembly. This type of degradation is harmful in rare cases (broken bolts in the drive shaft). Even if the manufacturer does not provide the criteria, by experience is assessed that the maximum time between phases of a well adjusted mechanism should not be as noticeable as the example above, we suggest a maximum of 5 ms.

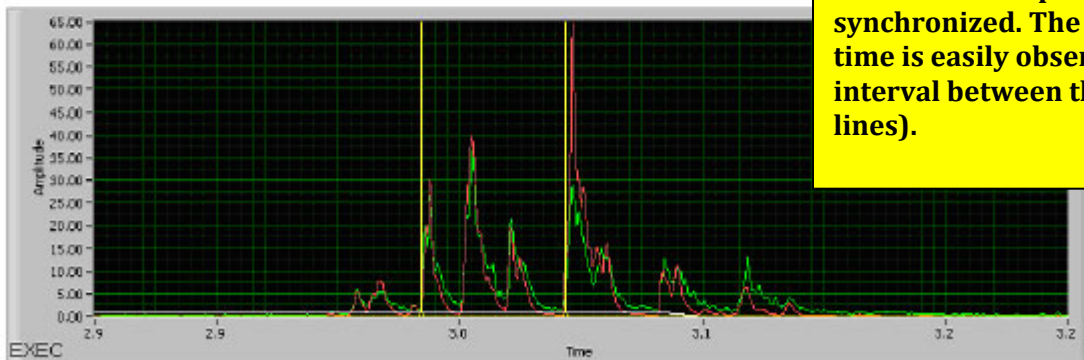
The acoustic trace is very
clear when the phases are
synchronized. The transition
time is easily observed (the
interval between the yellow
lines).

b) Perfect synchronization in the lower frequencies

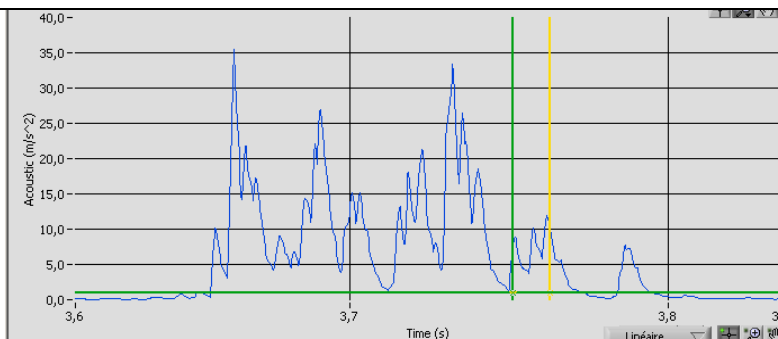
The delay between the three phases can sometimes be measured (11 ms in this example)

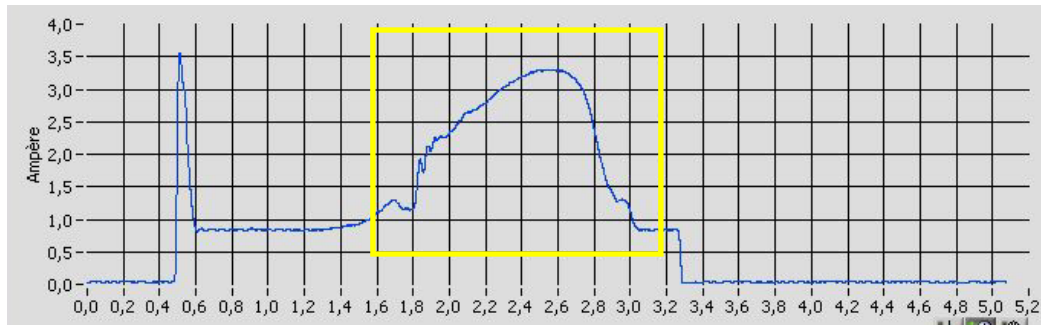
Signature before lubrication

The trace of the motor current shows obvious fluctuations towards the end of the operation. There is a lack of lubrication of the drive mechanism. The lack of lubrication of the drive mechanism has a significant effect on the stress of the motor and sometimes causes a refusal to operate followed by the start of the motor protection.

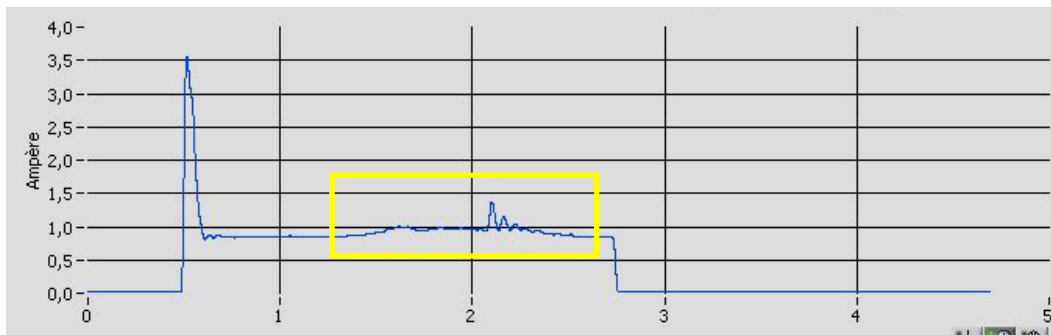
Signature after lubrication - It may be noted that high currents are substantially reduced and the operating time are slightly decreased

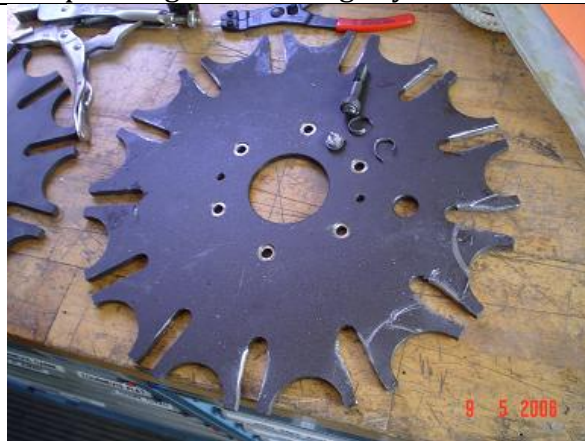
Damage at the **cross** may result from a lack of lubrication

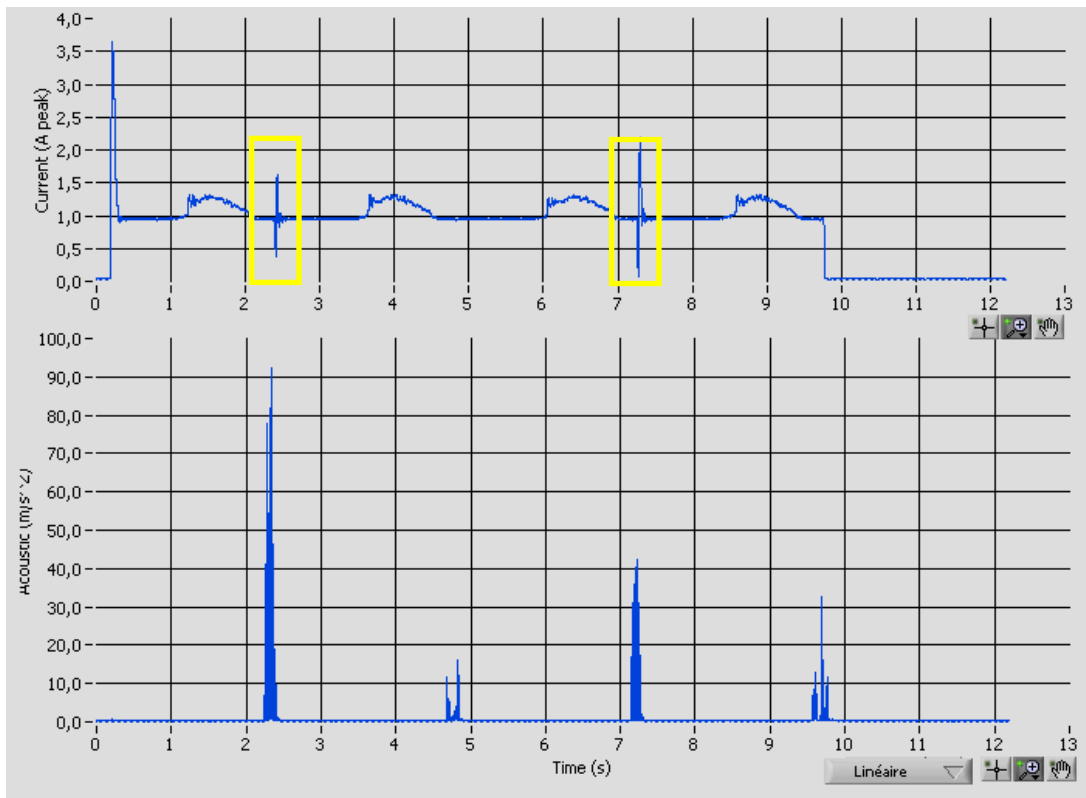
It is to note that sometimes with multiple operations there are important current fluctuations. These phenomena are due to a malfunction of the control relay. Usually a minor problem that can be tuned either by adjusting or replacing the defective relay.
