Diagnostic Cards
-
**Reinhausen - models C, D, E, F, G, M
and T**

Diagnostic Cards

Reinhausen - models C, D, E, F, G, M and T

The following diagnostic cards focus on the symptoms of the major problems of Reinhausen tap-changers (OLTP) - models C, D, E, F, G, M and T as seen on the acoustic signatures. It is important to note that several of the anomalies illustrated here do not show up in the tabular report of the DIAC software.

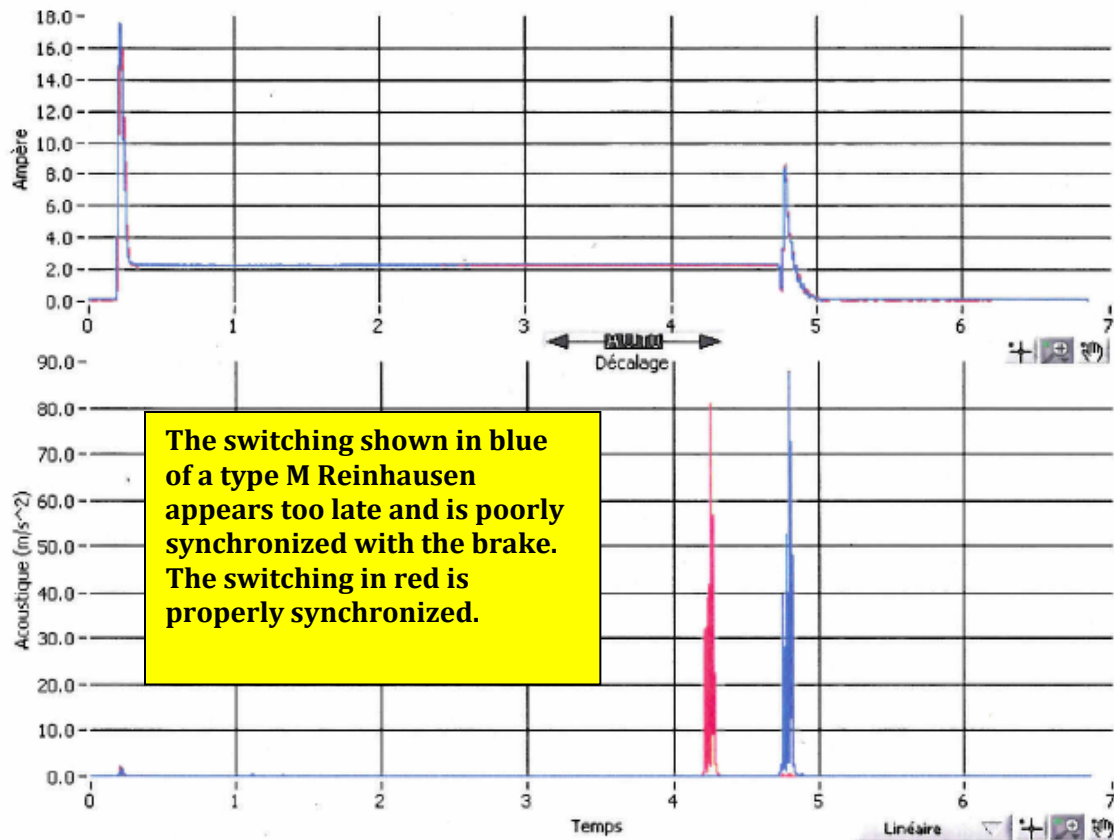
A desynchronization may result from a poor adjustment, or following an inspection of a poor reinsertion. In extreme cases, the switching is so misadjusted that it may not happen in the current operation but during the subsequent operation, which may cause a delay of taps between two devices in parallel.

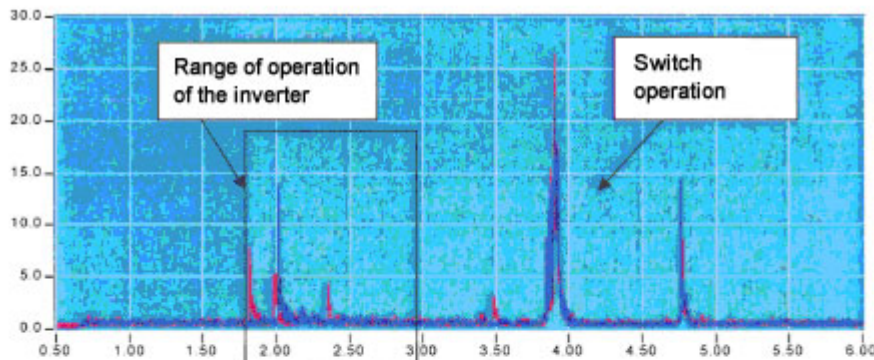
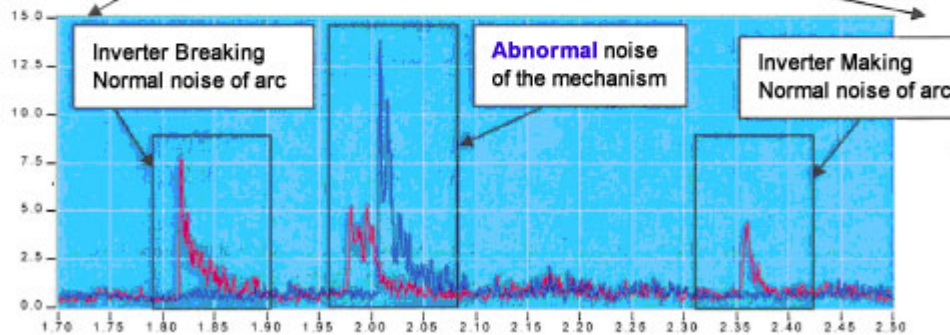
Card 2: Wear of the transmission

The mechanical test of a type D Reinhausen is shown in blue.

The test under voltage is shown in red.

Part of the drive mechanism to check if there is a suspicious noise in the reversal.

This noise (knocking) is caused by excessive wear of the drive mechanism under the lid (in particular, the bearing and the pin of the Maltese cross) causing a partial blockage of the mechanism. In an advanced state, this wear can cause the breaking of the switch inside the main tank. The abnormal noise is accompanied by a **hard spot** (handle or an increase of the motor current) visible during the operation.

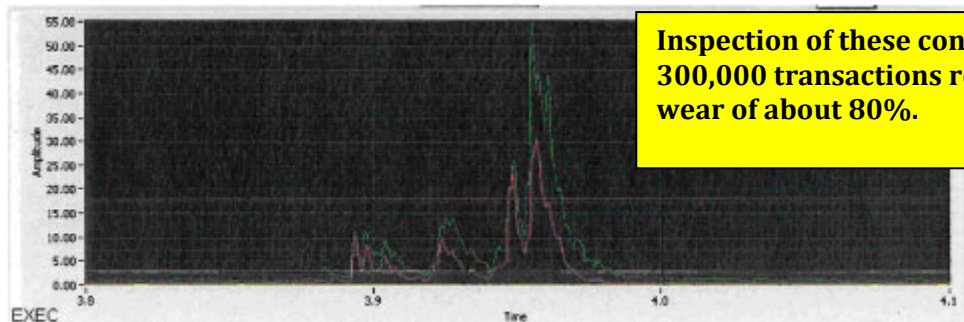
a) After 300,000 operations (January 7, 2004 - Counter 632338 - In Load)

The wear of contacts on types M and T, are seen as gaps between low and high frequency envelopes. A new mechanism will show similar envelopes while the low-frequency envelope becomes dominant as the wear increases.

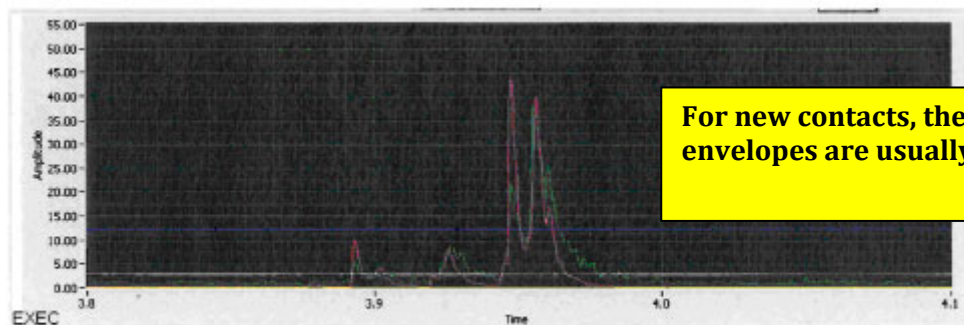
b) New contacts (January 15, 2004 - Counter 634015)

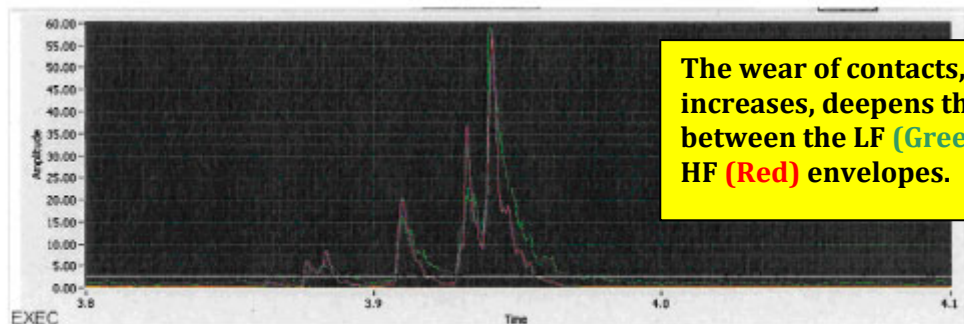
c) After 125,000 operations (November 5, 2004 - Counter 761087)

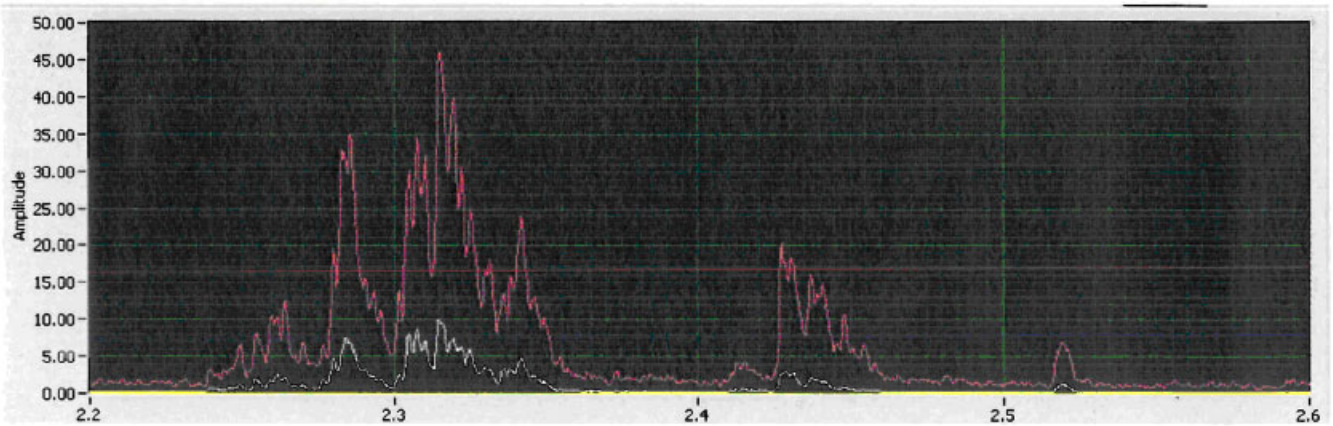
a) Before the change of the switch

In addition to the wear of contacts, gaps between frequency bands are also indicative of the general wear of the switch. The above example illustrates a case of extreme wear of a type M mechanism.

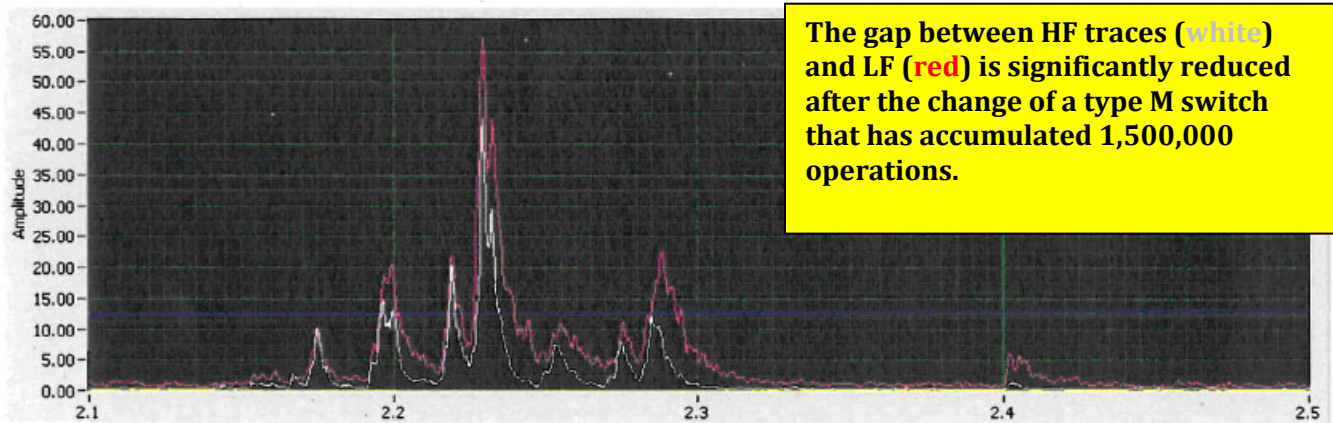
The gap between HF traces (white) and LF (red) is significantly reduced after the change of a type M switch that has accumulated 1,500,000 operations.

b) After the change of the switch

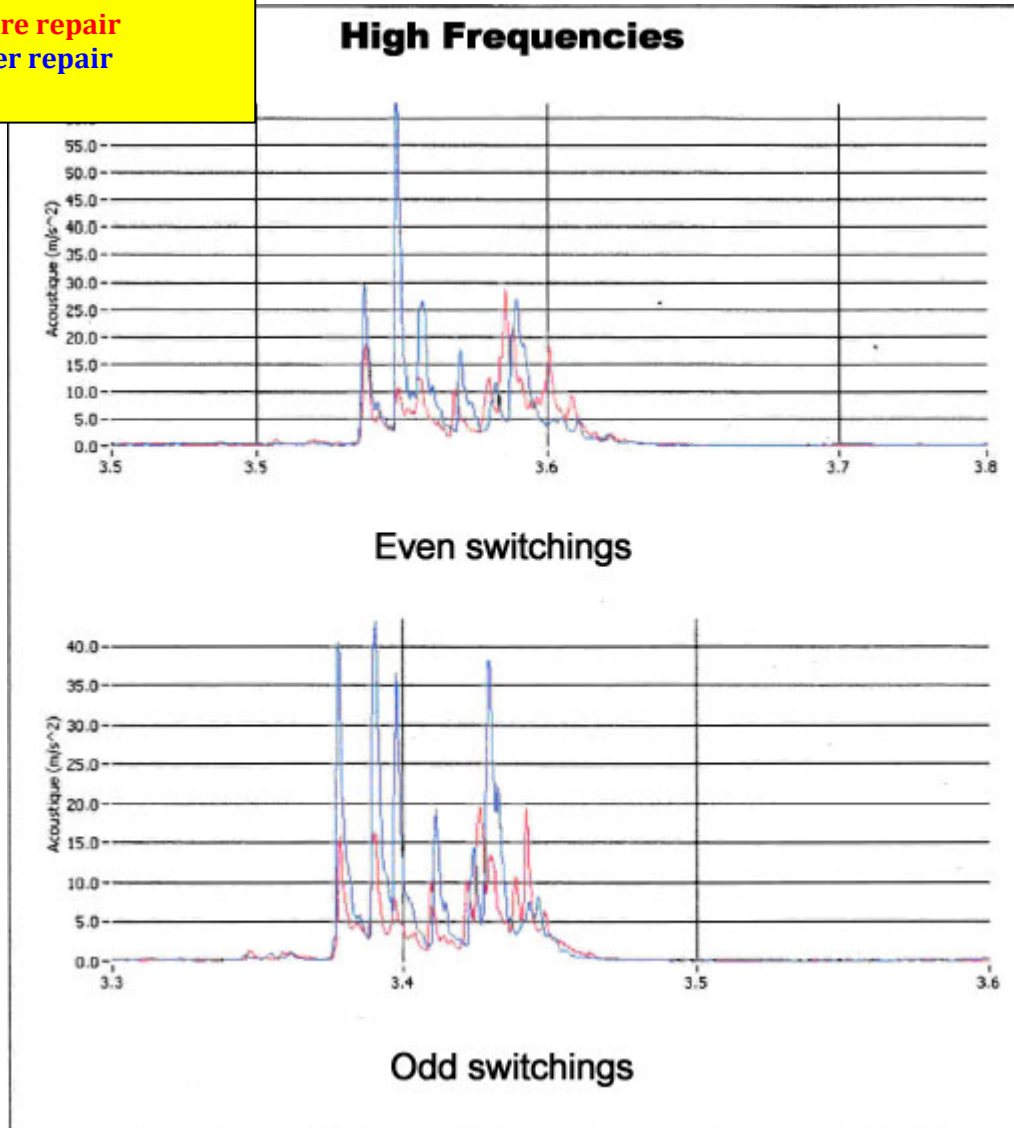
Effect of changing springs
on the envelope of high
frequencies:

Red- before repair
Blue - after repair

The weakening of a type D spring is expressed by a decrease in high frequency envelopes as shown in the example above.

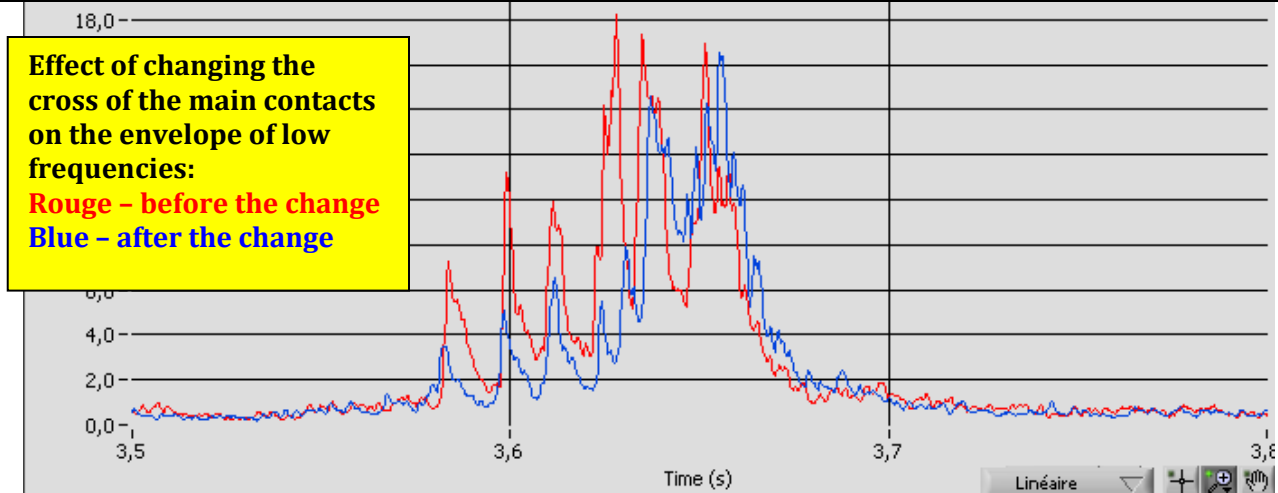
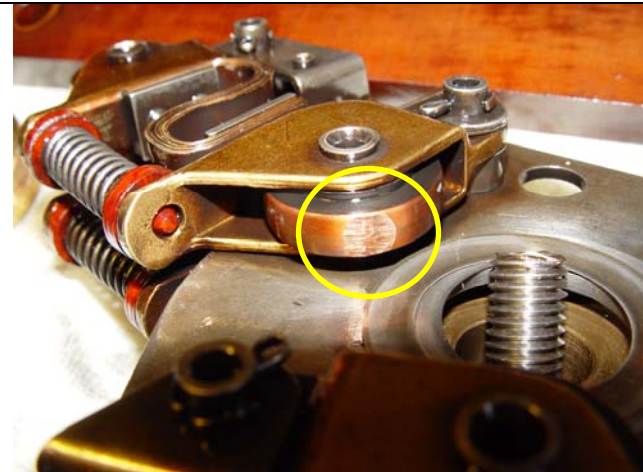
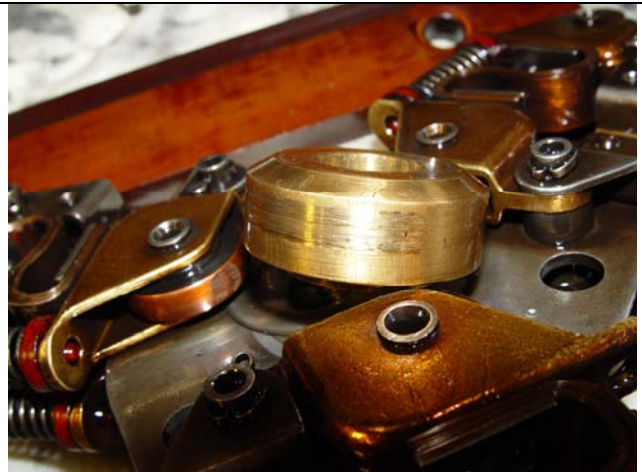
Card 6: Wear of the cross of main contacts

Damage observed on the cross used

The roll of the cross of the main contacts on a type D-0466 mechanism can wear off and show flats and streaks as above. Such type of wear can cause variations in the resistance measurements. The change of the cross is easily perceptible on the signatures of low-frequencies,
