Diagnostic Cards
-
ABB UC - models B, C, D, G and L

Diagnostic Cards

ABB UC - models B, C, D, G and L

The diagnostic cards that follow focus on the symptoms of major problems of tap changers (OLTP) of the ABB UC family, models B, C, D, G, and L, as seen by their acoustic signatures. It is important to note that several of the anomalies illustrated do not show up in the tabular report of the DIAC software.

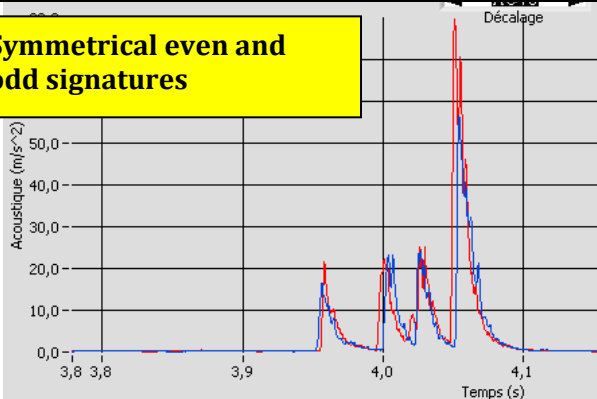
Symmetrical even and odd signatures

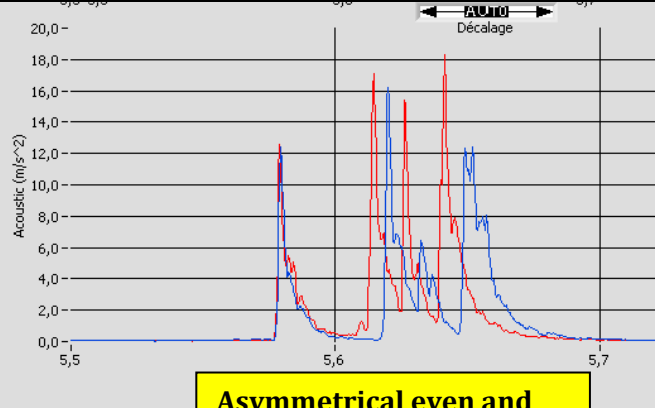
Asymmetrical even and odd signatures

The probable causes of this asymmetry are:

- ✓ The excessive wear of the **driving wheel** of the switch
- ✓ A bad adjustment of the switch (adjustment screw – pass-through bolts)
- ✓ An uneven wear of contacts between the even and odd sides

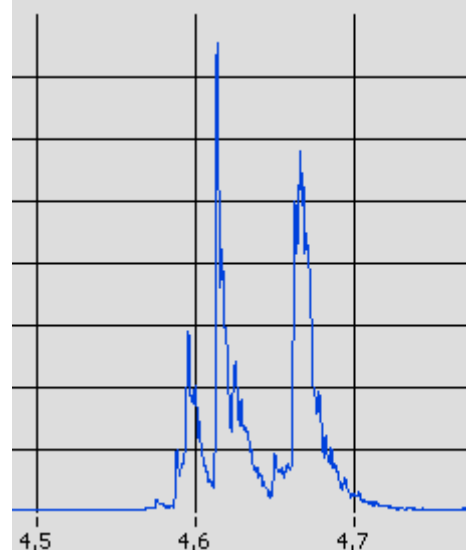
Time of transition barely perceptible

When the transition time is barely perceptible by a visual examination of the acoustic signature, the most likely causes are:

- ✓ Misalignment of the mechanism (pass-through bolts)
- ✓ Wear of the mechanism
- ✓ Wear of the **driving** ring

These anomalies are followed by an asymmetry between even and odd operations. Contacts badly worn may also complicate the identification of the 3rd pic, but without causing an asymmetry.

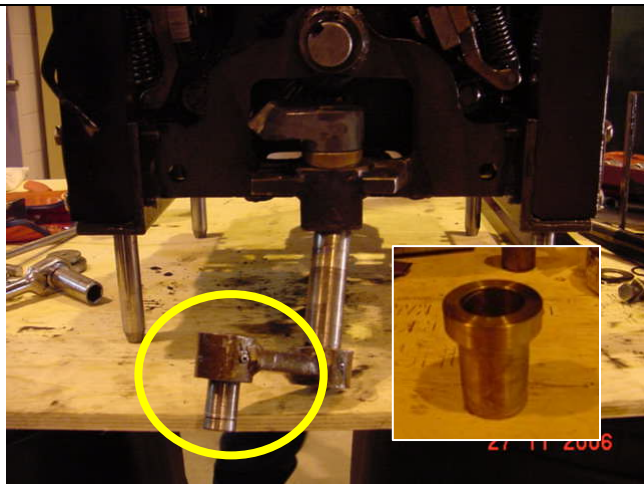
Wear of driving finger and ring

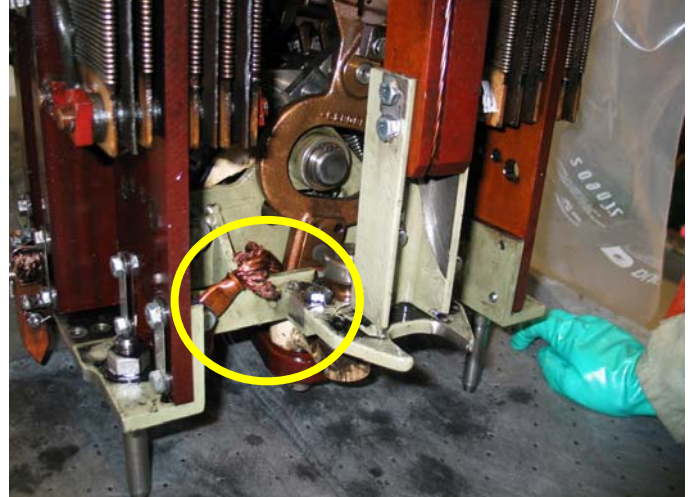
Braid placed at the corner

An improper installation of the braid may interfere with the operation of the mechanism and eventually cause its failure.

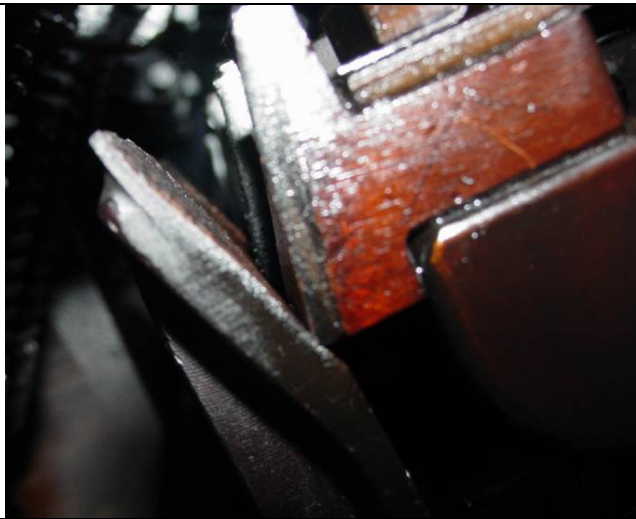
Worn contacts (before repairs)

The loss of material caused by the wear of the driving contacts, for inertial effect, a variation in the sequence and a reduction of the impact noise of the main arc contacts.

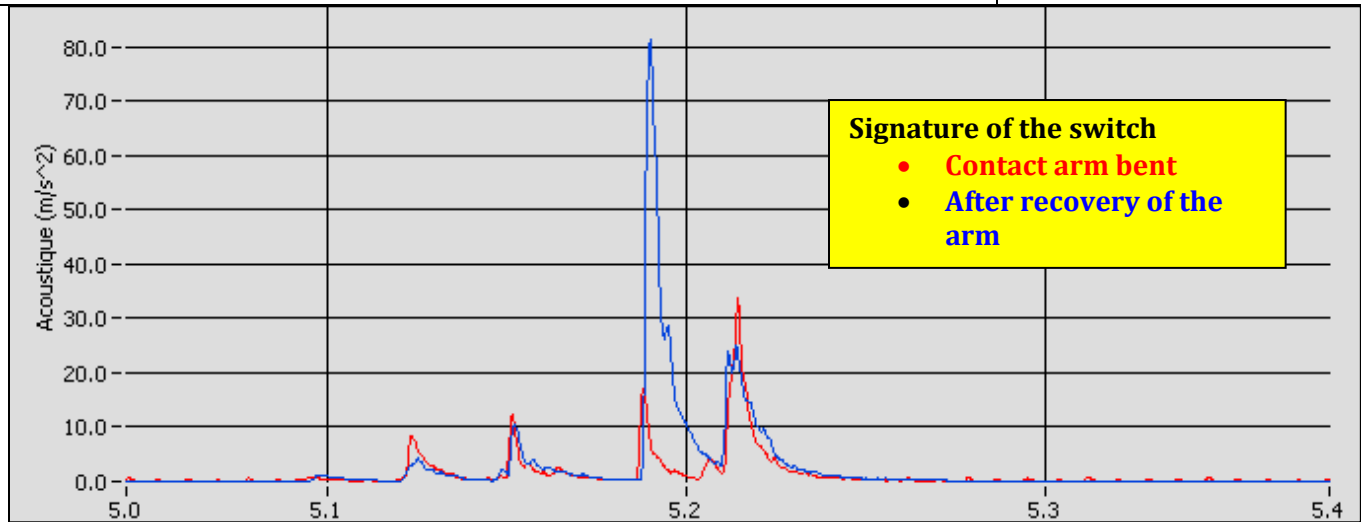
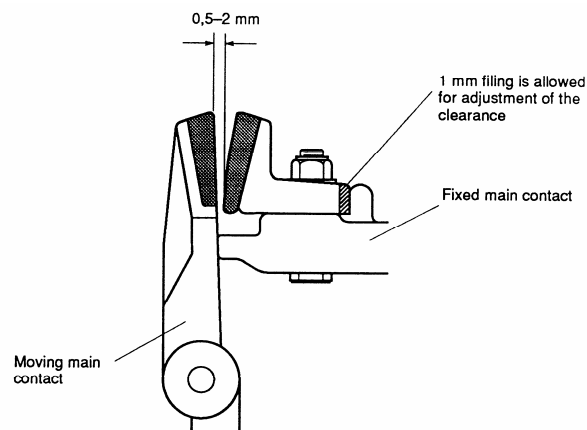
Card 6: Bending the arms of mobile contacts**Models :**
All

As a result of repeated impacts during normal operations, the copper arm of the mobile contacts is bent and the minimum distance between mobile and fixed points of tungsten (0.5 mm) is no longer respected. This anomaly may cause local overheating due to the lower conductivity of tungsten. This anomaly is visible on the noise impact of arcing contacts. To discern the phenomenon of wear, **you can note that the bowing of the arm contacts does not alter the sequence.**

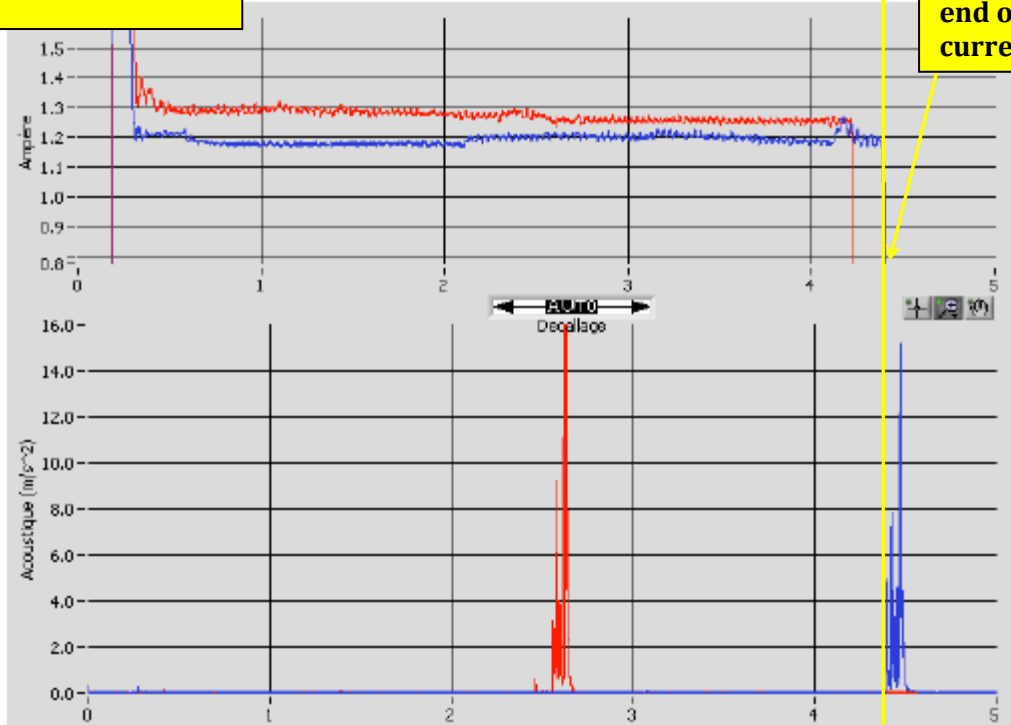
Card 7: Switching synchronization

The switching occurs too early on the red trace (downward operation) and too late on the blue trace (upward operation).

The rise of the switching occurs after the end of the motor current!

Following repairs, or adjustments in the driving mechanism, it is possible that the switching is out of sync. In these models, this anomaly can be demonstrated by comparing the upward and downward operations. In order to correct the adjustment, we must rebuild the **shaft coupling** at the output of the control box.

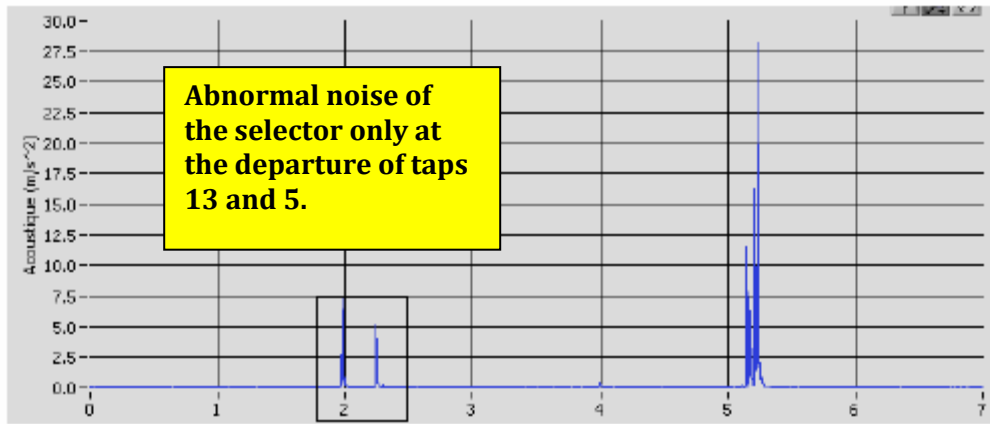
Abnormal noise of the selector

A misalignment of the selector contacts can cause abnormal noise during its operation. For a model with inverter (or pre-selector) that noise will be observed in the two operations corresponding to the same tap as shown above. In this example, there is a noise at the departure of the taps 5 and 13 only, which corresponds to the same fixed contact.

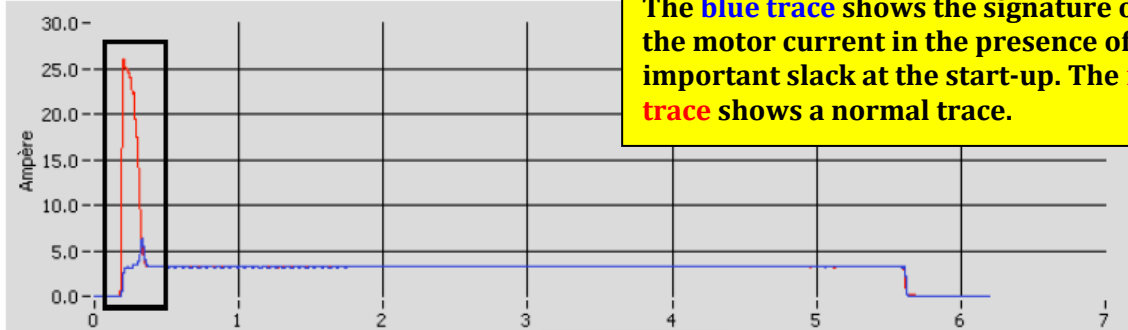
Card 9: Slack in the control rod

An important **slack** in the control rod can be shown in the signature of the motor current as shown above. When the **motor starts to reduce**, the amplitude of the inrush current can be significantly reduced.

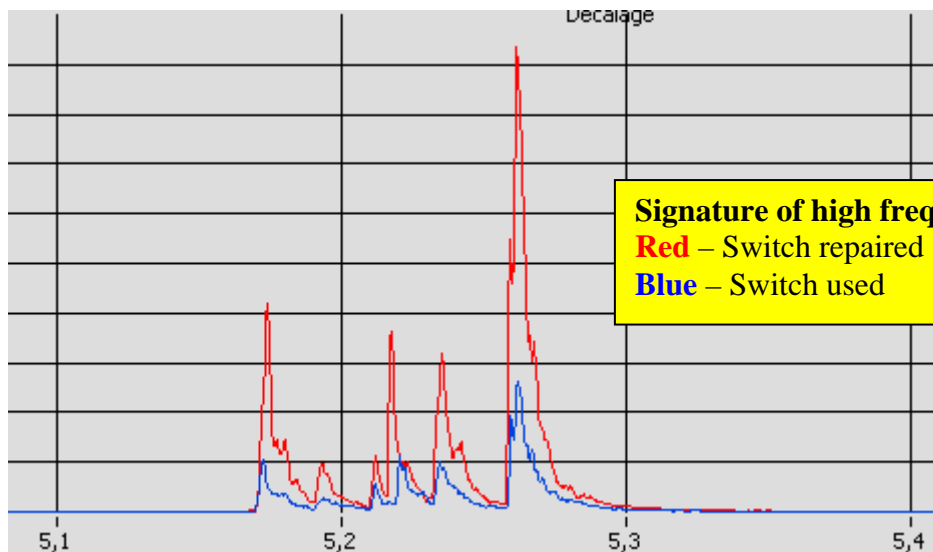
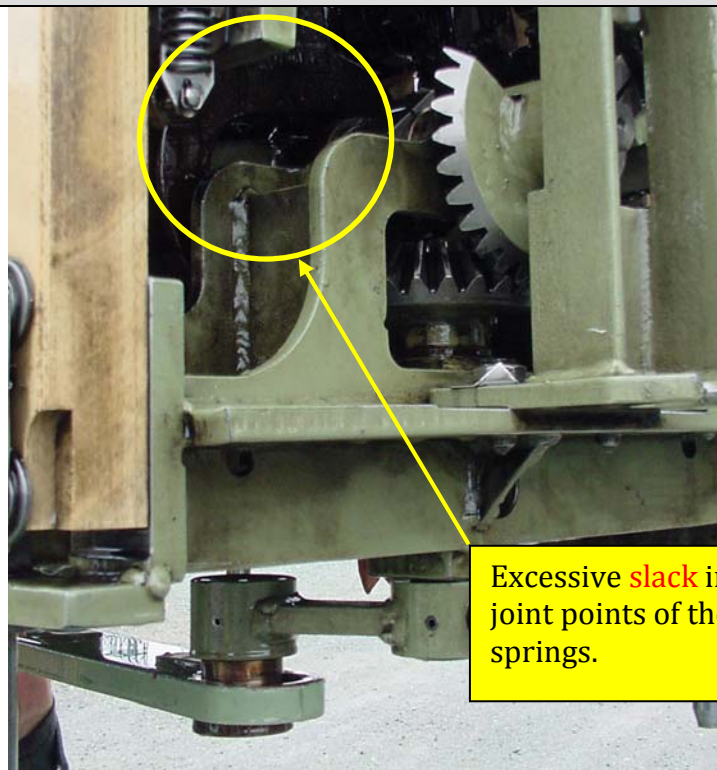
Card 10: Advanced wear of the wheel switch

The **slack** caused by a very advanced wear of the **wheel switch** (the unit shown above had accumulated 400,000 operations) may cause the blocking of the mechanism, a loss of synchronization with the switch that can cause an arc across the terminals of the selector in the tank. This degradation is easily noticeable on the acoustic signature by a significant decrease of amplitudes with the wear.

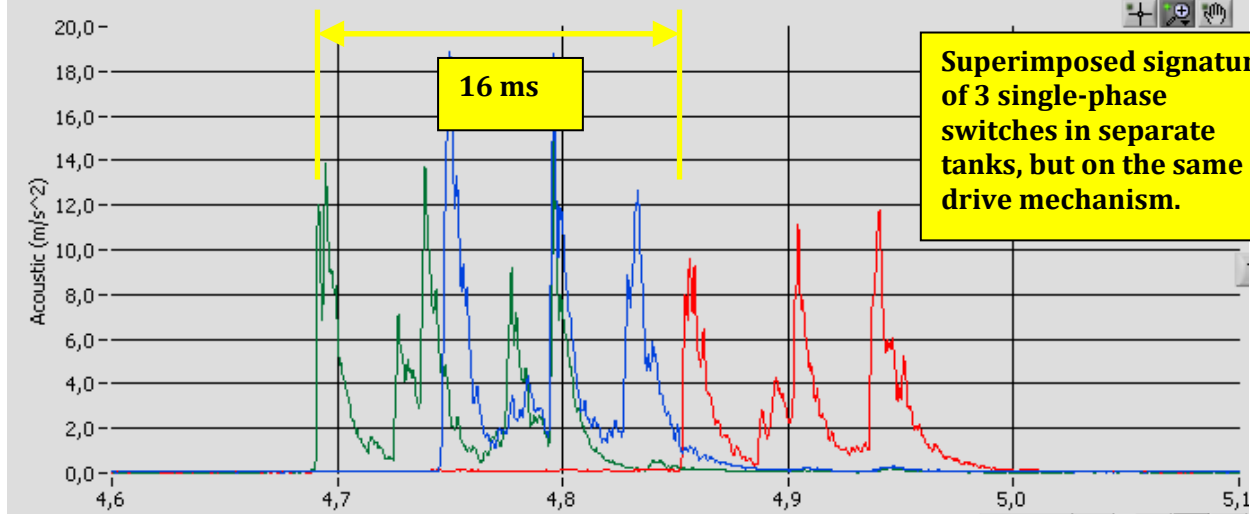
Card 11: Desynchronization between switches**Models :**

Synchronization between single-phase switches can be accurately verified especially when they are in separate tanks but on a single mechanism as shown above. By performing the measurement with 3 accelerometers, the signatures of the 3 switches occur simultaneously and the timing is measured directly. If the manufacturer does not specify a maximum offset, the adjustment (coupling shafts) can usually be made so that the offset does not exceeds 25 ms.

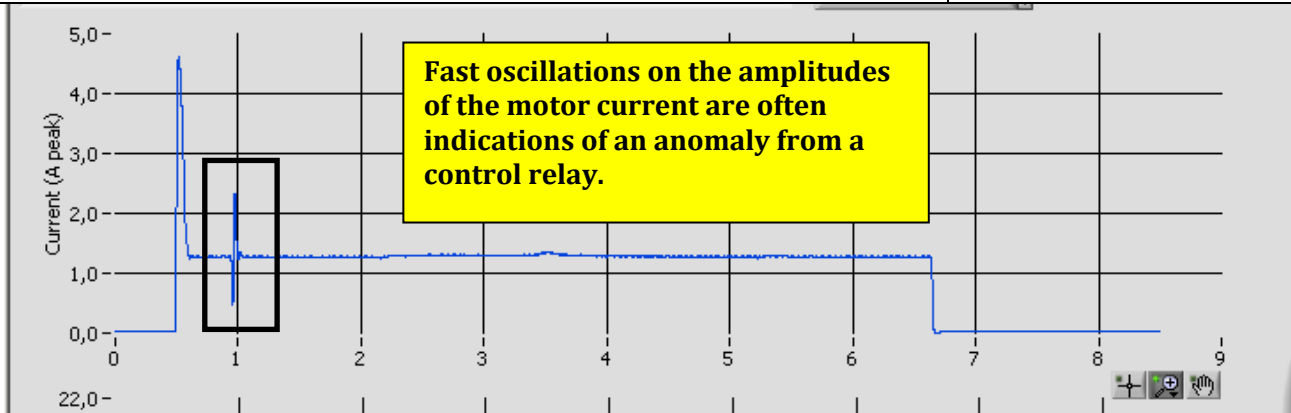
Card 12: Faulty control relay**Models :**
All

Anomalies of operation or of adjustment of control relays (upward, downward, maintenance, etc.) can often be observed by rapid fluctuations of the current. These anomalies are usually benign but still indicate a deterioration of the device which can ultimately lead to a refusal to operate; the operations are jerky or jumping to a position other than the set point. From the point of operation, this behavior explains the reports of **lag** control

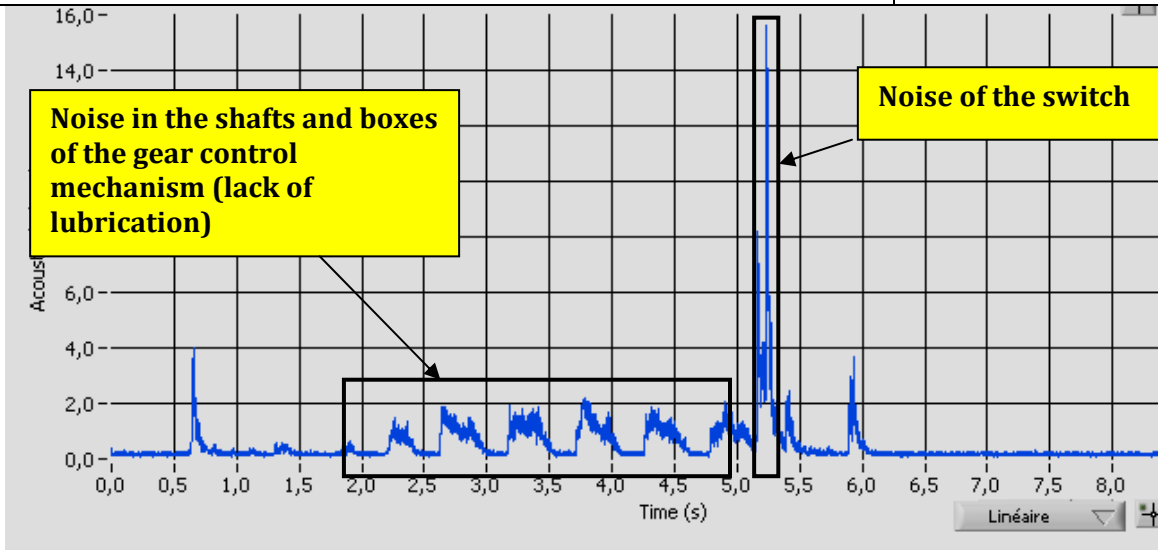
Card 13: Lack of lubrication of the control gear

A lack of lubrication of the gear drive mechanism may affect the acoustic signature as shown in this example. This phenomenon is highlighted in particular in the signature of the lower frequencies.

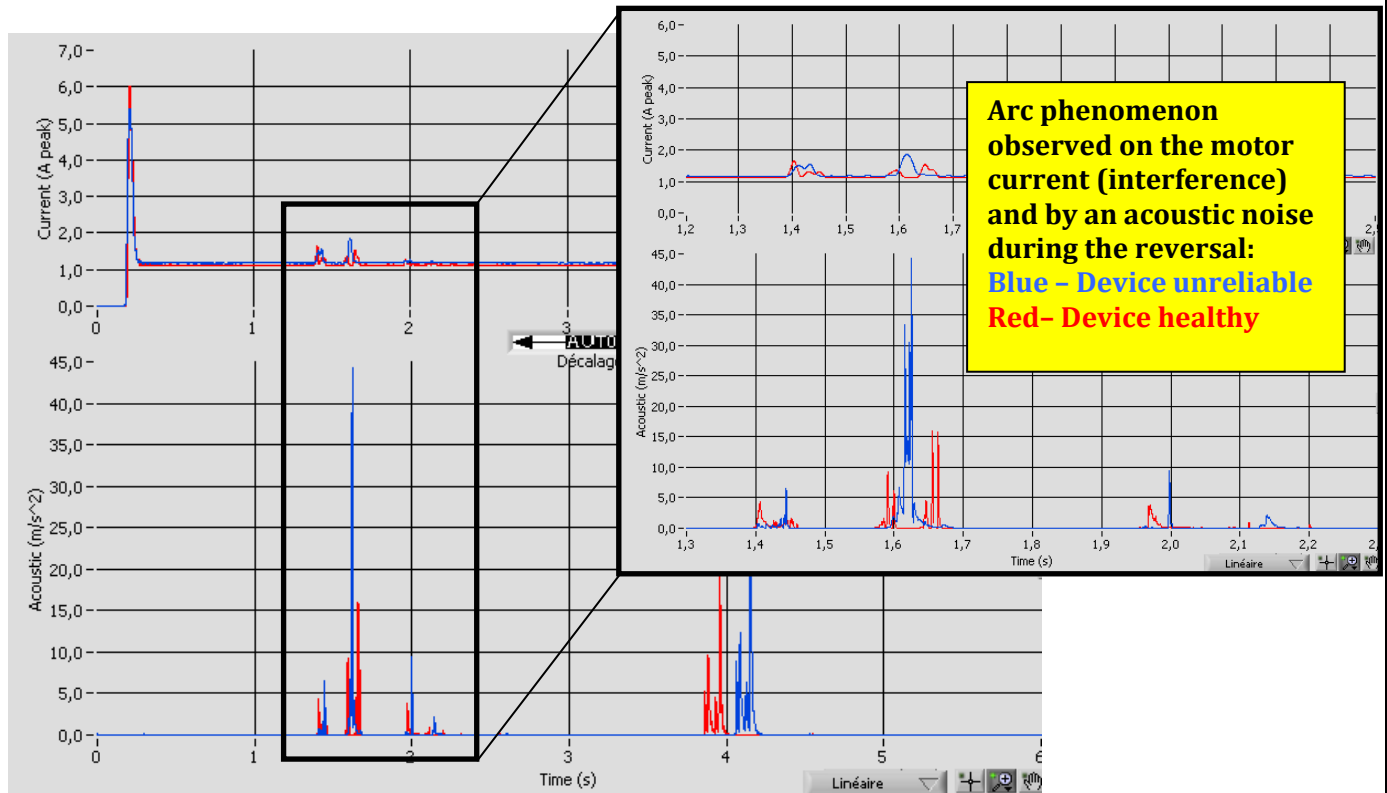
Card 14: Anomaly in the voltage limiter device

The operation of the inverter under voltage causes a low-intensity arc, which is picked up by the current clamp (for electromagnetic interference) by means of the acoustic noise of the spark. It can often be observed at the time of the contact separation, a few alternations to 120 Hz corresponding to voltages peaks.

Depending on the voltage level, some manufacturers install voltage limiter devices to reduce this phenomenon. In case of failure of this device, one can observe that the amplitudes of the noise increases as shown in the figure above. And the phenomenon can also be maintained over a longer period (not in this example).

The long-term consequences of such anomalies are not well known.
