Diagnostic Cards
-
Federal Pioneer Reactive

Diagnostic Cards

Federal Pioneer Reactive

The following pages consist of diagnostic cards for tap changers (OLTP) of the Federal Pioneer Reactive family. They summarize the main operational problems specific to this family of tap changers.

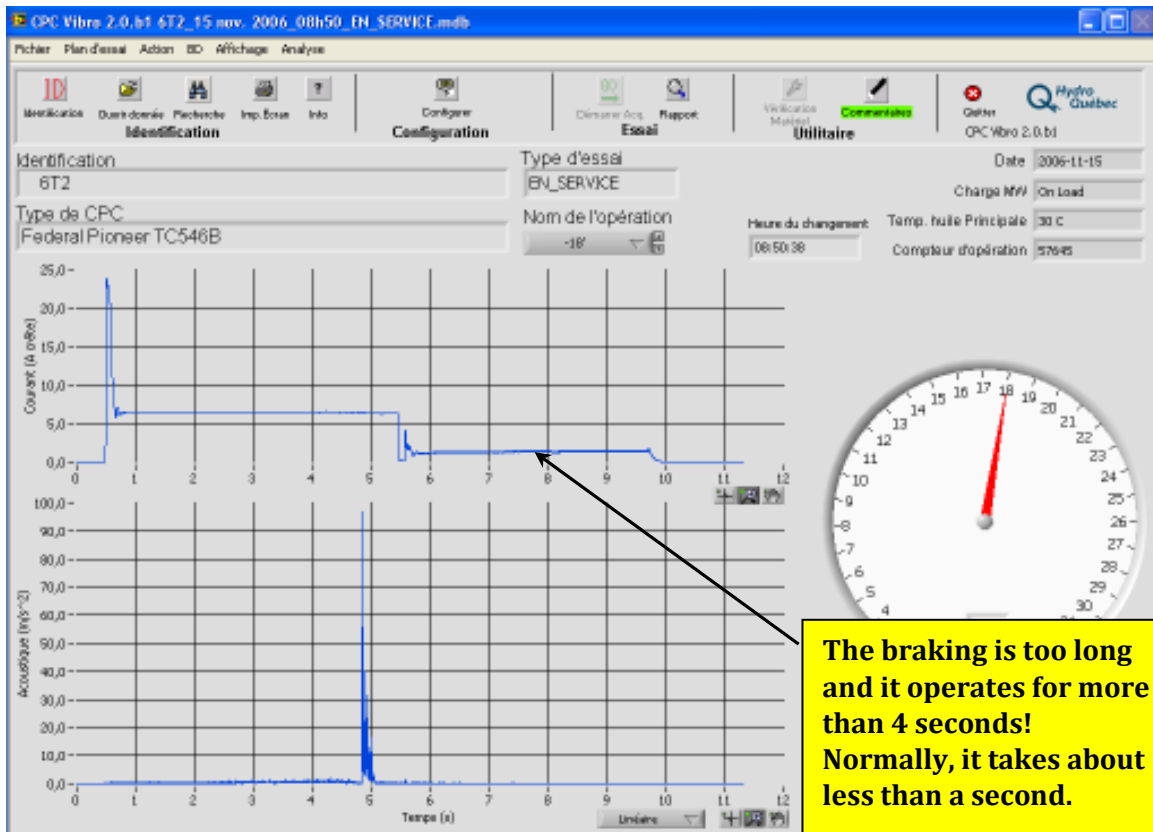
Card #1: The trace of the current contains an extended braking

Anomalies seen on the trace	Problem	Adjustment needed
The trace of the current contains an extended braking.	Dynamic brake is applied for an abnormally long time.	Adjust and repair the braking system.

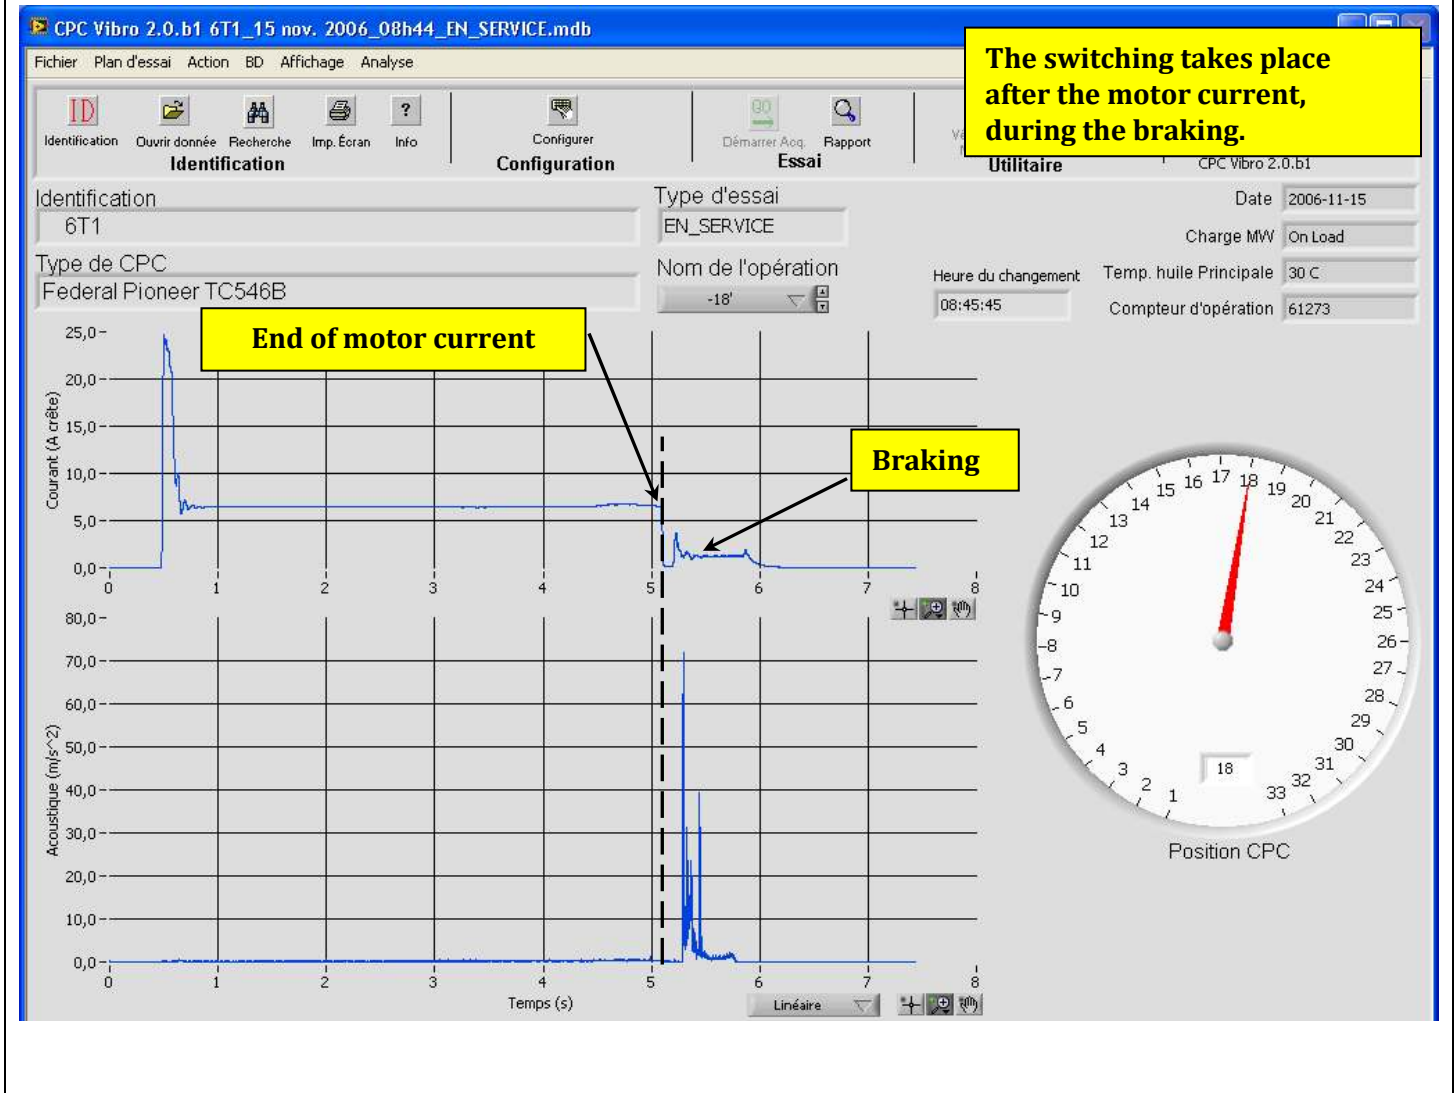
Card #2: The switching occurs too early/late.

Anomalies seen on the trace	Problem	Adjustment needed
The switching occurs too early/late. It happens after the end of the motor current during the braking or much too early in the operation.	Desynchronization of the switching with the braking.	Synchronize the switching.

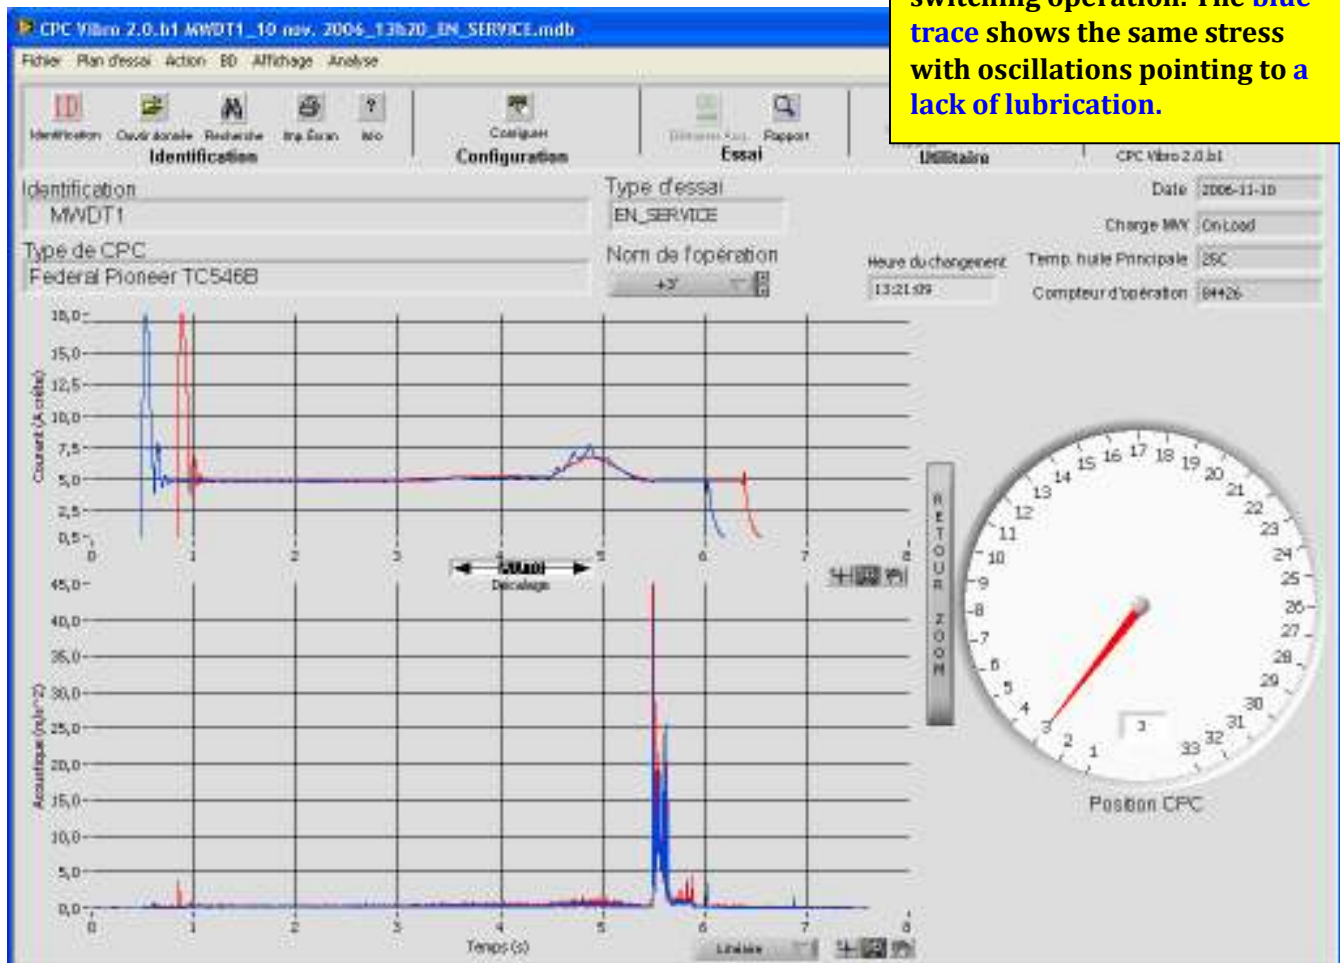
Card #3: Significant fluctuations on the trace of the motor current.

Anomalies seen on the trace	Problem	Adjustment needed
Fluctuations such as oscillations appear on the trace of the motor current during the operation of the switch, selector or inverter.	A lubrication problem of the drive mechanism.	Lubricate the drive mechanism. (CRITERIA???)

The red trace, lubricated mechanism, shows a further stress of the motor during the switching operation. The blue trace shows the same stress with oscillations pointing to a lack of lubrication.

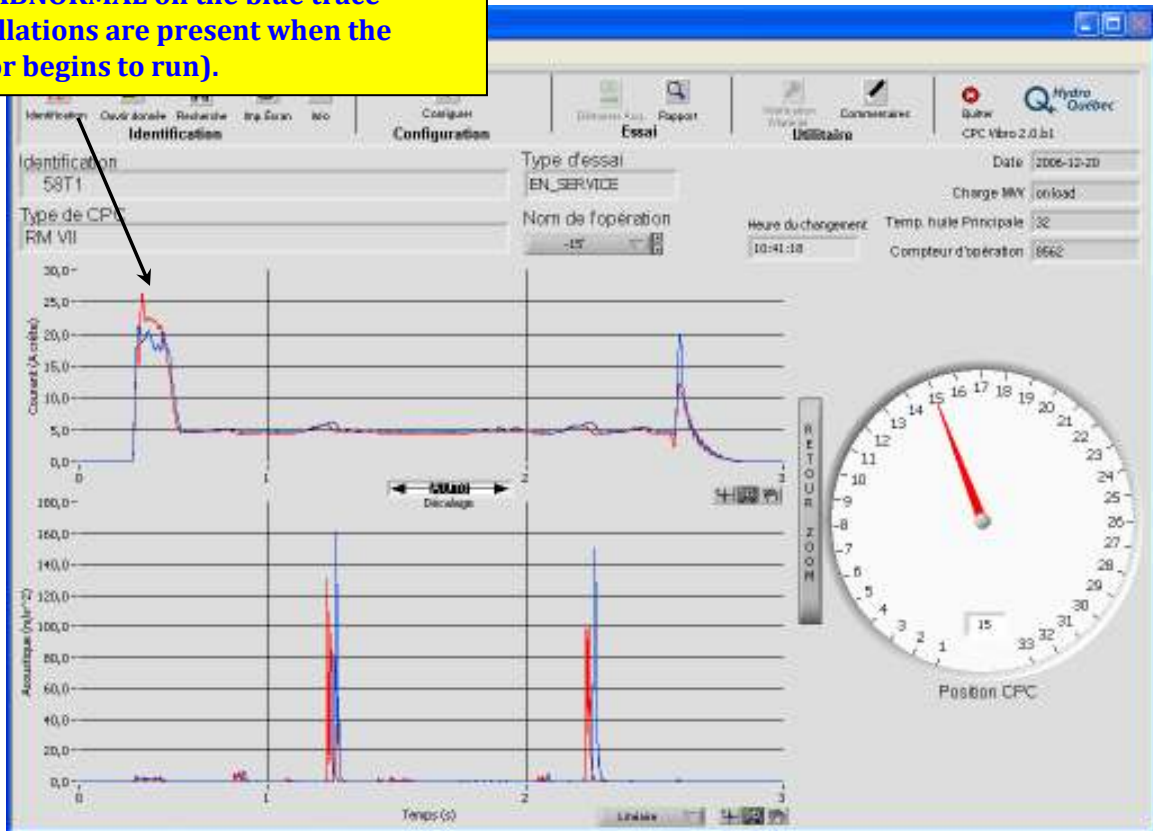
Card #4: The trace of the inrush contains oscillations.

Anomalies seen on the trace	Problem	Adjustment needed
The inrush trace is present on abnormal oscillations, while the normal inrush trace is generally smooth and stable.	These oscillations can be caused by a problem with the contactor that starts the motor or with the motor itself.	Readjust the contactor or replace the motor if it is defective. (CRITERIA???)

The inrush is **NORMAL** on the red trace and **ABNORMAL** on the blue trace (oscillations are present when the motor begins to run).

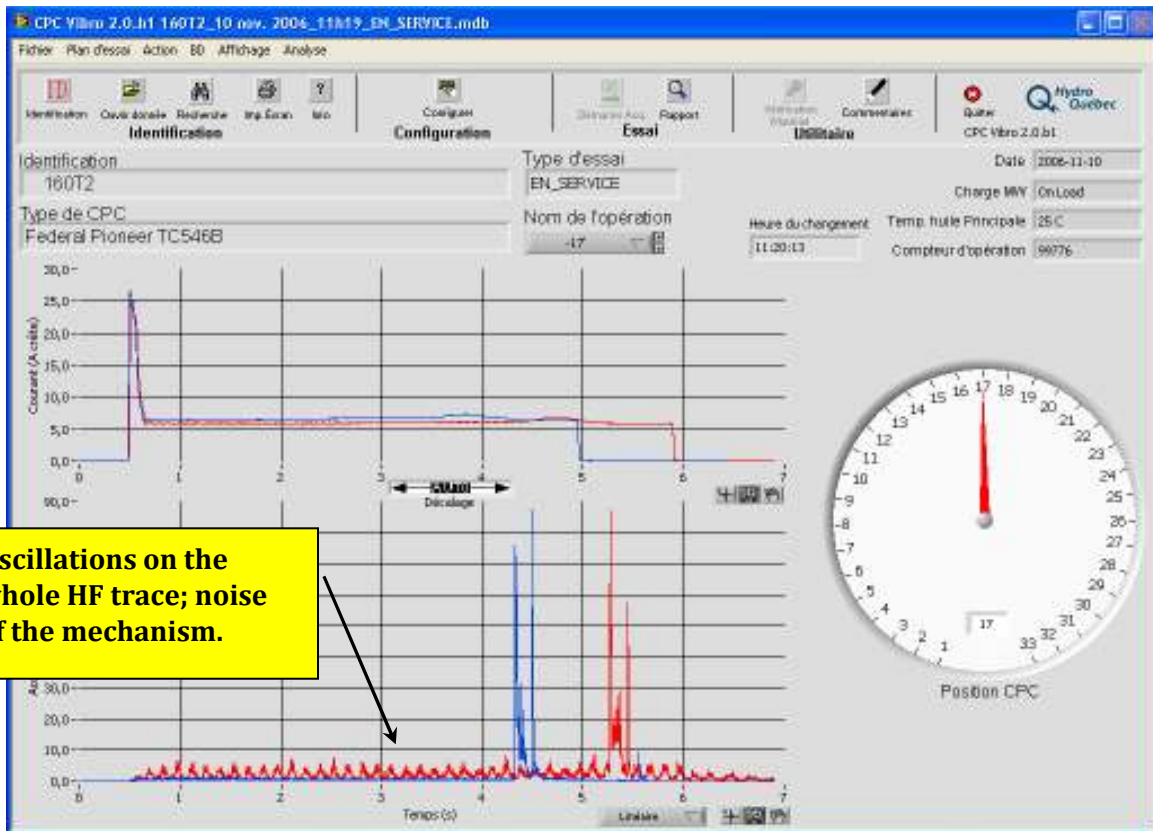
Card #5: Noise of the mechanism during its operation;
oscillations present throughout the HF trace.

Anomalies seen on the trace	Problem	Adjustment needed
Noise of the mechanism during its operation; the oscillations are present throughout all the trace of HF.	A lack of lubrication of the drive mechanism or an advanced wear of the drive mechanism is present.	Correct the situation by lubricating or replacing worn parts or observe the OLTP periodically to monitor the problem at hand.

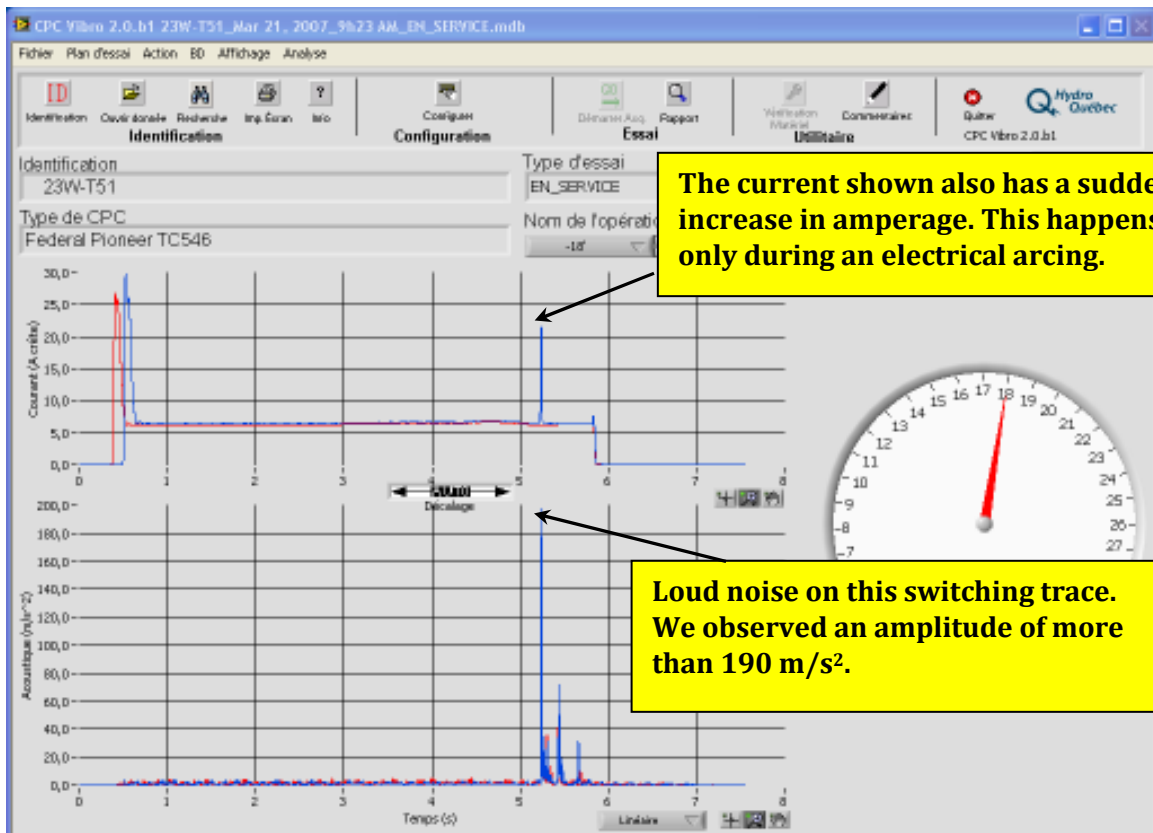
Card #6: Noise of very high amplitude during the switching operation.

Anomalies seen on the trace	Problem	Adjustment needed
The switching shows a noise with very high amplitude compared to normal switching, and compared with other noises on the same switching.	This may be due to a problem of the transition of the spring, a problem with the switch mechanism or another cause.	Identify the cause of the problem and repair, by readjustment of the mechanism, changing the much worn parts or the springs.

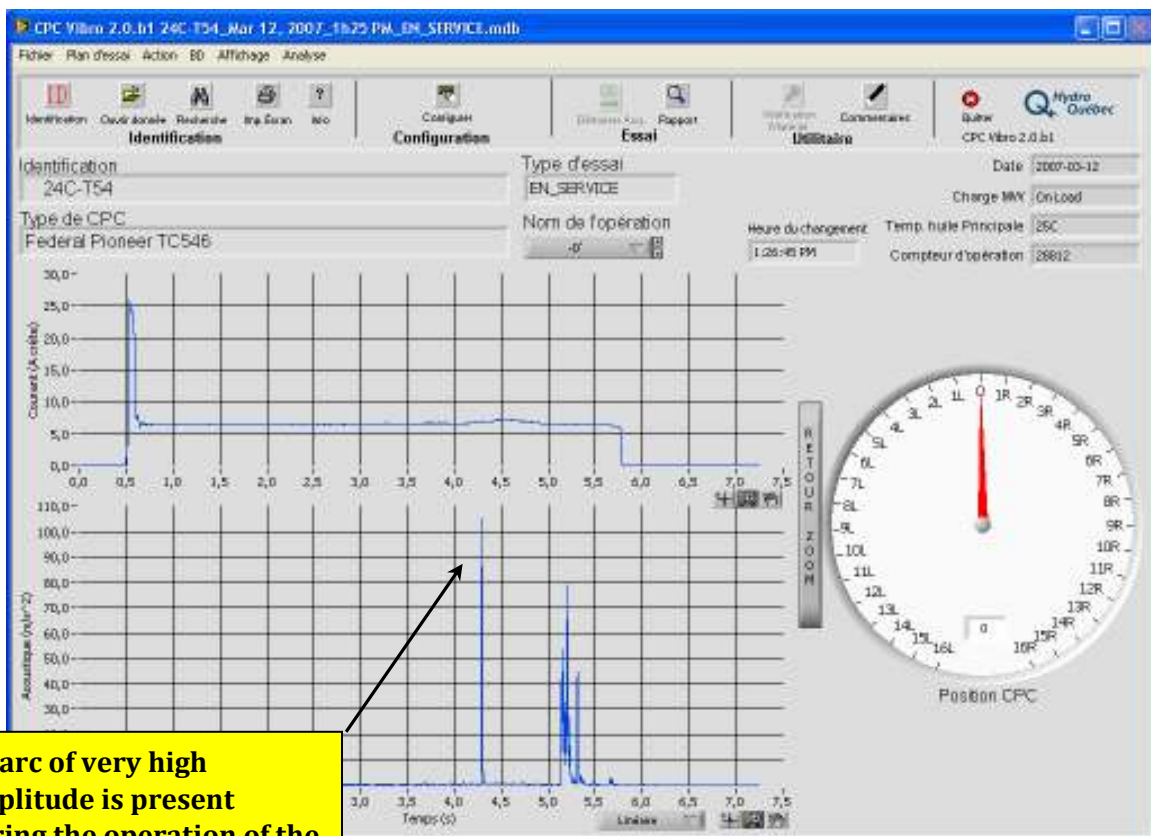
Card #7: Noise of very high amplitude during the operation of the inverter.

Anomalies seen on the trace	Problem	Adjustment needed
A noise of very high amplitude during the operation of the inverter.	This defines an arc of very high amplitude present during the operation of the inverter. This may be due to too much carbon in the oil, or to a problem with the limiting voltage device, or other sources.	Identify the cause of the problem and repair, change or filter the oil, etc.
