The vibro-acoustic method as fast diagnostic tool on load tap changers through the simultaneous analysis of vibration, dynamic resistance and high speed camera recordings.

**Fouad Brikci, Pier-Antoine Giguère, Zensol
Mathieu Soares, Carl Tardif, Hydro Québec**

CMDM 2015 - Condition Monitoring, Diagnosis and Maintenance, CIGRÉ
October 2015

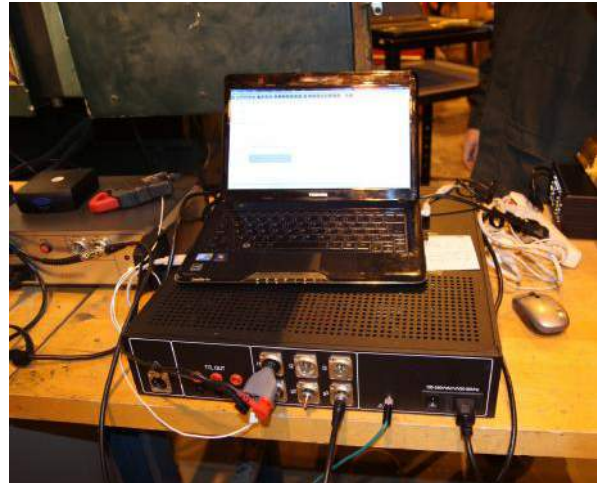
Fig. 1.1 Zensol OTM-X - Instrument for the acquisition of vibration, current and voltage signals.

For the recording of resistance and vibration curves, an acquisition system has been used, the Zensol OTM-X (Fig. 1.1). This instrument is characterized by 6 inputs: 3 analog inputs $\pm 5V$, for vibration transducers, and 3 analog inputs $\pm 10V$, for standard transducers. It has 16bits A/D conversion and configured with a sampling time of 10 microseconds. During the test, one accelerometer has been connected to

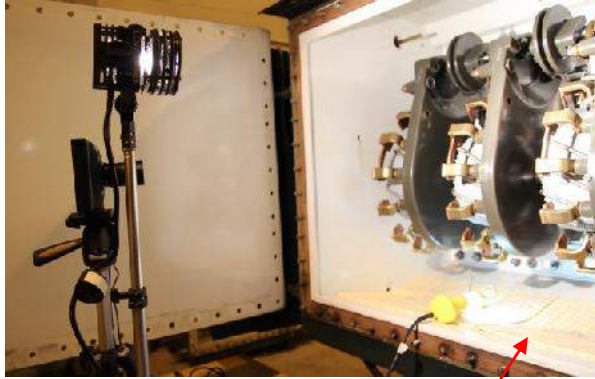
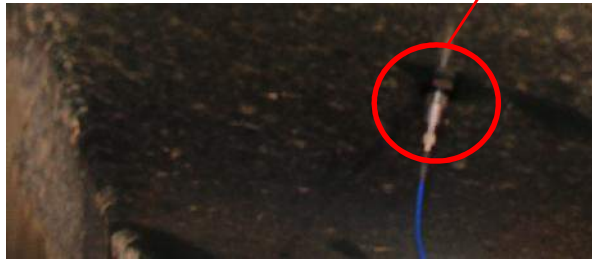
Fig. 1.3 High speed camera and position of accelerometer under OLTC.

In order to catch the highest amplitude of noise, the accelerometer has been located as close as possible to the moving taps. At the same time, a high speed camera has been placed in front of the mechanism to record the OLTC in operation (Fig. 1.3).

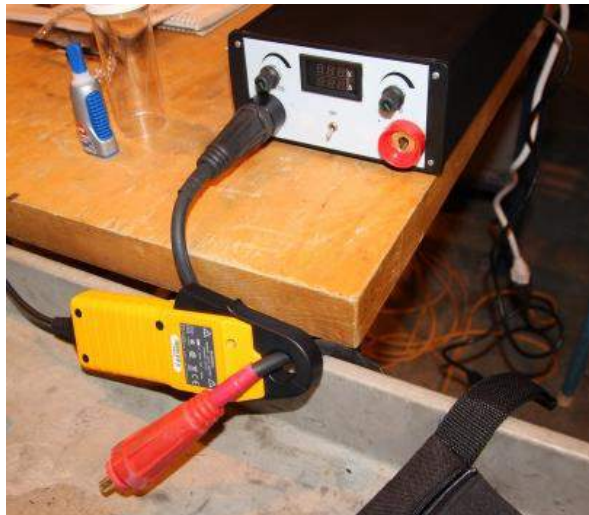
Fig. 1.4 DC voltage source and current clamp

To complete the set-up, a DC voltage source and a DC current clamp have been connected on the transformer, as shown in Fig. 1.4, Fig. 1.5 and Fig. 1.6.

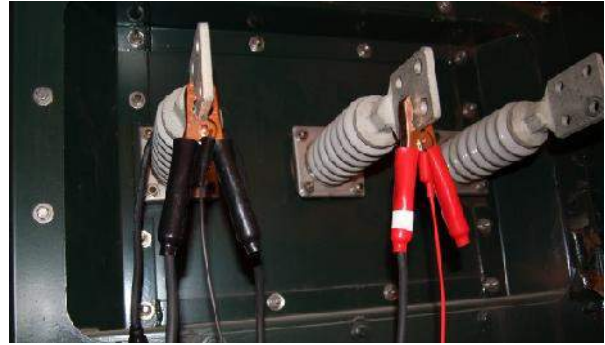
Fig. 1.5 Connection of contact clamps on the transformer

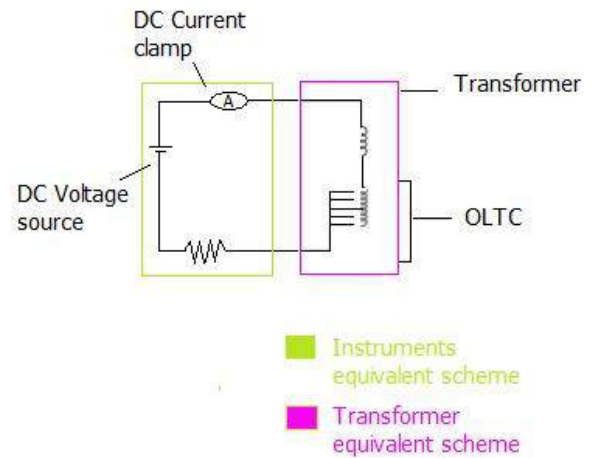
To better understand the disposition of the instruments, a symbolic scheme has been drawn and reported in Fig.1.6. The left part represents the set-up built by the authors - which includes the DC voltage source and current clamp - while the right part represents the transformer with its OLTC.

Fig. 1.6 Equivalent scheme of transformer and instruments

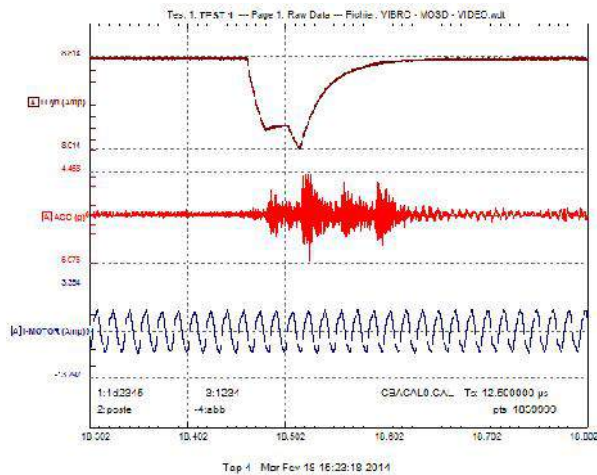
Fig. 1.7 shows the test results of the operation of the OLTC moving from tap 8 to tap 9. Starting from the top, this graphic shows: the dynamic current curve, the accelerometer signature and the motor current profile.

Fig. 1.7 Expanded test results for test 8 --> 9

As it can be observed, the accelerometer signature is characterized by 4 main peaks, the two first corresponding to a specific value of current. With the support of the video, these first two peaks have been identified as follows:

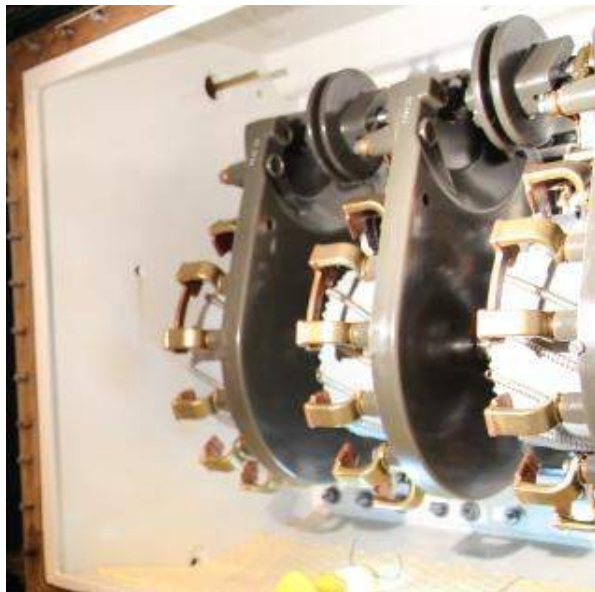
Fig. 1.10 Position 1 of the second accelerometer (Blue)

The truthfulness of this conclusion has been proved by the signatures recorded by a second accelerometer, installed directly on the mounting base of the fixed contacts (Fig.1.10). Fig. 1.11 shows a comparison of the two accelerometers signatures with respect to the dynamic current curve. As it can be observed, the relation between the current and the movements of the operating contacts is confirmed in both the accelerometer signatures. The additional two impacts of the external accelerometer (in red) can be probably related to ancillary mechanisms operating around the OLTC (such as brakes or springs).

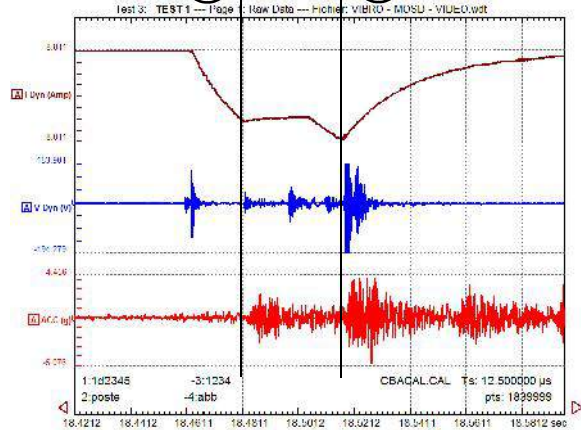
Fig. 1.11 Comparison of the two accelerometers signatures

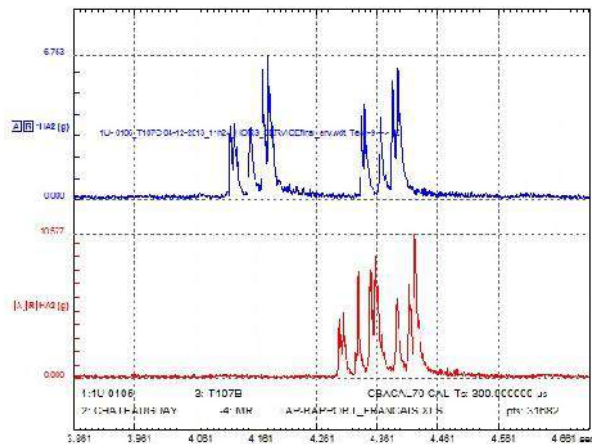
Fig. 1.12 Before maintenance 200ms gap

an intervention was made before too much damage was done. Fig. 1.12 shows the result of both tap changers on the same time scale. The red line represents the expected signature and the blue line represents the problematic one. The switching time of the TI2000 should be around 150ms, where the blue curve takes almost double that amount. The big gap was attributed to a problem with the coupling of the drive shaft on one of the two tap changers. This timing difference could have created circulating currents in between the tap changers. Fig 1.13 shows that after maintenance, this 200ms delay was corrected.

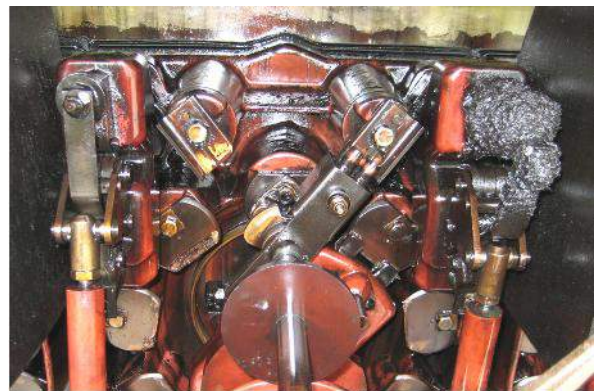
Fig. 1.14 Coking and burnt contacts of a TC-546

As a second example, here are tests done on a Federal Pioneer TC546. Over a three year period multiple interventions were done where the vibro-acoustic measurements were recorded, but not analyzed. In 2013, high values in dissolved gas analysis were picked up. The vibro-acoustic measurement were done before and after the maintenance as their norm specify. When they opened the tap changer, they discovered a lot of coking and burnt contacts. (Fig 1.14)

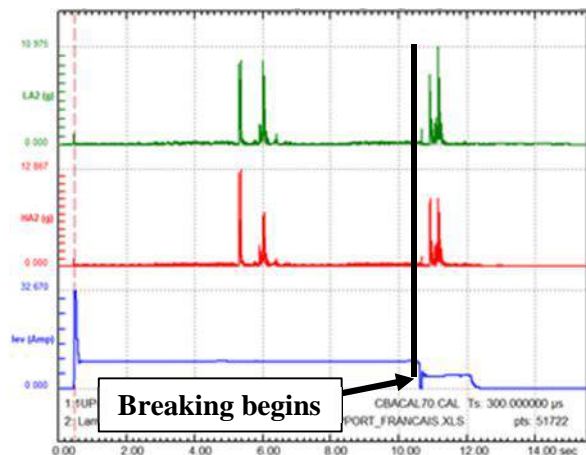
The Fig. 1.15 2013 Before maintenance, timing problem
 The last impact is seen on the next test, since the tap changer didn't stop at the right place.
 (Fig 1.16)

The sequence of movements in the tap changer must follow a predetermined order. In 2013, the breaks were applied too early and the final movements of the tap changer end after the expected time (Fig. 1.15). Still in 2013, after maintenance, they didn't realize that the timing was still off and it even got worse.

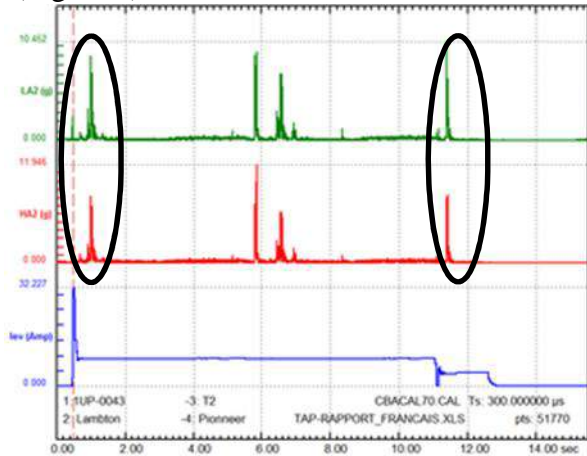
Fig. 1.16 2013 After maintenance, worse timing problems.

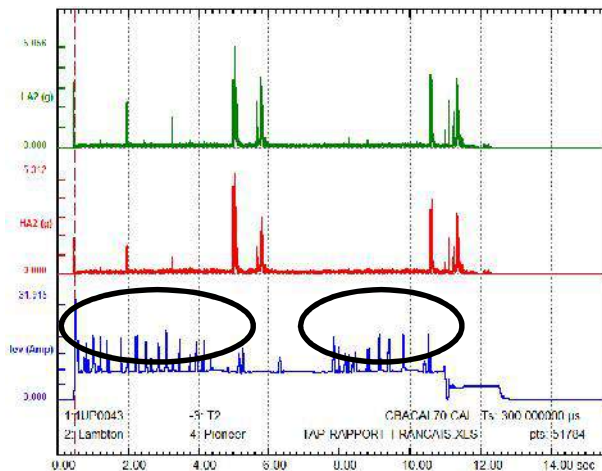
Fig. 1.17 2014 After maintenance, current spikes.

It doesn't end there, following another dissolved gas analysis, they went back to open the tap changer to find it in an even worse condition. They cleaned everything and replaced the burnt parts again. They corrected part of the timing issue but a new problem appears, the drive chain has been tightened too much and we can see it as spikes on the motor current. (Fig 1.17)
