# **The vibro-acoustic method as fast diagnostic tool on load tap changers through the simultaneous analysis of vibration, dynamic resistance and high speed camera recordings.**

**Fouad Brikci, Pier-Antoine Giguère, Zensol  
Mathieu Soares, Carl Tardif, Hydro Québec**

CMDM 2015 - Condition Monitoring, Diagnosis and Maintenance, CIGRÉ  
October 2015

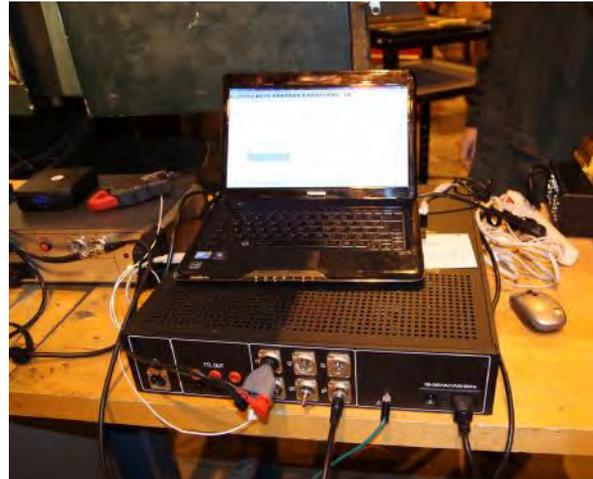
Fig. 1.1 Zensol OTM-X - Instrument for the acquisition of vibration, current and voltage signals.

For the recording of resistance and vibration curves, an acquisition system has been used, the Zensol OTM-X (Fig. 1.1). This instrument is characterized by 6 inputs: 3 analog inputs  $\pm 5V$ , for vibration transducers, and 3 analog inputs  $\pm 10V$ , for standard transducers. It has 16bits A/D conversion and configured with a sampling time of 10 microseconds. During the test, one accelerometer has been connected to

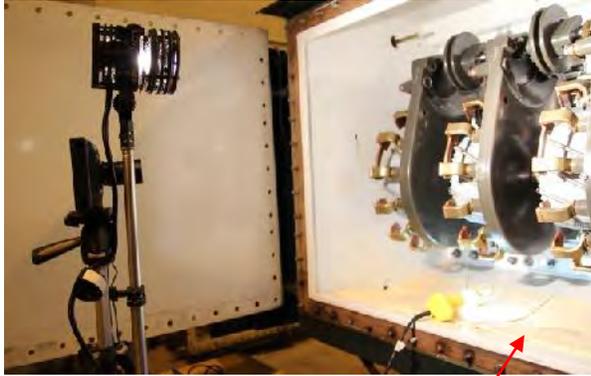
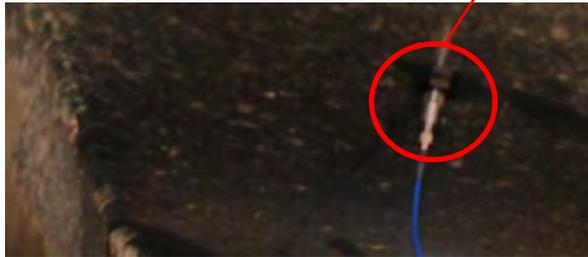
Fig. 1.3 High speed camera and position of accelerometer under OLTC.

In order to catch the highest amplitude of noise, the accelerometer has been located as close as possible to the moving taps. At the same time, a high speed camera has been placed in front of the mechanism to record the OLTC in operation (Fig. 1.3).

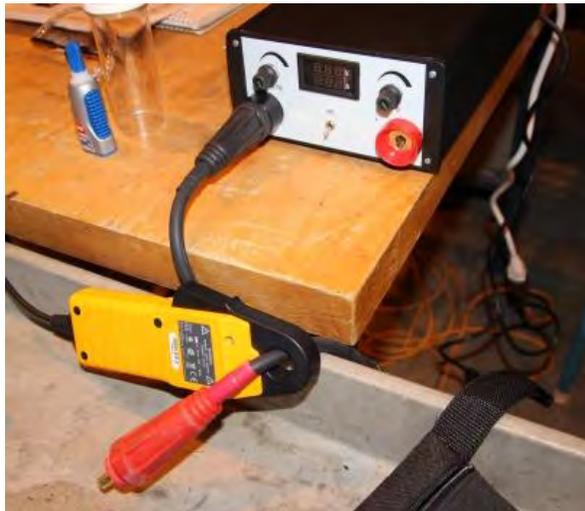
Fig. 1.4 DC voltage source and current clamp

To complete the set-up, a DC voltage source and a DC current clamp have been connected on the transformer, as shown in Fig. 1.4, Fig. 1.5 and Fig. 1.6.

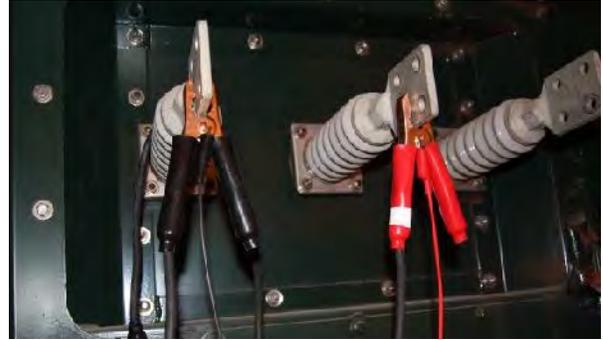
Fig. 1.5 Connection of contact clamps on the transformer

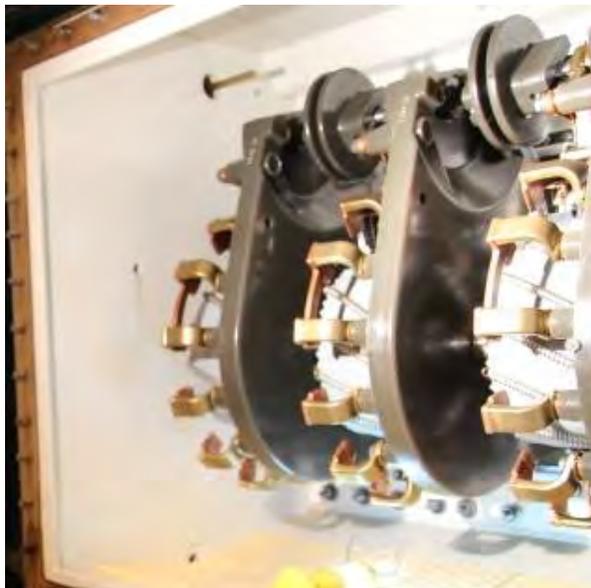
Fig. 1.10 Position 1 of the second accelerometer (Blue)

The truthfulness of this conclusion has been proved by the signatures recorded by a second accelerometer, installed directly on the mounting base of the fixed contacts (Fig.1.10). Fig. 1.11 shows a comparison of the two accelerometers signatures with respect to the dynamic current curve. As it can be observed, the relation between the current and the movements of the operating contacts is confirmed in both the accelerometer signatures. The additional two impacts of the external accelerometer (in red) can be probably related to ancillary mechanisms operating around the OLTC (such as brakes or springs).

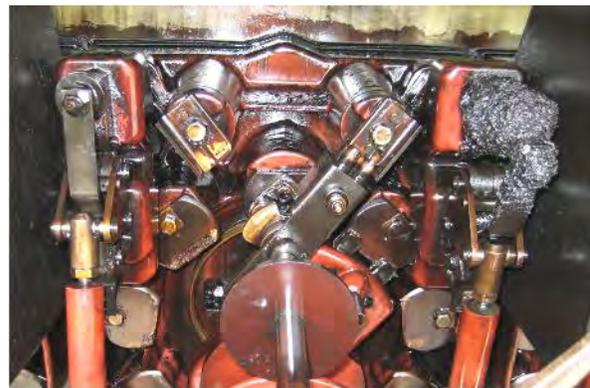
Fig. 1.14 Coking and burnt contacts of a TC-546

As a second example, here are tests done on a Federal Pioneer TC546. Over a three year period multiple interventions were done where the vibro-acoustic measurements were recorded, but not analyzed. In 2013, high values in dissolved gas analysis were picked up. The vibro-acoustic measurement were done before and after the maintenance as their norm specify. When they opened the tap changer, they discovered a lot of coking and burnt contacts. (Fig 1.14)
