DIAGNOSTIC/TYPICAL SIGNATURES

February 1st, 2013

Contents per Brand and Model

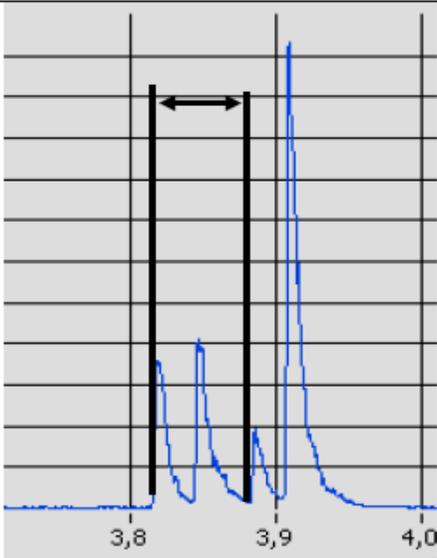
#9 ABB – UC (B, C, D, G and L) - Time of transition not perceptible

<p>Time of transition well identified</p>

<p>Time of transition barely perceptible</p>	<p>When the transition time is barely perceptible by a visual examination of the acoustic signature, the most likely causes are:</p> <ul style="list-style-type: none"> -Misalignment of the mechanism (pass-through bolts) -Wear of the mechanism -Wear of the driving ring <p>These anomalies are followed by an assymetry between even and odd operations. Contacts badly worn may also complicate the identification of the 3rd pic, but without causing an assymetry.</p>

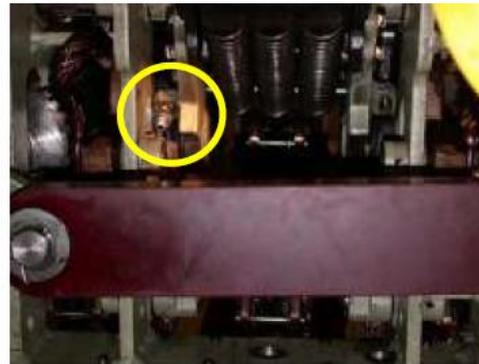
Wear of driving finger and ring

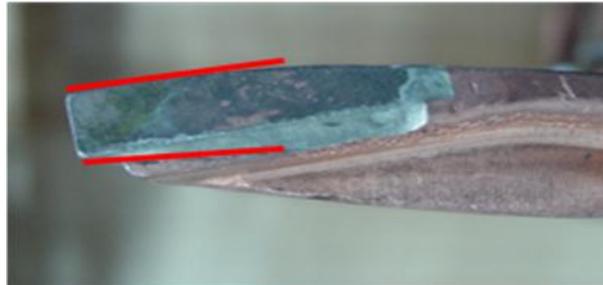
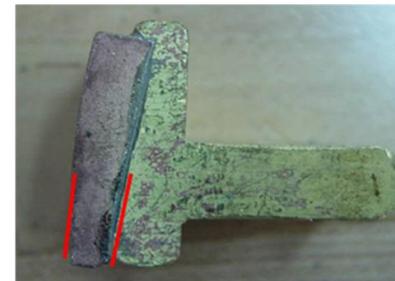
#13 ABB – UCCRN - Contact wear by missing impacts

The closing of the main contacts becomes very weak with the wear of contacts.

Contact wear is confirmed by opening up the ABB UCCRN tap changer and replacing the arcing contacts, as highlighted by the traces.

The loss of material caused by the wear of the driving contacts, for inertial effect, a variation in the sequence and a reduction of the impact noise of the main arc contacts. Trending of the suspected contacts is necessary to know the speed of the degradation.

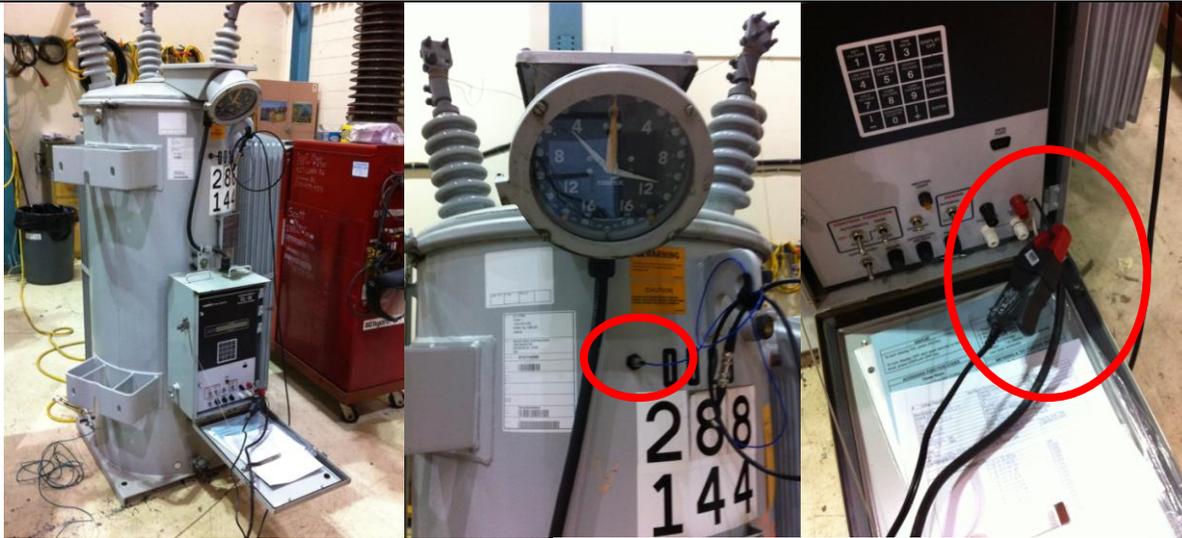
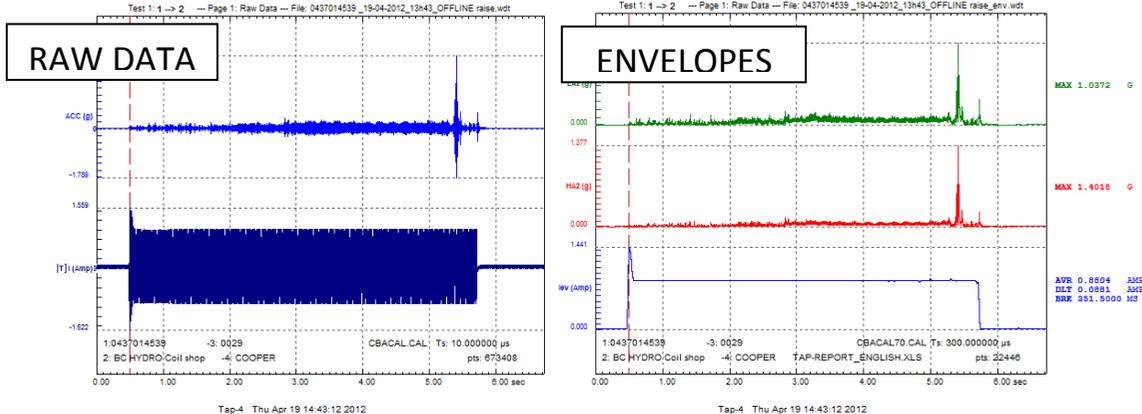
#63 Other application – COOPER VR 32 voltage regulator with CL 5C control

Exploratory tests have been performed on a voltage regulator as a tap changer is used inside. Results are pretty similar to the ones we obtain when we do tests on transformer's tap changers.

We notice that the impact amplitude is quite low. It would be interesting to use a more precise accelerometer with a + or – 10G limitations instead of + or – 50Gs as we did.

It also would be interesting to do a test on a same kind of regulator in order to compare each other as we do on transformer's tap changers.

Tests have been performed OFF-LINE with accelerometers with a limitation of + or – 50G and AC current clamp.

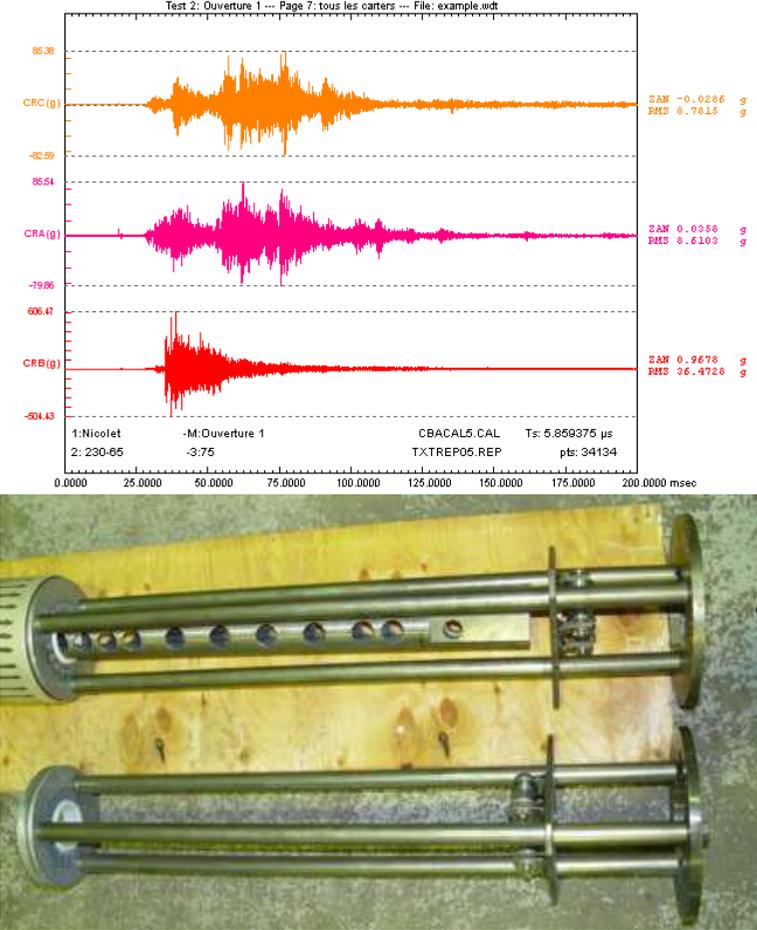
#65 Other application – Circuit breakers (bad assembly)

<p>The figure displays three stacked vibration waveforms for phases CRC (orange), CRA (magenta), and CRB (red). The x-axis represents time in milliseconds from 0.0000 to 200.0000. The y-axis represents acceleration in g. The CRC waveform shows a peak of 85.38 g. The CRA waveform shows a peak of 85.54 g. The CRB waveform shows a significantly higher peak of 606.47 g. Statistical data for each phase is provided on the right:</p>

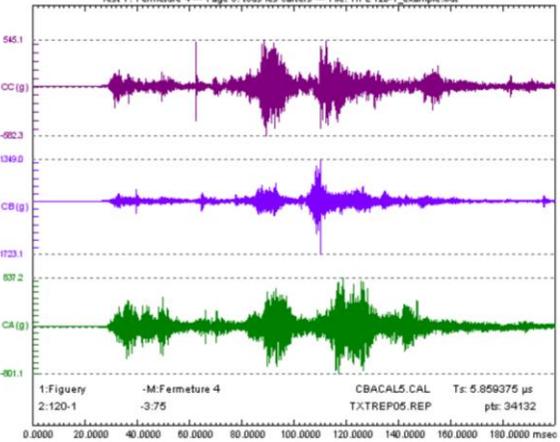
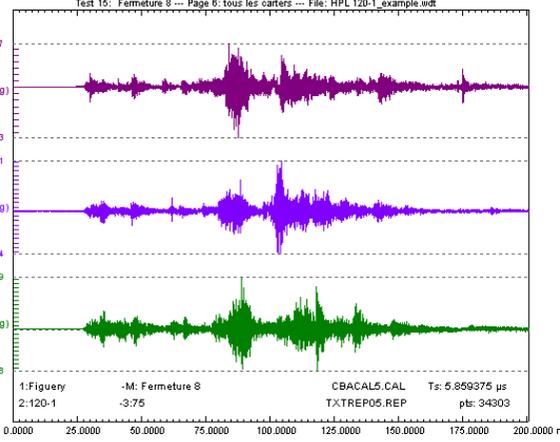
#66 Other application – Circuit breakers (bad adjustment)

<p>BEFORE REPAIR</p> </div> <div style="text-align: center;">

<p>AFTER REPAIR</p> </div> </div> <div style="display: flex; justify-content: space-around; margin-top: 10px;">

</div>	<p>This example shows two cases where a bad adjustment has broken the casing of a breaker that has produced an explosion and the other has produced a SF6 alarm. These two cases have been detected thanks to vibration testing.</p> <p>The figure shows the high impacts around 1300G for the middle trace which is phase B, whereas phases A and C show amplitude around 500G.</p>
<p>Notes: We see after repair, similar shapes and amplitudes for all three phases. The pictures show impact marks inside the casing of phase B.</p>
