Diagnostic Cards
-
ABB UC - models B, C, D, G and L

Diagnostic Cards

ABB UC - models B, C, D, G and L

The diagnostic cards that follow focus on the symptoms of major problems of tap changers (OLTP) of the ABB UC family, models B, C, D, G, and L, as seen by their acoustic signatures. It is important to note that several of the anomalies illustrated do not show up in the tabular report of the DIAC software.

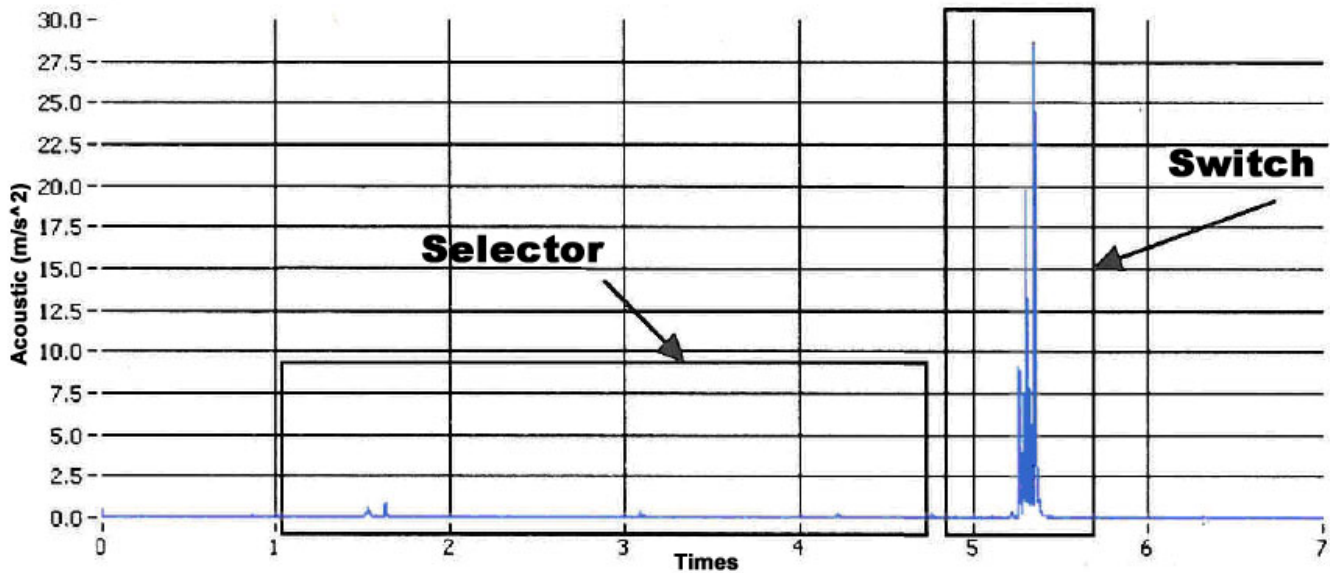
Card 1: Asymmetry of signatures switching

Symmetrical even and odd signatures

To check the symmetry of the switch, you must graphically superimpose the signature of an even operation to an odd one.

The probable causes of this asymmetry are:

- ✓ The excessive wear of the **driving wheel** of the switch
- ✓ A bad adjustment of the switch (adjustment screw – pass-through bolts)
- ✓ An uneven wear of contacts between the even and odd sides

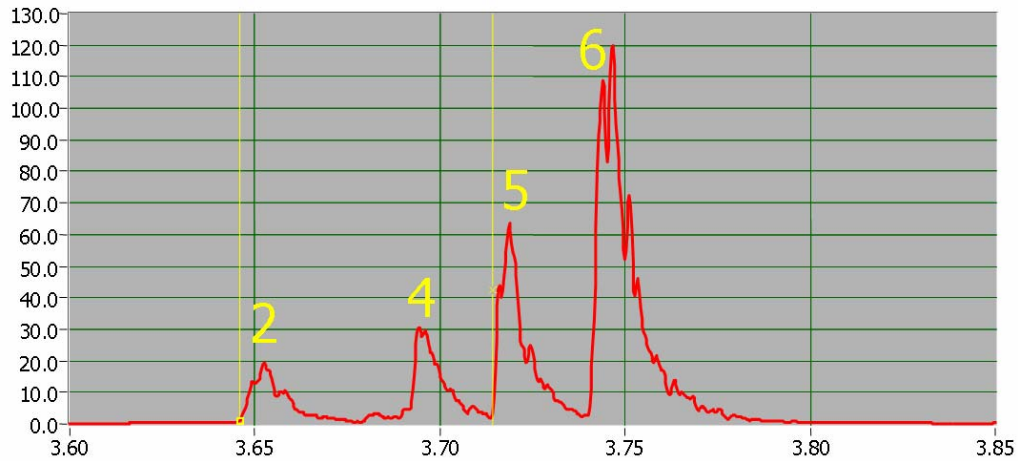
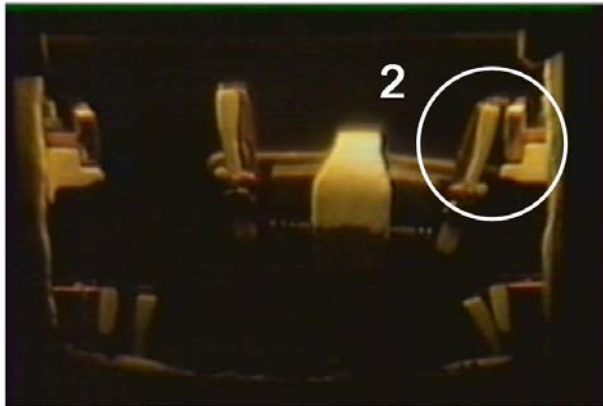
Card 2: Calculation of the transition time**Models :**
All

Opening of the main contacts, right side

The switching of ABB-UC has 6 stages, which has distinctive acoustic signatures for a switch in good condition, 4 contacts events to assess the transition time (duration of insertion resistance) by the difference defined by steps 2 and 5 identified above. Values may vary depending on the switch but are typically between 40 ms (e.g.: UCB) and 70 ms (e.g.: UCC).

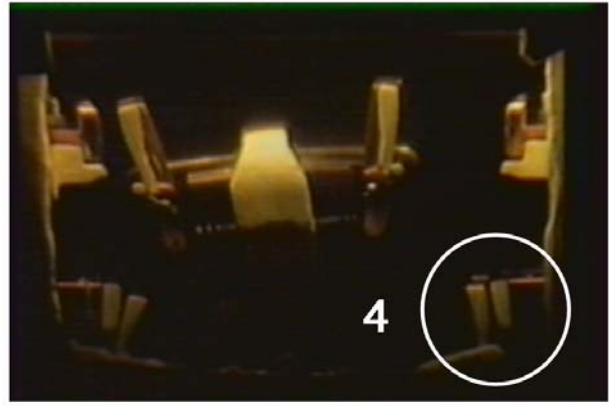
Opening of the auxiliary contacts, right side

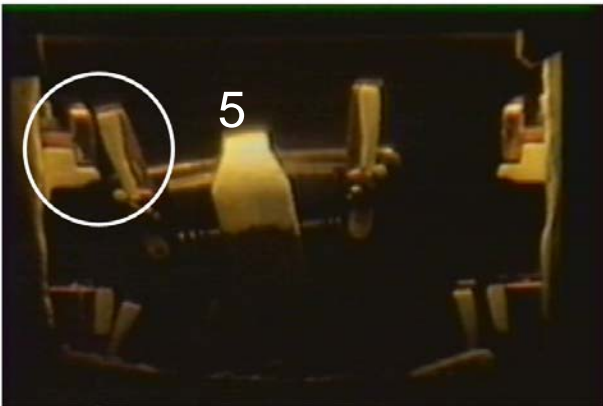
Closing the main contacts on the left side

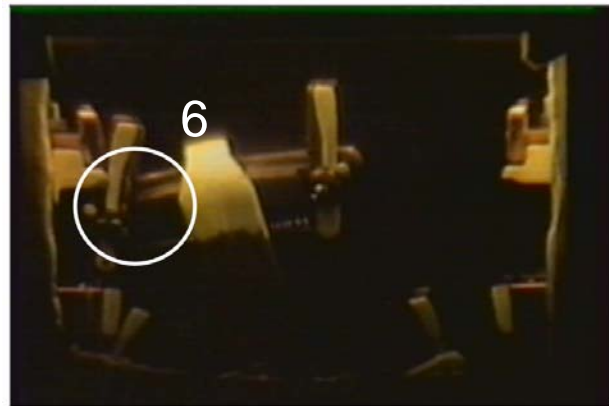
Stop at the end of the limit switch

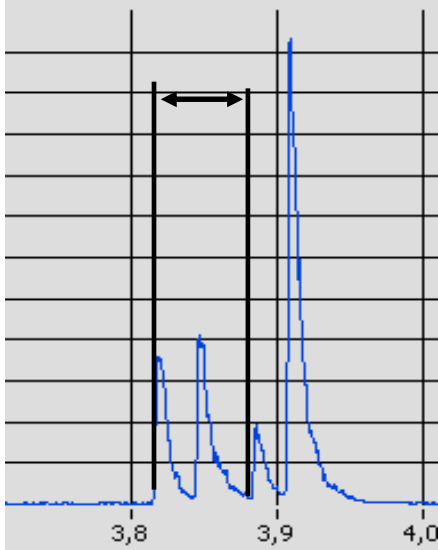
Card 3: Time of transition not perceptible

Time of transition well identified

When the transition time is barely perceptible by a visual examination of the acoustic signature, the most likely causes are:

- ✓ Misalignment of the mechanism (pass-through bolts)
- ✓ Wear of the mechanism
- ✓ Wear of the **driving** ring

These anomalies are followed by an asymmetry between even and odd operations. Contacts badly worn may also complicate the identification of the 3rd pic, but without causing an asymmetry.

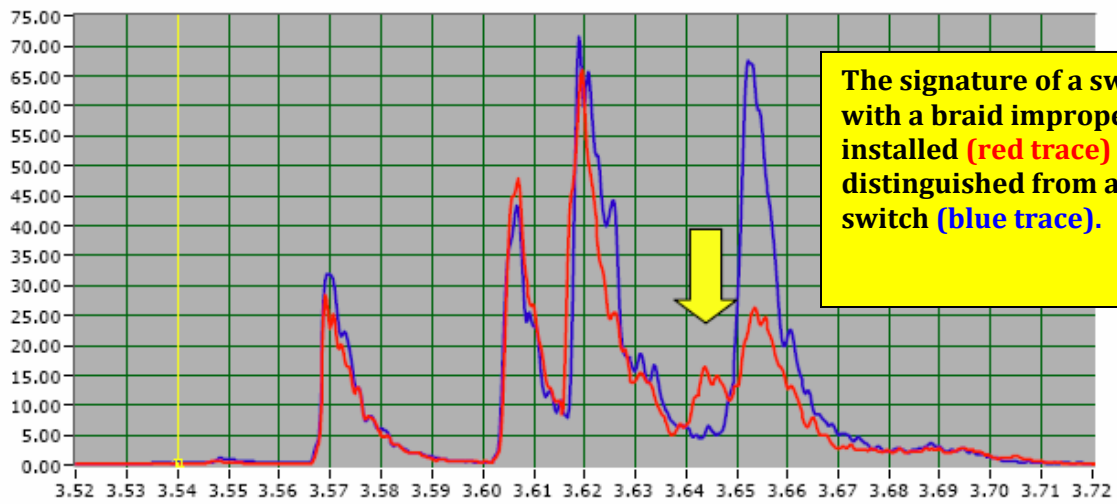
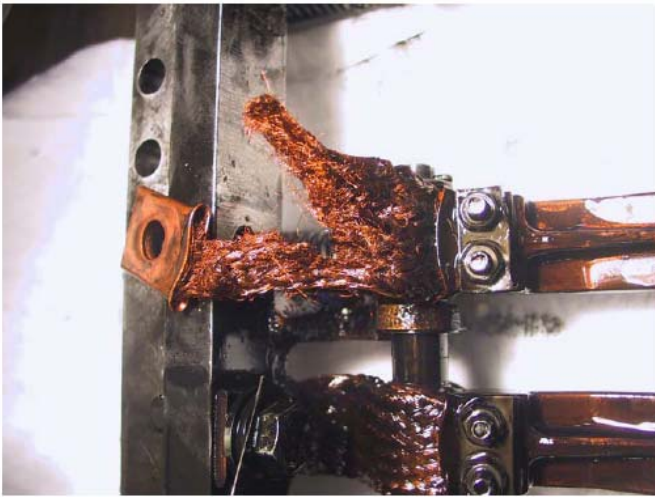
Card 4: Braid improperly installed

Braid connecting the moving contacts

An improper installation of the braid may interfere with the operation of the mechanism and eventually cause its failure.

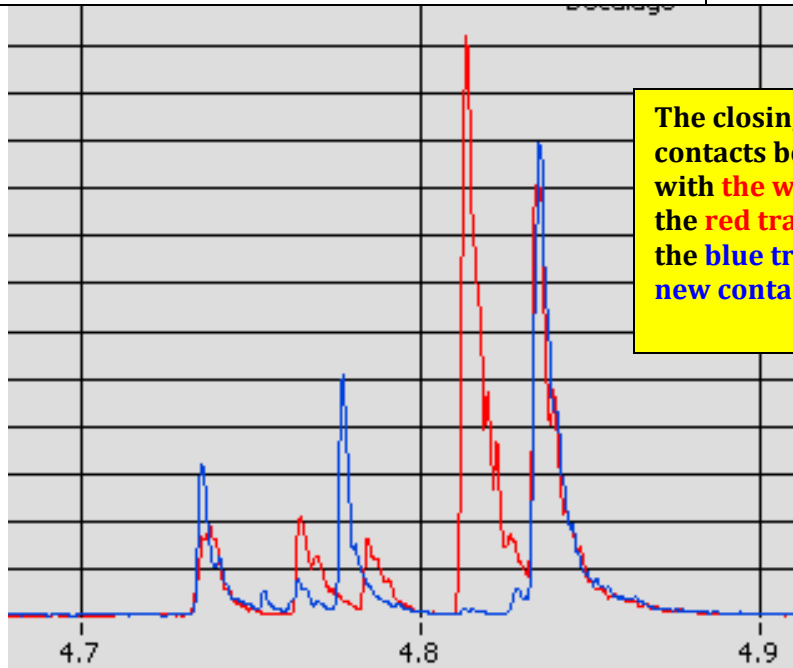
Card 5: Wear of the arcing contacts

Worn contacts (before repairs)

The loss of material caused by the wear of the driving contacts, for inertial effect, a variation in the sequence and a reduction of the impact noise of the main arc contacts.

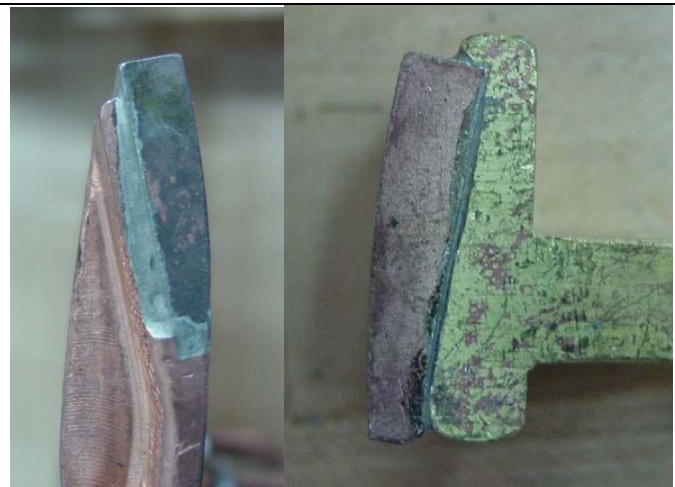
New contacts

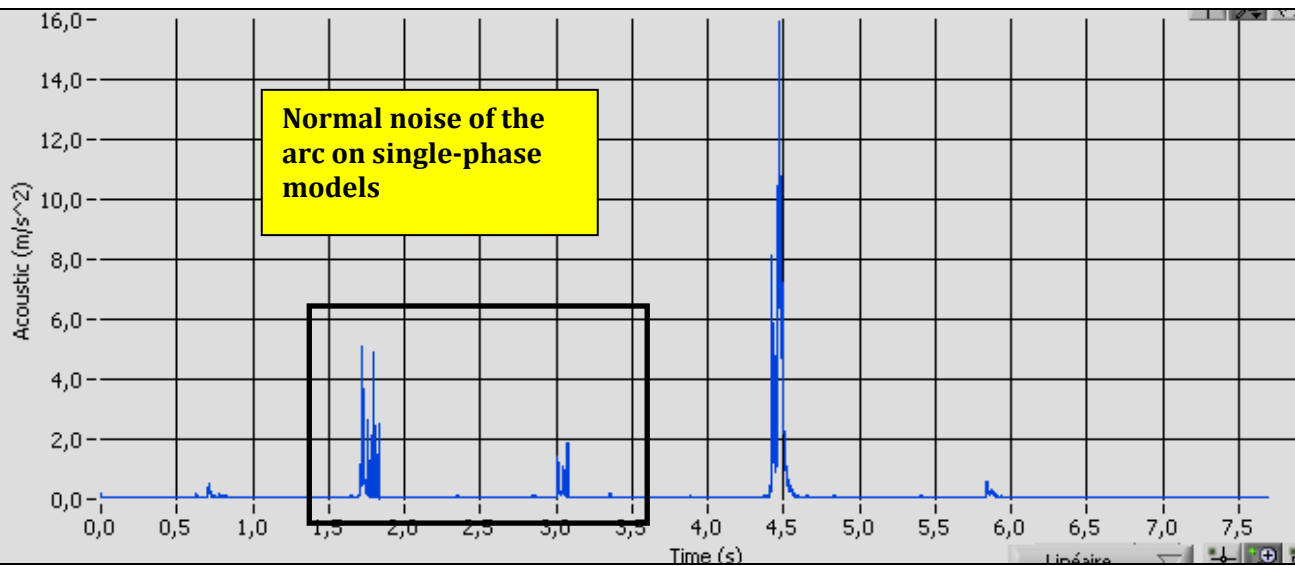
Note: For single-phase models, this noise can be confused with a normal arc noise when the test is performed under voltage (see figure below). These arc noises can be observed both at departure and arrival of the selector. The amplitude is usually a little higher at the departure of the selector when the movement **remove the turns of regulation** and vice versa for the arrival. For these models, the misalignment of contacts can be observed only if the test is performed **disconnected from voltage**.

Normal noise of the arc on a single-phase model (UCBRT)
